Aquatic Ecology Survey Site Images

TEN-T Priority Route Improvement Project, Donegal

TT_MGT0337-RPS-P3-ZZ-RP-E-EN0001

EIAR

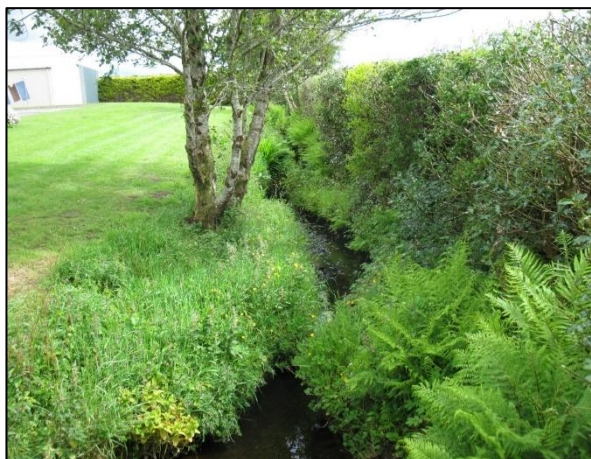
W1-01 (June 2020) Tributary of Burn Daurnett, view downstream of crossing point.

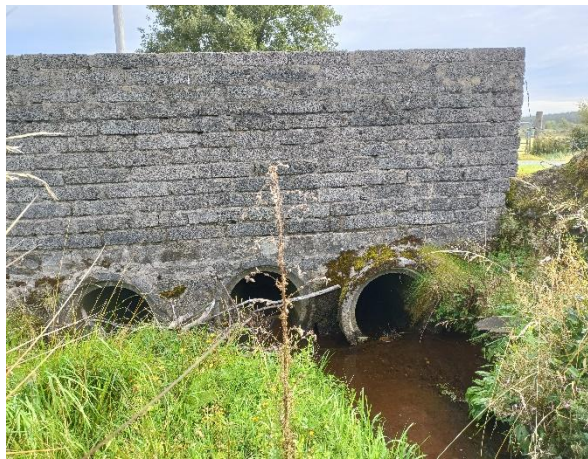
W1-01 (Sept. 2024) Tributary of Burn Daurnett, view of existing triple pipe culvert and headwall.

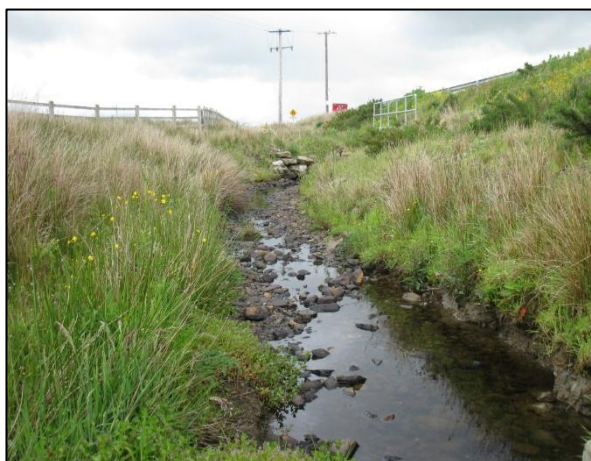
W1-02 (June 2020) Tributary of Burn Daurnett following N15 culvert upgrade.

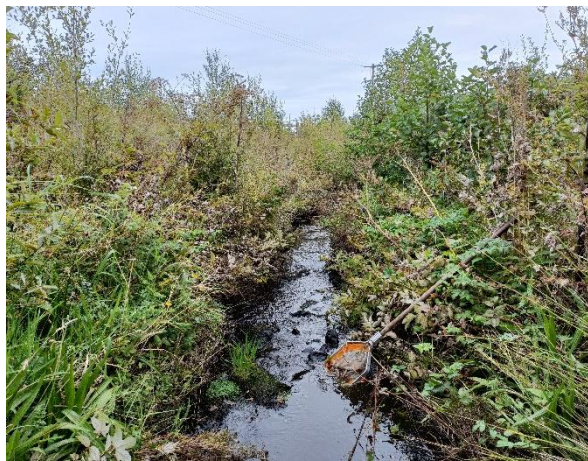
W1-02 (Sept 2024) Tributary of Burn Daurnett , riparian scrub regrowth and channel 'naturalising' after culvert upgrade.

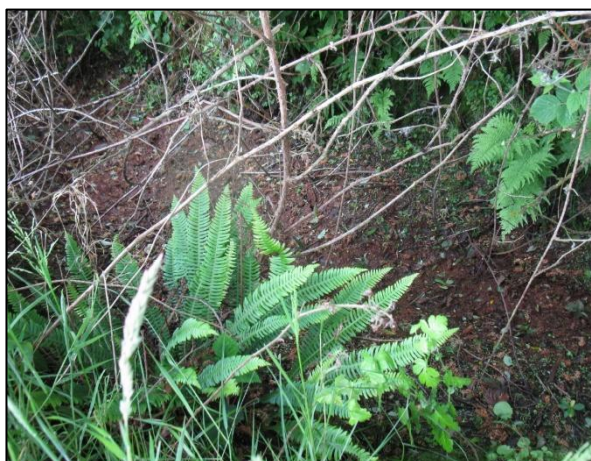
W1-03 (Sept 2025) Cappyry: dry ditch, ephemeral.

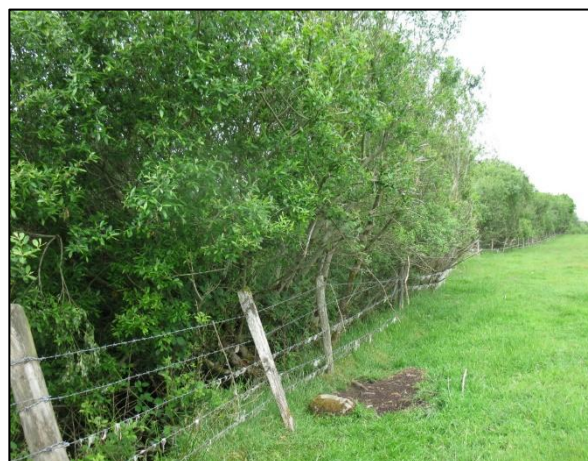
W1-04 (Sept 2025) Cappyry: dry ditch, ephemeral.

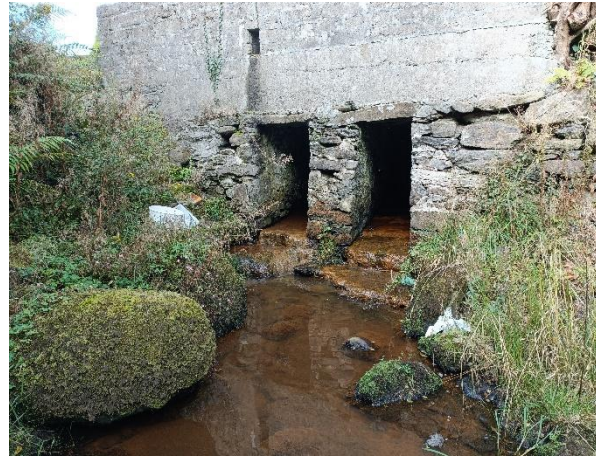
W1-05 (Sept. 2024) Cappry, downstream of crossing point – sewage fungus on culvert apron

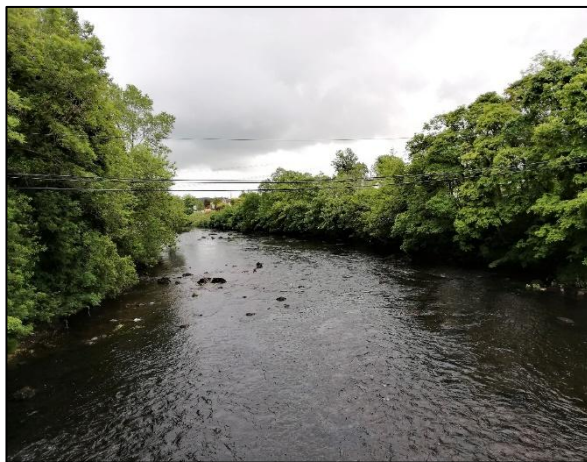
W1-06 (June 2020) River Finn at crossing point

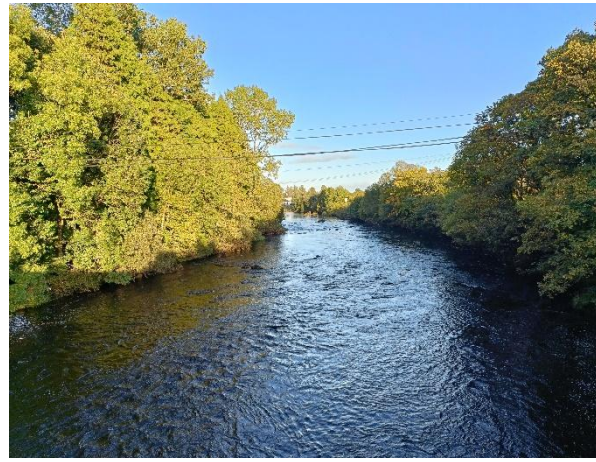
W1-06 (Sept 2024) River Finn at crossing point, view downstream

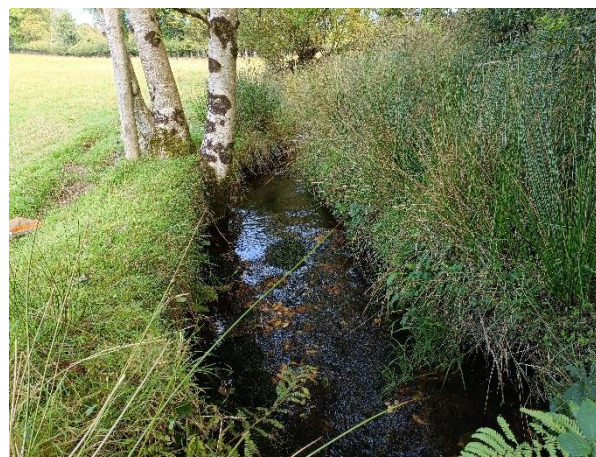
W1-07 (Sept 2024) Dromboe Lower, reach within SAC downstream of crossing point, salmonids observed.

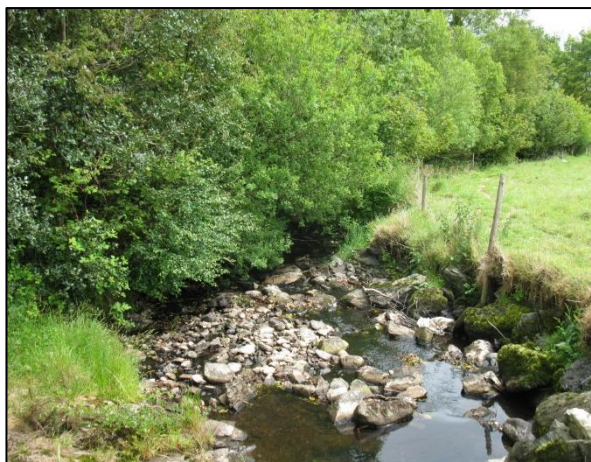
W1-08 (June 2020) Backlees, view downstream in crossing reach.

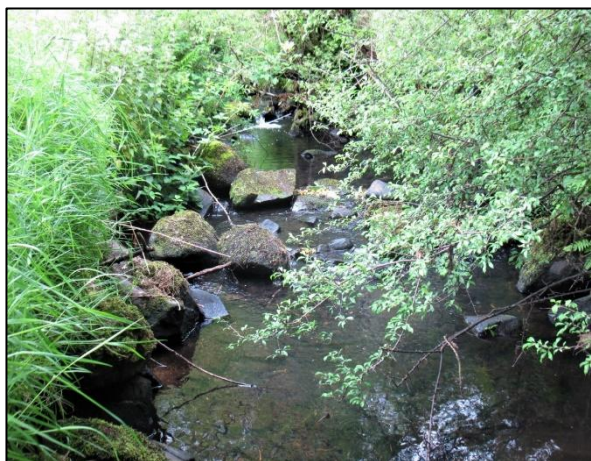
W1-09 (Sept 2024) Backlees, upstream of W1-08.

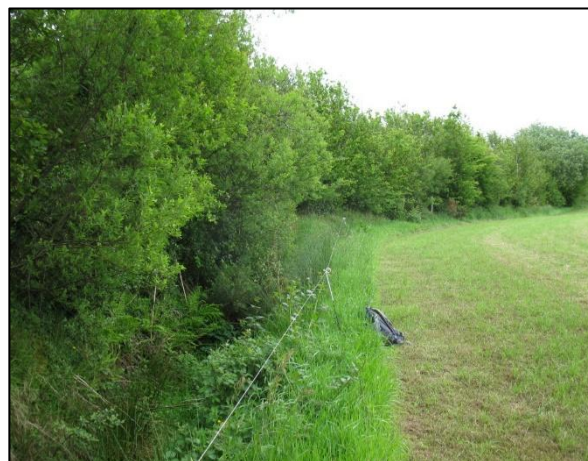
W1-10 (June 2020) Greenhills 01: damp/dry field boundary drain. No change observed Sept. 2024.

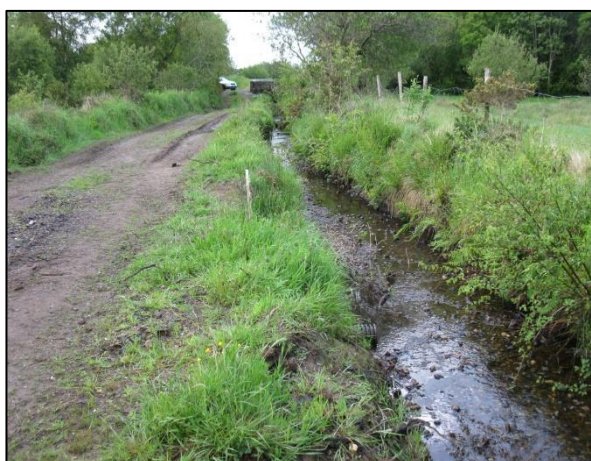
W1-11 (June 2020) Magheracorran (at Teevickmoy), view downstream towards N13 crossing. Trout observed.

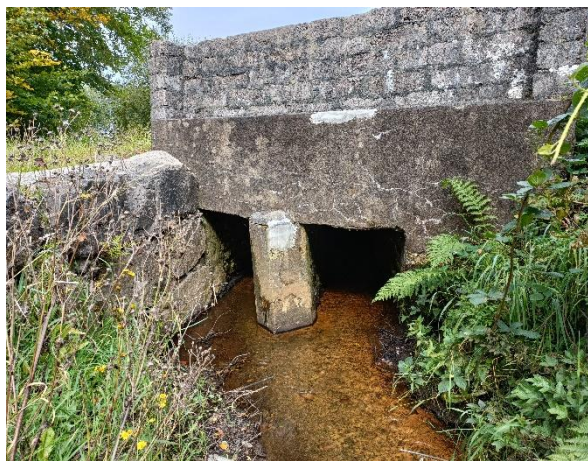
W1-11 (Sept. 2024) Magheracorran, view downstream at N13 culvert entrance. Trout observed.

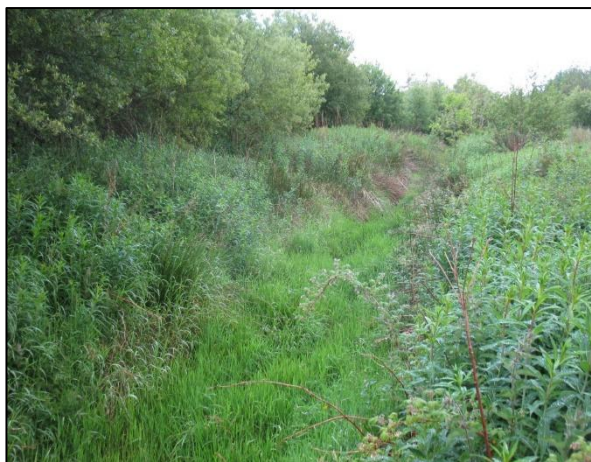
W1-12 (June 2020) Lisnaree, virtually dry / stagnant drain.

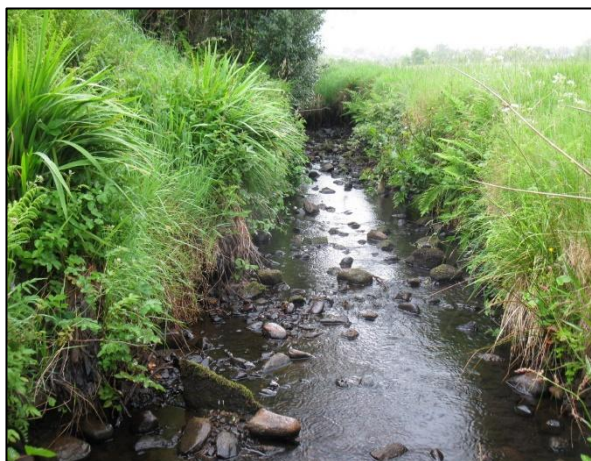
W1-13 (June 2020) Magheracorrán, downstream crossings at N13 tie in. No change to habitat in 2024.

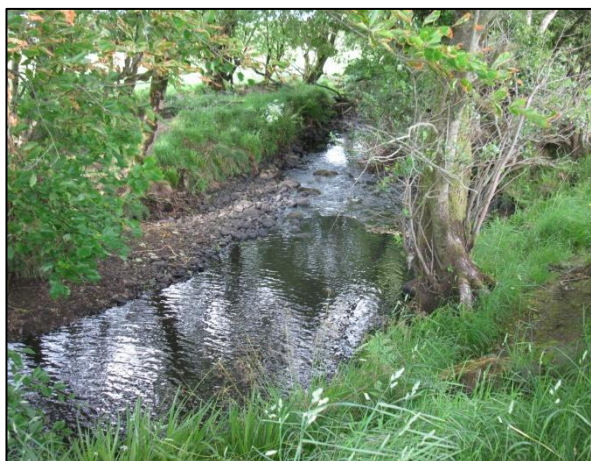
W1-14 (June 2020) Cloghroe River, view downstream in crossing reach. No change to habitat in 2024.

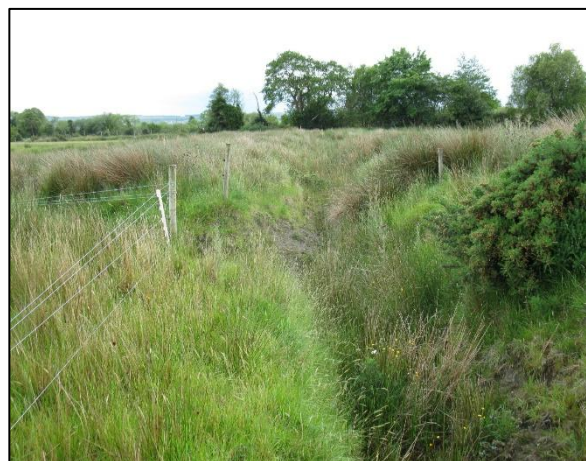
W1-15 (Sept 2024) Kilross 01, upper headwater of Lough Alaán – dry drain.

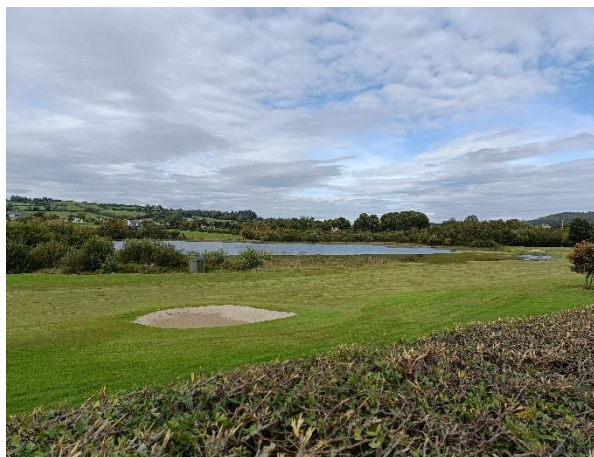
Lough Alaán (Sept. 2024). Reed fringed lake set in Ballybofey and Stranorlar Golf Course.

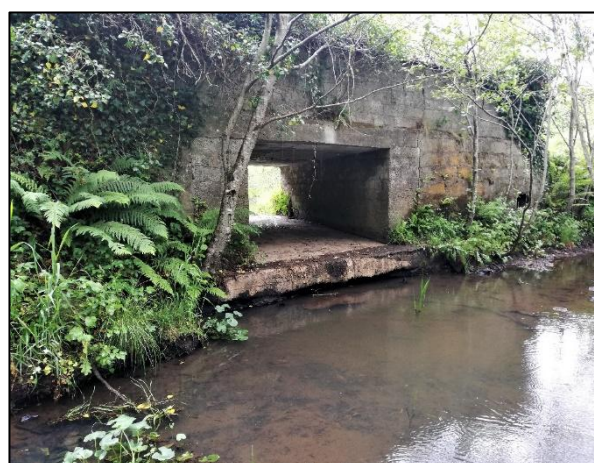
W1-17 (Sept 2024) Mullaghagarry, existing culvert on local road. Flow is undermining culvert bed. Fish passage barrier.

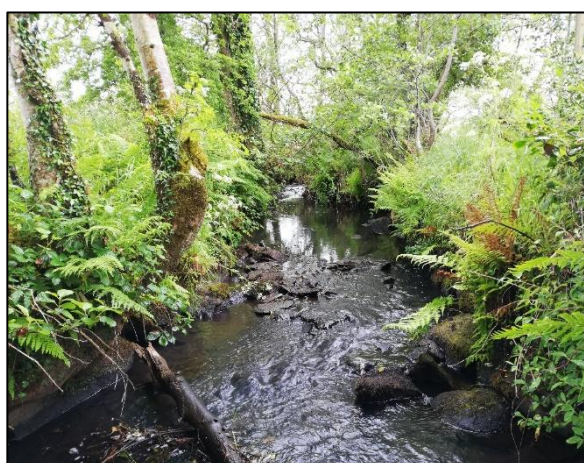
W1-18 (June 2020) Mullaghagarry, typical instream habitat. No change in 2024.

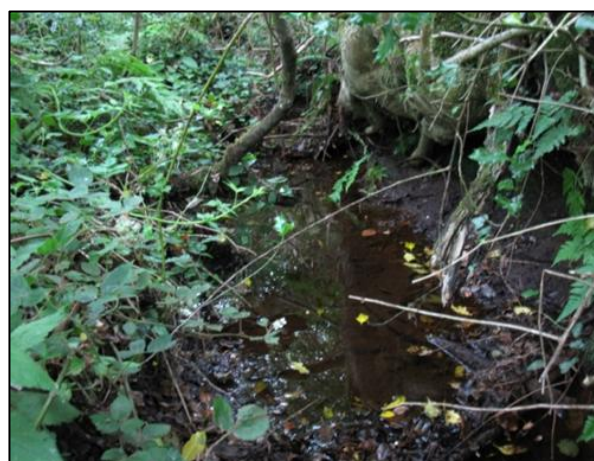
W1-19 (Sept 2024) Treanamullin, minor field drain.

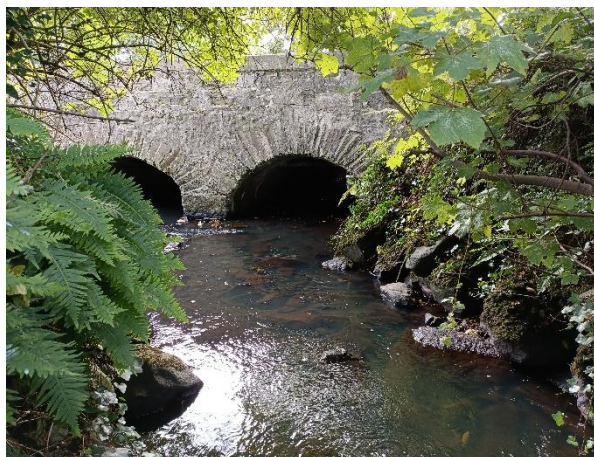
W1-20 (Sept 2024) Mullaghagarry, existing N15 stone arch culvert. Salmonids observed.

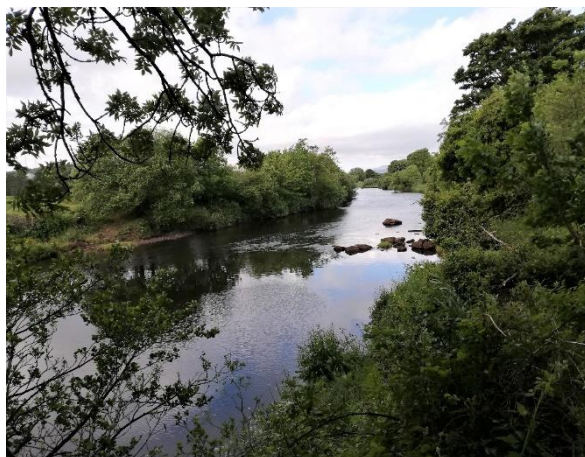
W1-21 (Sept. 2024) River Finn downstream of Mullaghagarry confluence.

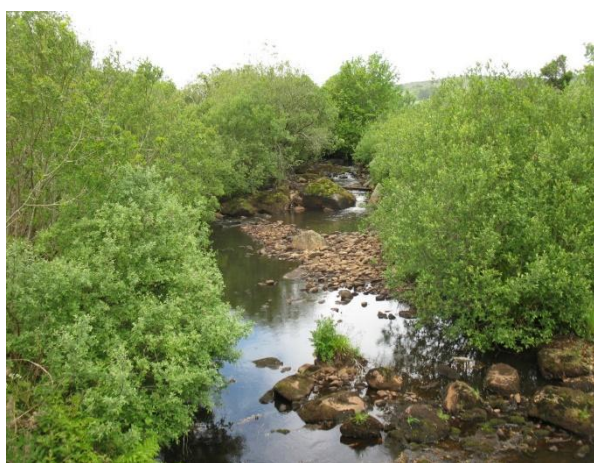
W1-22 (June 2020) Burn Daurnett, view upstream near Cappry. No direct impact on this site, Indirect effects only.

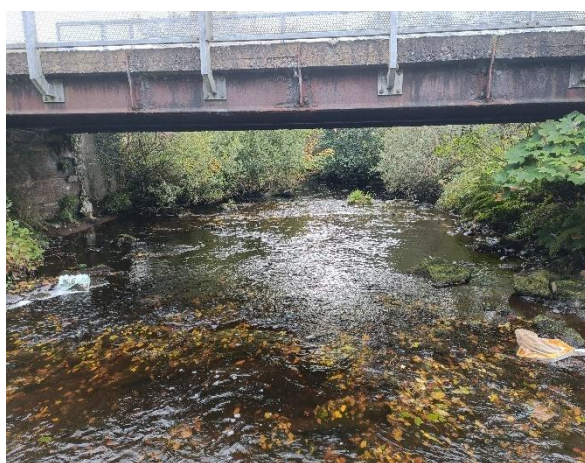
W1-22 (Sept. 2024) Burn Daurnett, view downstream near Cappry.

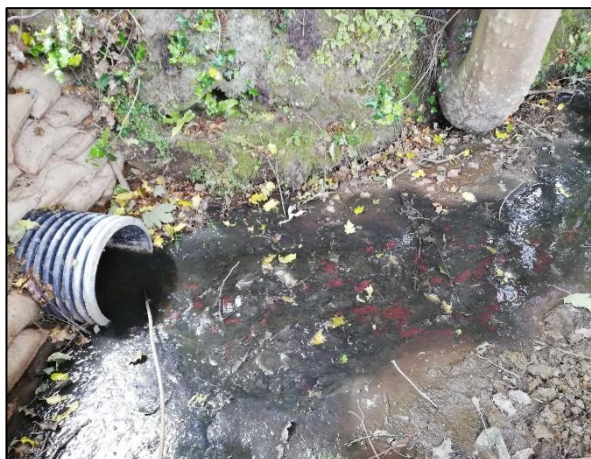
W2-01 (June 2020 and Sept. 2024) Unnamed tributary of Swilly in Drumany - polluted discharge.

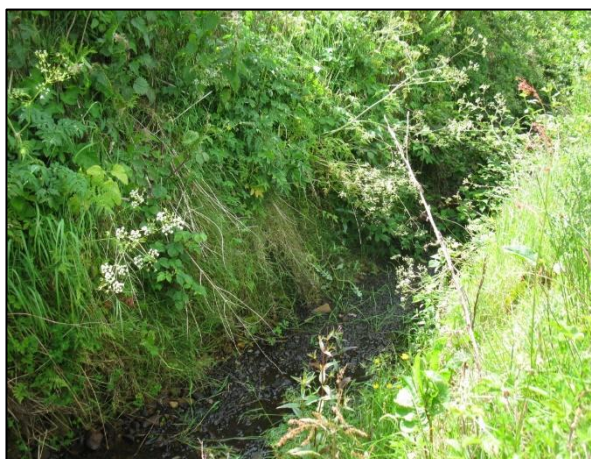
W2-02 (June 2020 and Sept. 2024) Side branch of Drumany tributary. No flow, small pools of residual water only

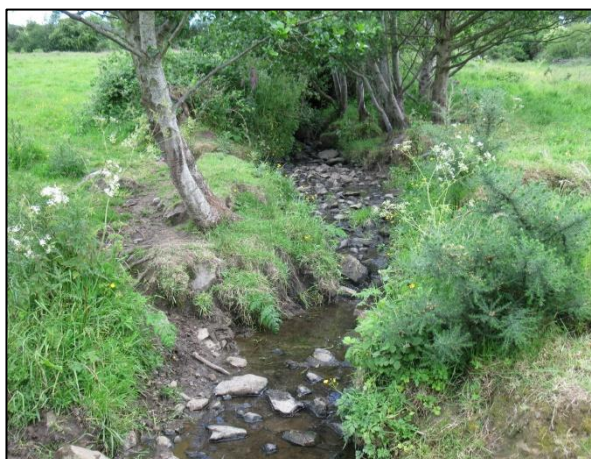
W2-04 (June 2020) Unnamed tributary of Swilly in Drumany - flows into screened pipe/culvert under existing road just downstream

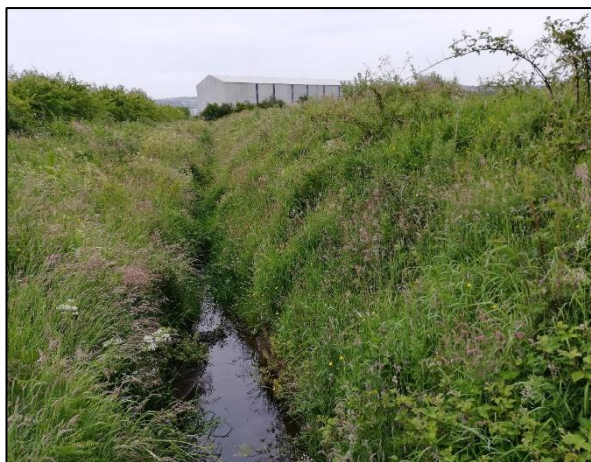
W2-05 (June 2024) Unnamed tributary of Swilly near Drumany Lower / Bunnagee– almost stagnant drain, trickle flow upstream

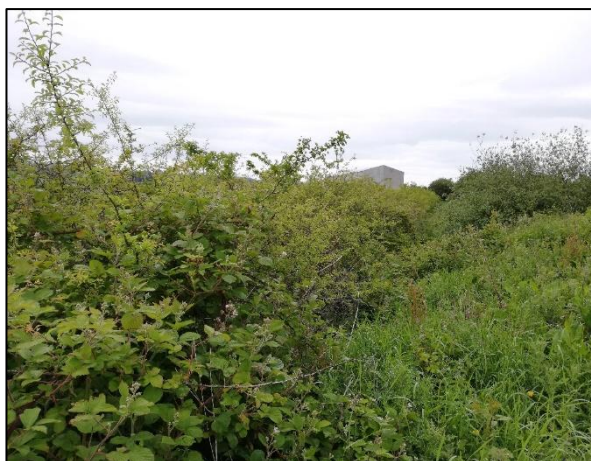
W2-06 (June 2020 and Sept. 2024) Bunnagee drain – dry.

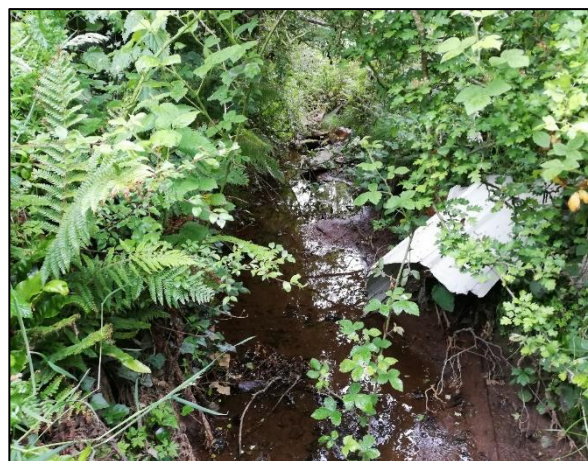
W2-07 (June 2020 and Sept. 2024) Deepened drain, stagnant to trickle flow over silty substrate.

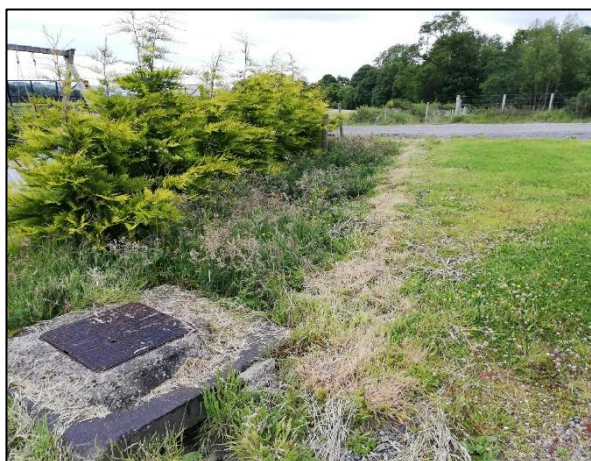
W2-08 (Sept. 2024) piped at upper end of watercourse in crossing reach.

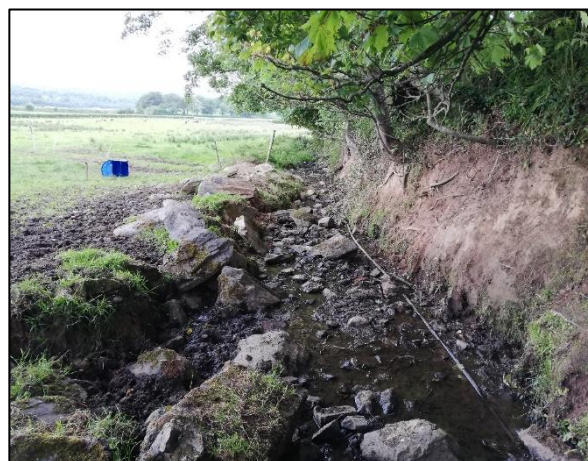
W2-08 (Sept. 2024) cattle access downstream in field boundary ditch – heavily polluted

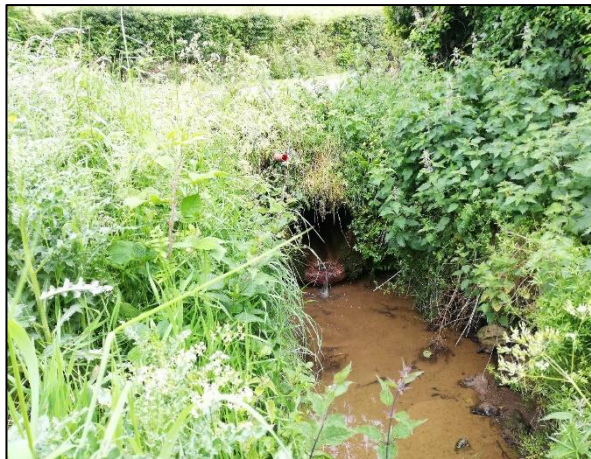
W2-09 (June 2020) watercourse is piped along urban road and emerges to silty drain.

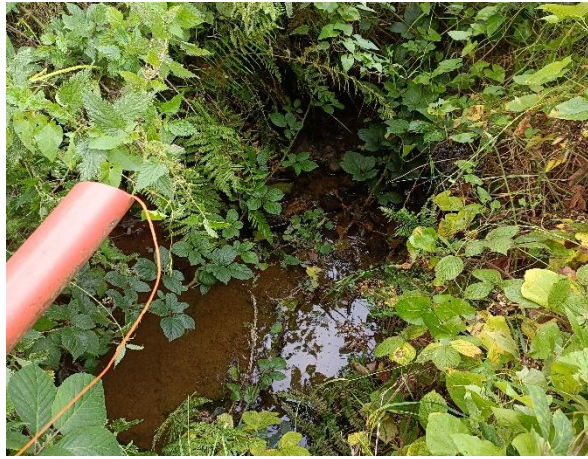
W2-09 (Sept. 2024) Stagnant outfall area from piped watercourse.

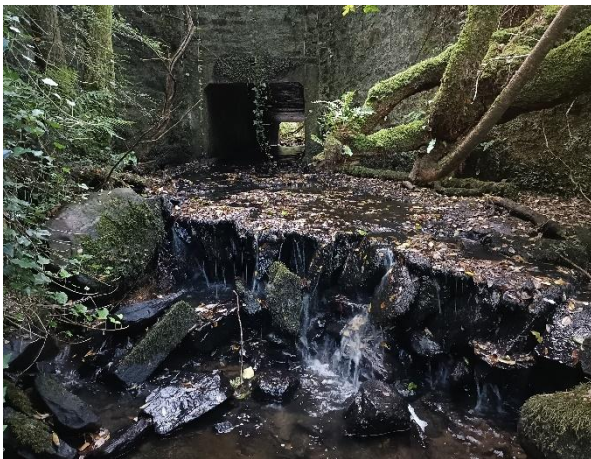
W2-10 (Sept. 2024) Farsetmore at existing local road crossing. Fish passage barrier.

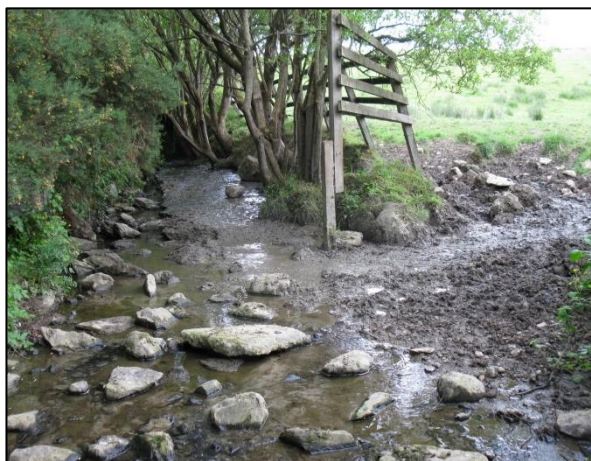
W2-12 (Sept. 2024) Farsetmore, downstream of existing N14 crossing showing polluted cattle access reach.

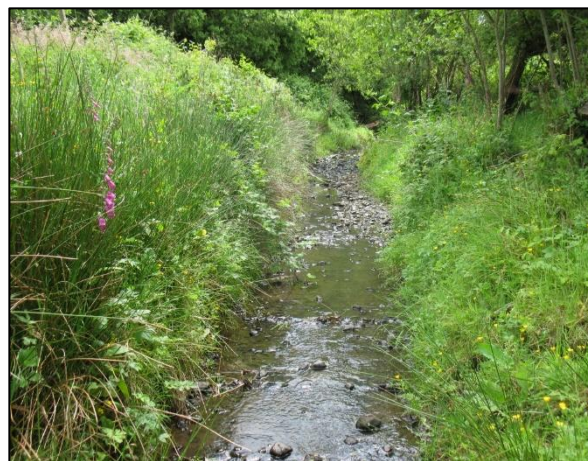
W2-12 (Sept. 2024) Farsetmore, downstream of existing N14 crossing and downstream of cattle access – should be a trout stream.

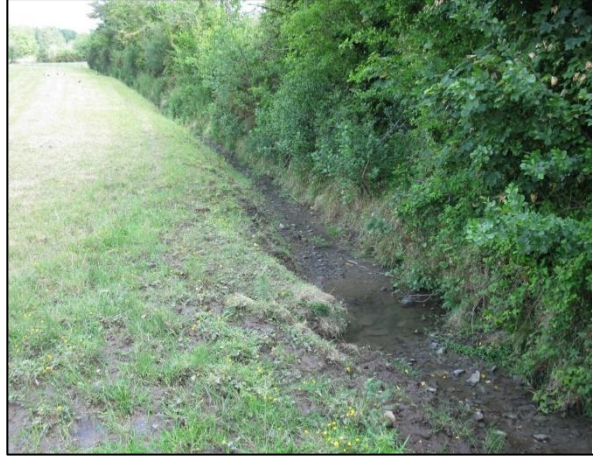
W2-14 (June 2020 and Sept. 2024) Maghera_Mor 39 – stagnant pools only, no visible flow. Ephemeral.

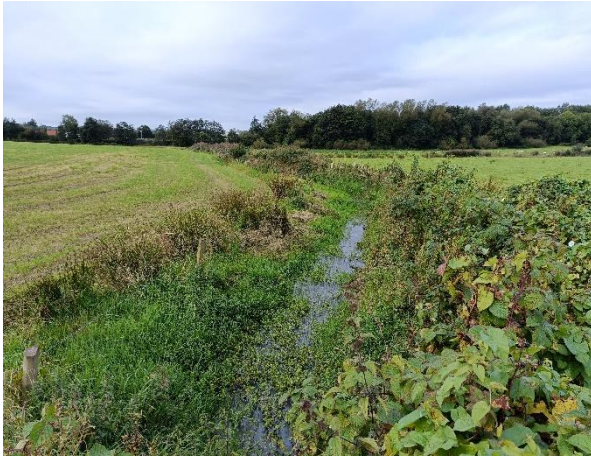
Downstream of W2-13 / W2-14 (Sept. 2024) stagnant: “linear wetland” formed by vegetated, low-gradient drain.

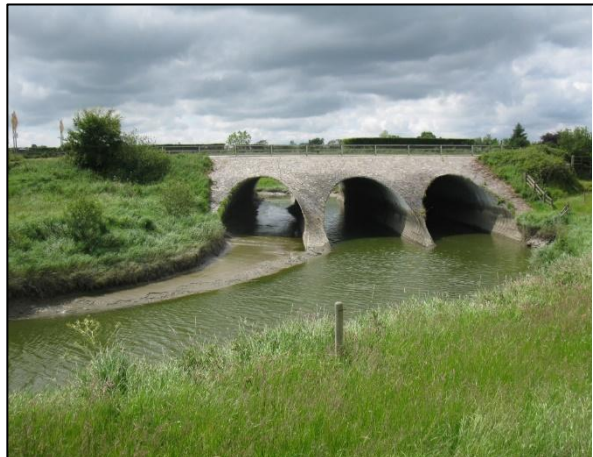
W2-15 (Sept. 2024) – Isle Burn (EPA “Leslie Hill stream”) existing crossing structure at Swilly Estuary on SAC boundary, view upstream from northern side.

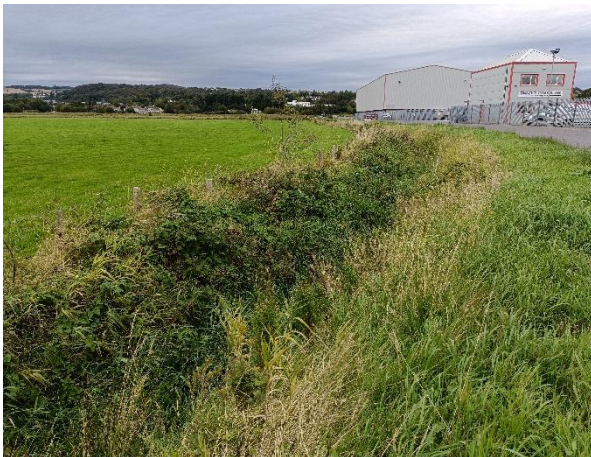
W2-16 (Sept. 2024) Milk Isle drain: virtually dry, vegetated, low-gradient drain.

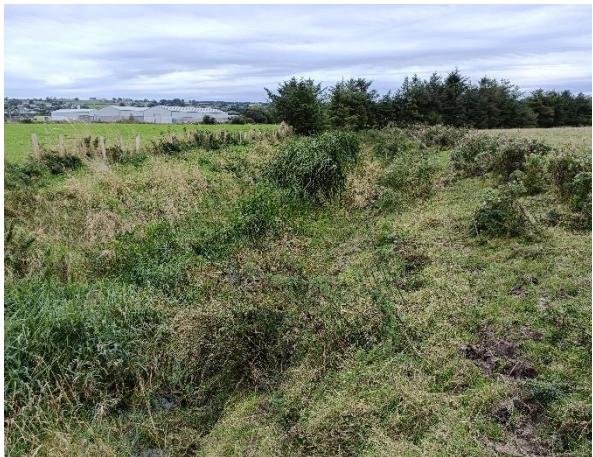
W2-17 (Sept. 2024) Milk Isle drain: virtually dry, vegetated, low-gradient drain. Some stagnant water.

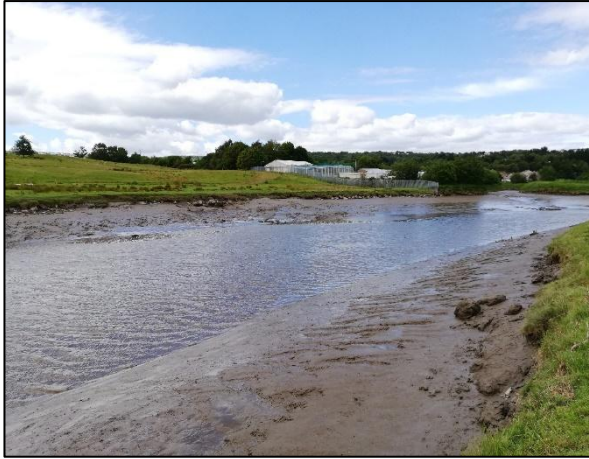
W2-18 (June 2020) River Swilly crossing location, from Milk Isle (eastern) side, view downstream at low tide showing intertidal mud.

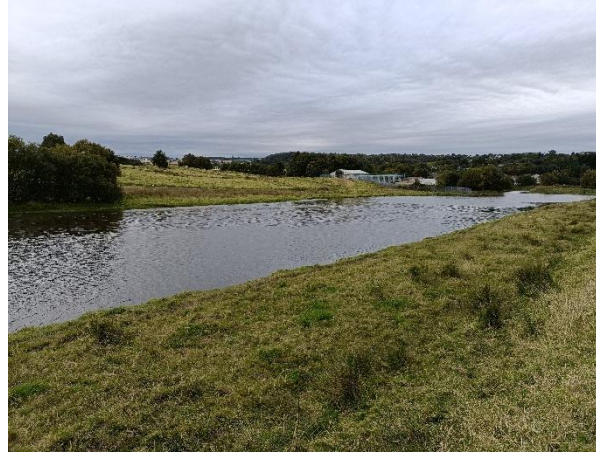
W2-18 (Sept. 2024) River Swilly crossing location, view downstream at high tide showing set back embankment area in foreground.

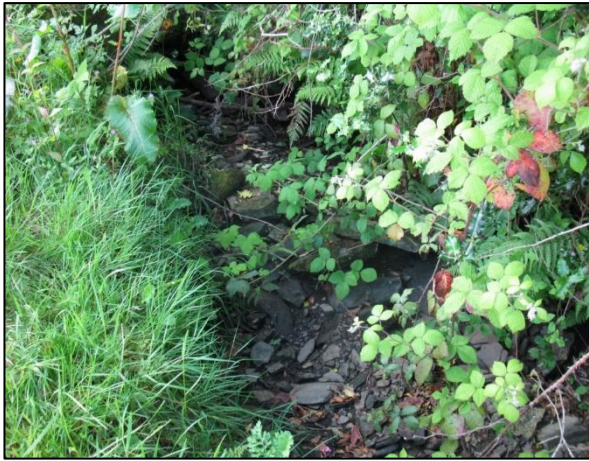
W2-19 (Sept 2024) Coaghmill – dry with occasional shallow pools.

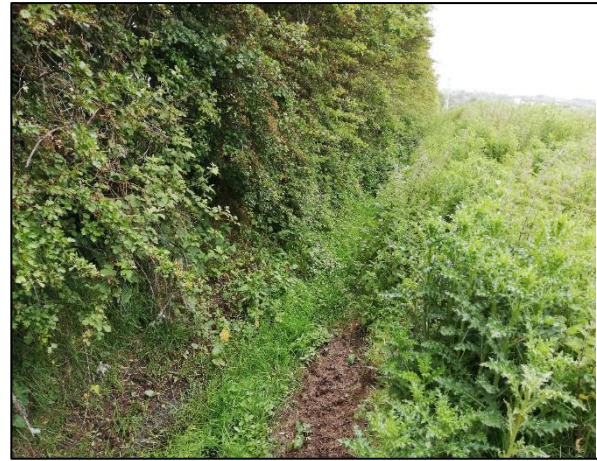
W2-20 (Sept. 2024) Bunnagee drain – generally dry, connects to W2-21 downstream.

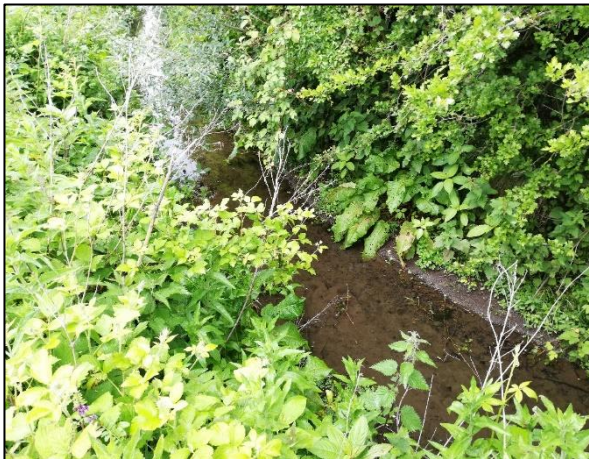
W2-21 (June 2020 and Sept. 2024). Bunnagee drain: low gradient, silty sand substrate.

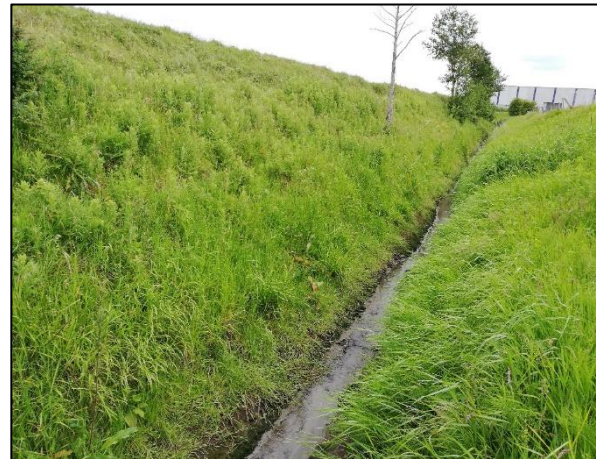
W2-22 (June 2020 and Sept. 2024) Typical embankment toe-drain at Bunnagee.

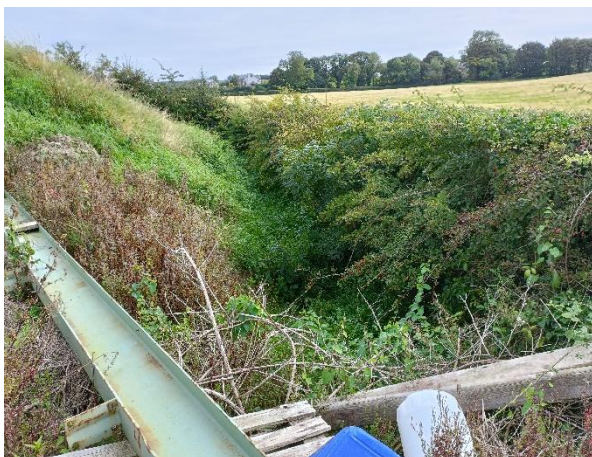
W2-23 (Sept 2024) Dromore 39, dry at crossing point, piped under industrial area access.

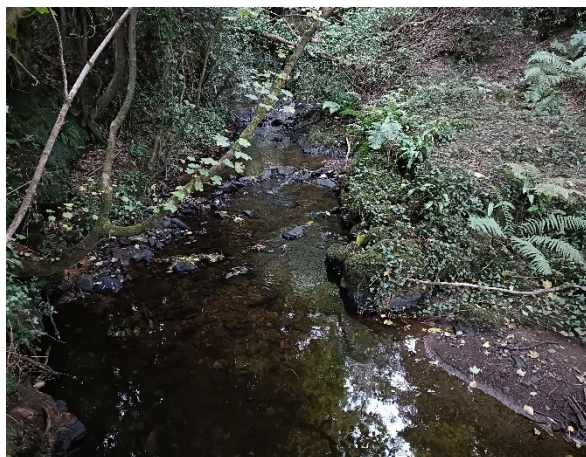
W2-24 (Sept. 2024) Corranagh Burn (EPA Lurgybrack). No direct impact but sampled downstream of proposed works in this catchment.

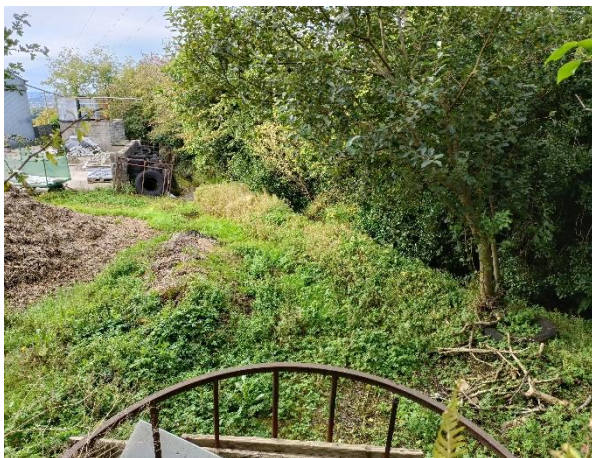
W2-25 (Sept. 2024) Ephemeral drain in Corranagh townland (connects to Lurgybrack W2-24).

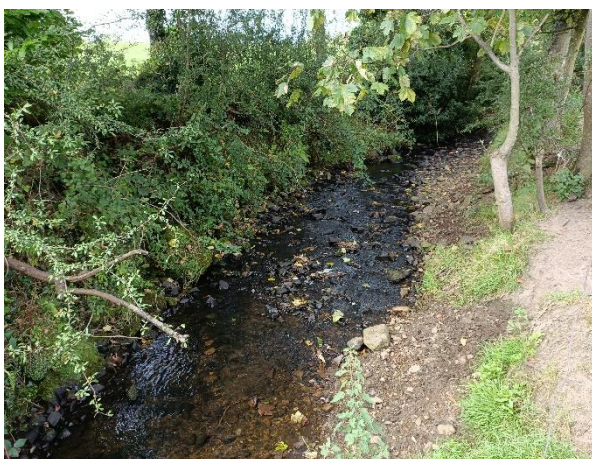
W2-27 (Sept. 2024) Magheraboy 39 in Aghelard townland, 3.7km downstream of W2-26. Trout stream.

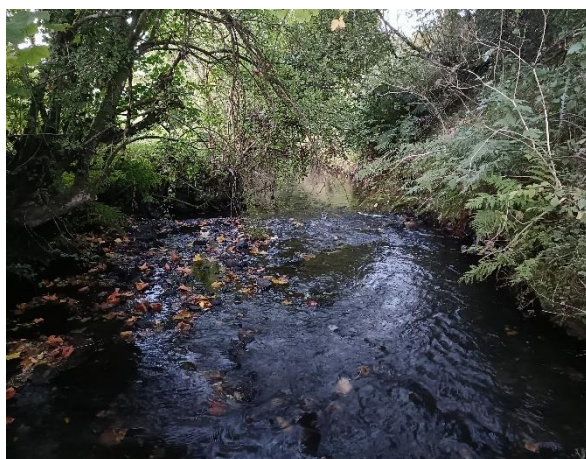
W2-28 (Sept. 2024) Dooballagh Burn, main channel at Foundry Bridge. Trout captured in kick sample.
