# Archaeological Consultancy Services Contract: Stage (i): TEN-T Priority Route Improvement: TA3 Carnshannagh Updated Stage (i)a Test Excavation and Stage (i)h Metal Detection Survey Report

Prepared for Donegal County Council  
By Denis Shine and James McKee

Updated July 2022

**Project Name:** TEN-T Priority Route Improvement Project: Stage (i), Co. Donegal

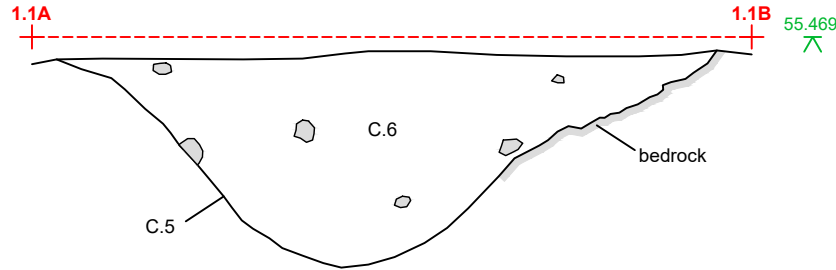
(i) Trench 60. South-facing section of C.5 and C.6

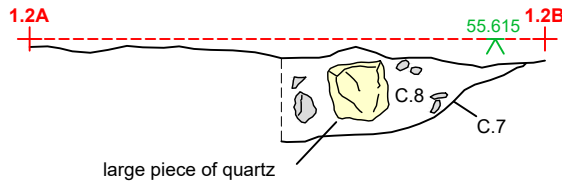
(ii) Trench 60. West-facing section of C.7 and C.8

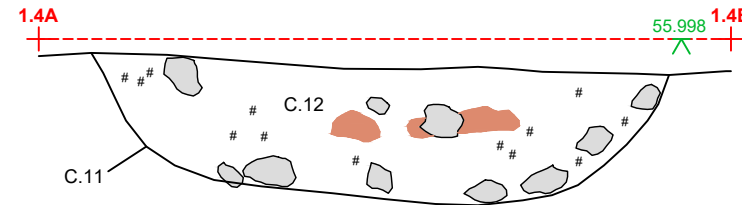
(iv) Trench 59. Southwest-facing section of C.11 and C.12

<b>C.14</b>	S Field	59	Pit fill (in [C.13]) consisting of a light brown moderately compact silty clay, containing occasional charcoal and burnt clay. Not recorded on geophysics.	1.40m x 0.84m x not sectioned
<b>C.15</b>	S Field	59	Pit cut containing C.16, C.40 and C.41. Oval feature, with a gradual break of slope at the top, concave sides and an imperceptible break of slope at the base, which is flat. Not recorded on geophysics. The feature is related to [C.7], [C.9], [C.11], [C.13], [C.17] and [C.19], a series of pit cuts in Trenches 59 and 60, as well as probable pit, C.28, which was not sectioned, and two further pits [C.43] and [C.45] in Trench 66.	1.35m x 1.00m x 0.15m
<b>C.16</b>	S Field	59	Pit fill (in [C.15]) consisting of a light grey moderately compact silty clay, containing occasional charcoal. Pit [C.15] also contains C.40 and C.41. Not recorded on geophysics.	1.35m x 1.00m x 0.15m

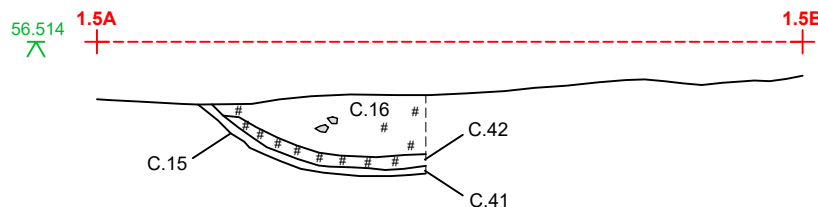
(v) Trench 59. East-facing section of C.15, C.16, C.40 and C.41

<b>C.40</b>	S Field	59	Pit fill (in [C.15]) consisting of a grey/black loose silty clay, rich in charcoal. Pit [C.15] also contains C.16 and C.41. Not recorded on geophysics.	Length and width undetermined, 0.03m deep

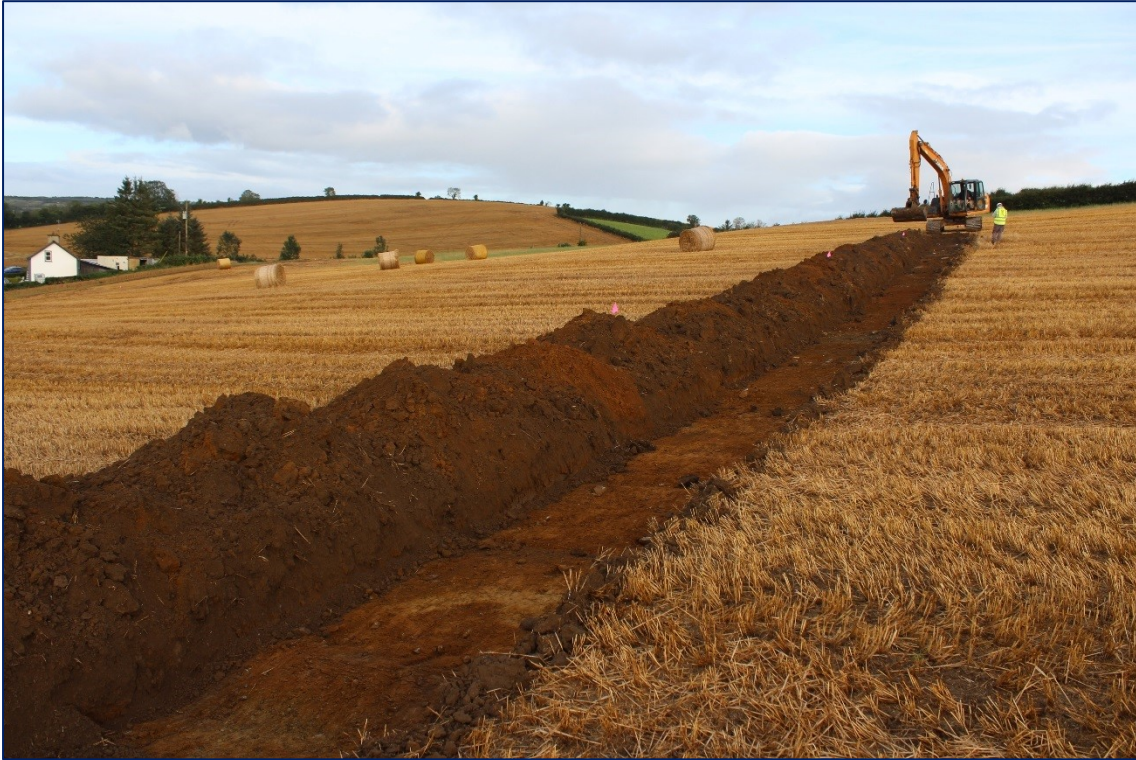
Plate 1: Example of trenching in the southern field (T37); facing northwest

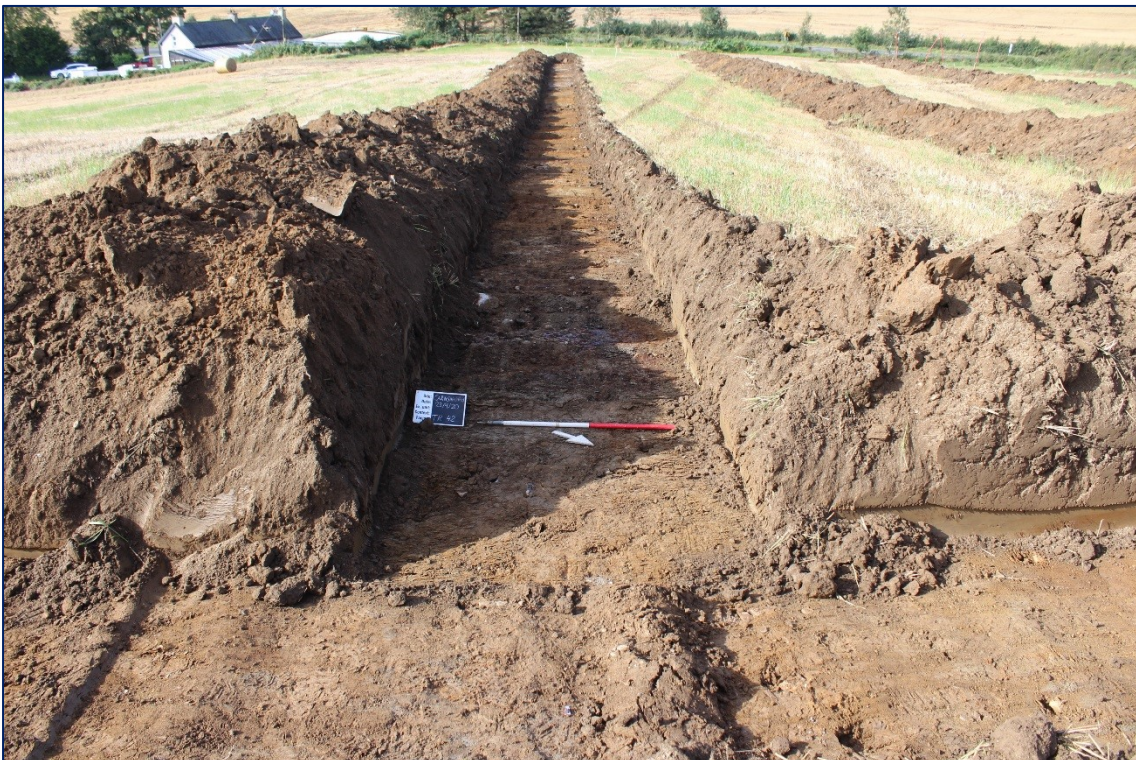
Plate 2: Example of trenching in the southern field (T42); facing west

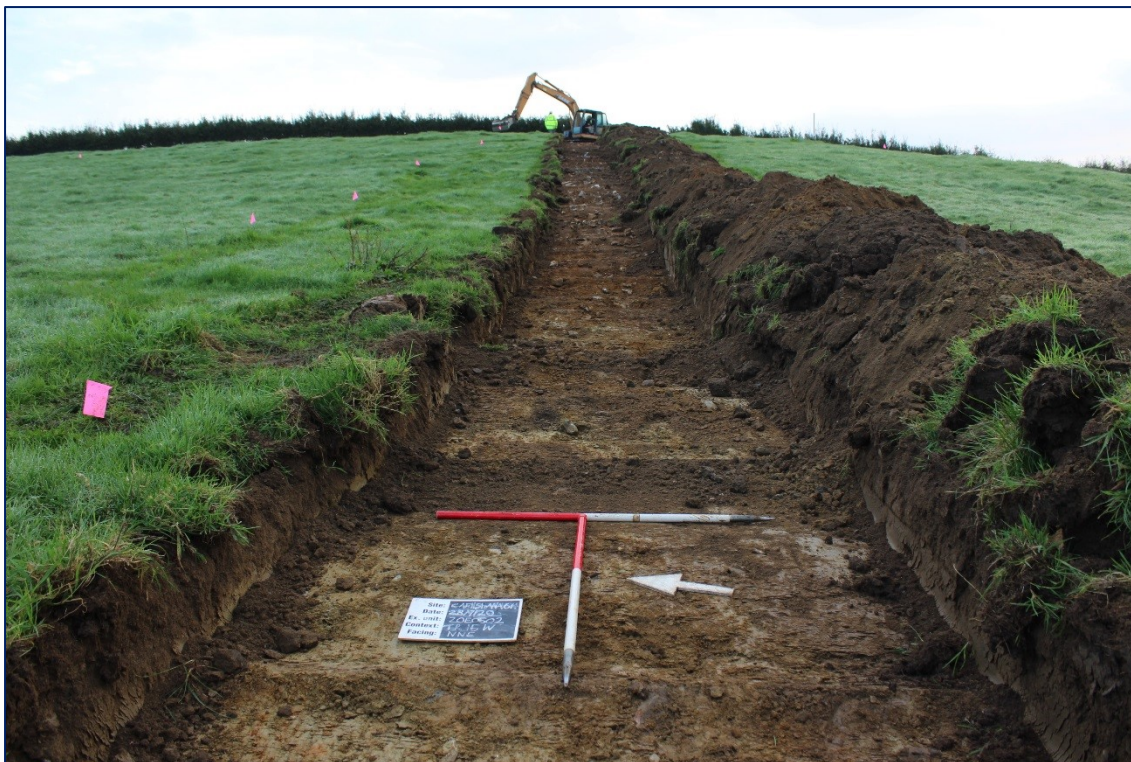
Plate 3: Example of trenching in the northern fields (T15); facing east

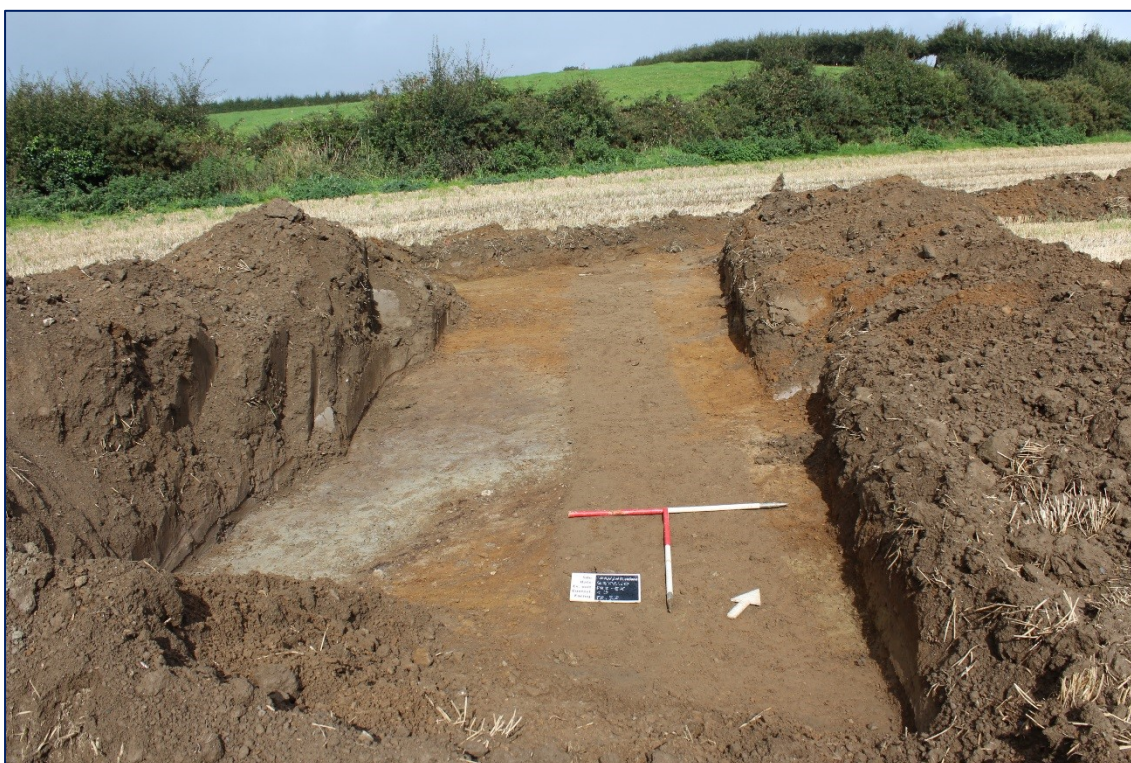
Plate 4: Post-medieval/modern field boundary/drain ([C.4]); facing northwest

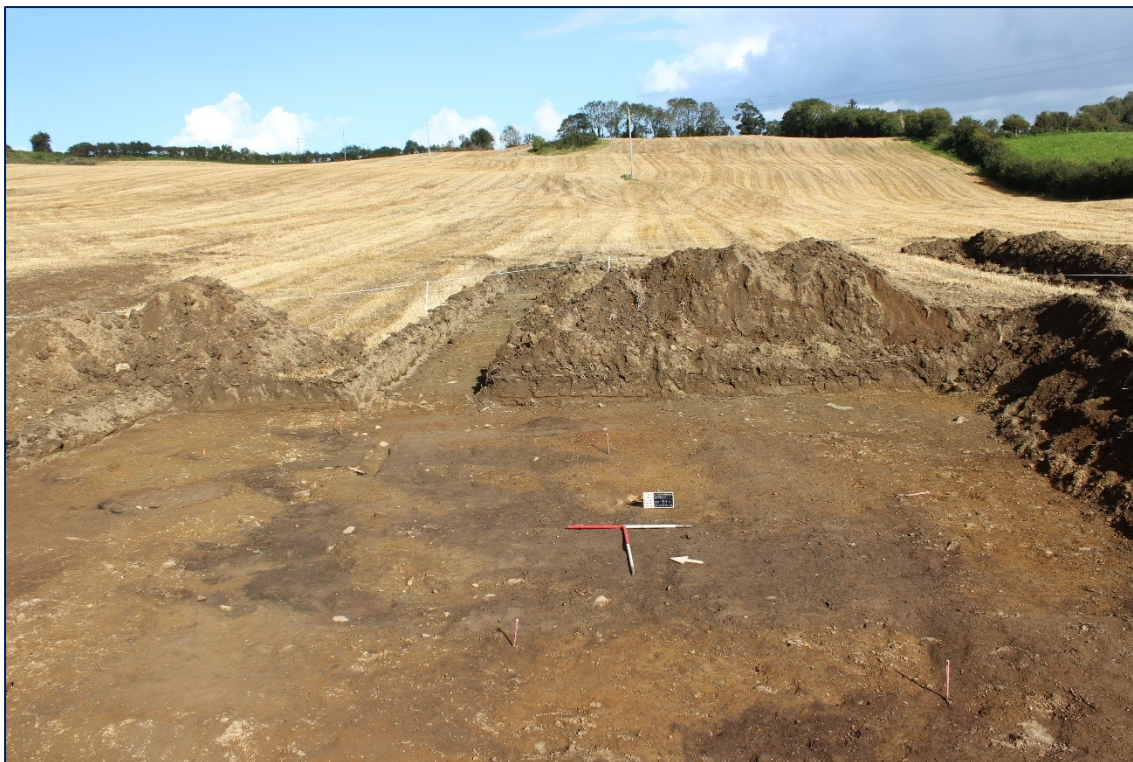
Plate 5: Extension on T59, showing settlement features; facing east

A total of 49 archaeological contexts were recorded from Carnshannagh, which are presented in full in Appendix 1. This cluster of features, likely representing a small prehistoric settlement, included a minimum of five postholes, seven stakeholes, eight pits (of indeterminate function) and a large burnt spread/deposit, based on initial assessment (Figures 8–11; Plates 5–11). The archaeological features can be summarised as follows:

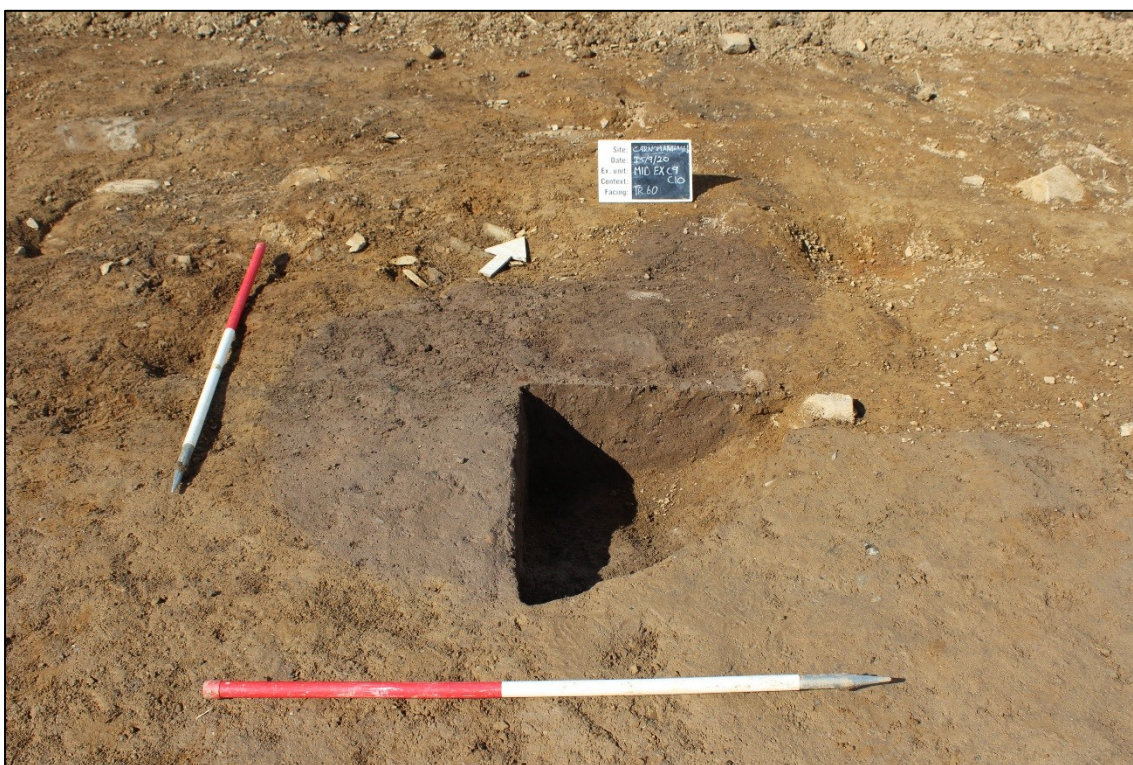
Plate 6: Pit [C.9] and (C.10) in T60; facing northwest

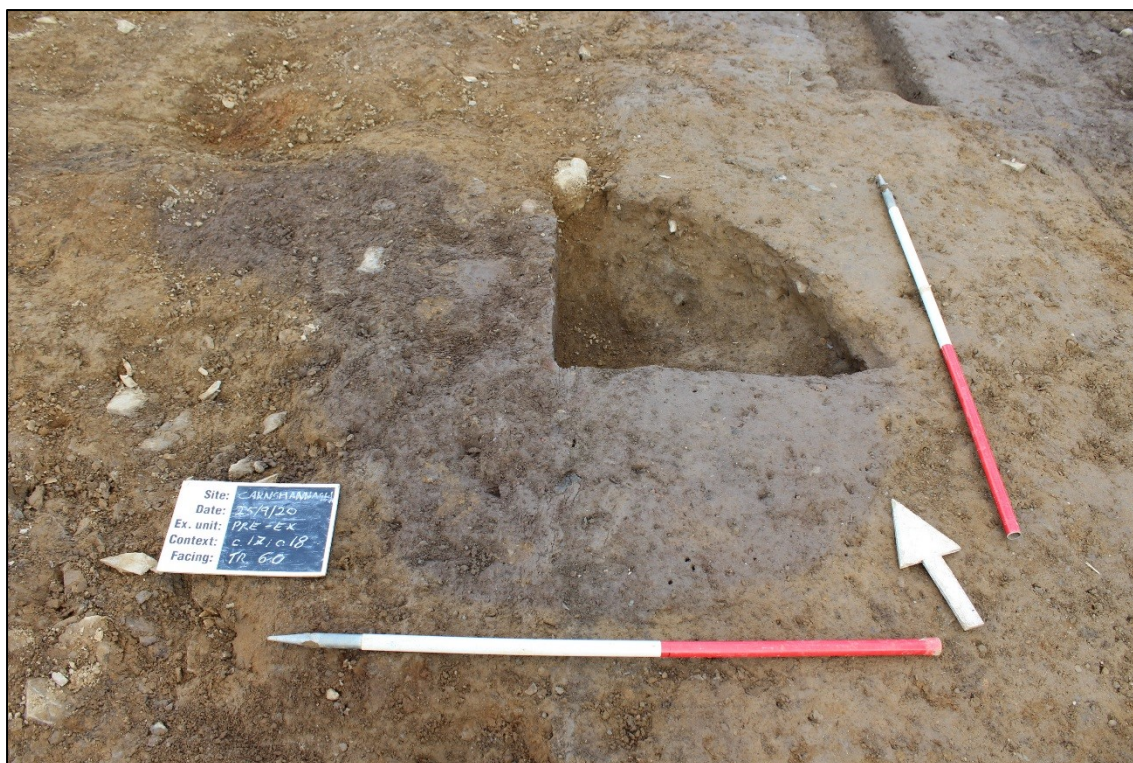
Plate 7: Pit [C.17] and (C.18) in T60; facing north

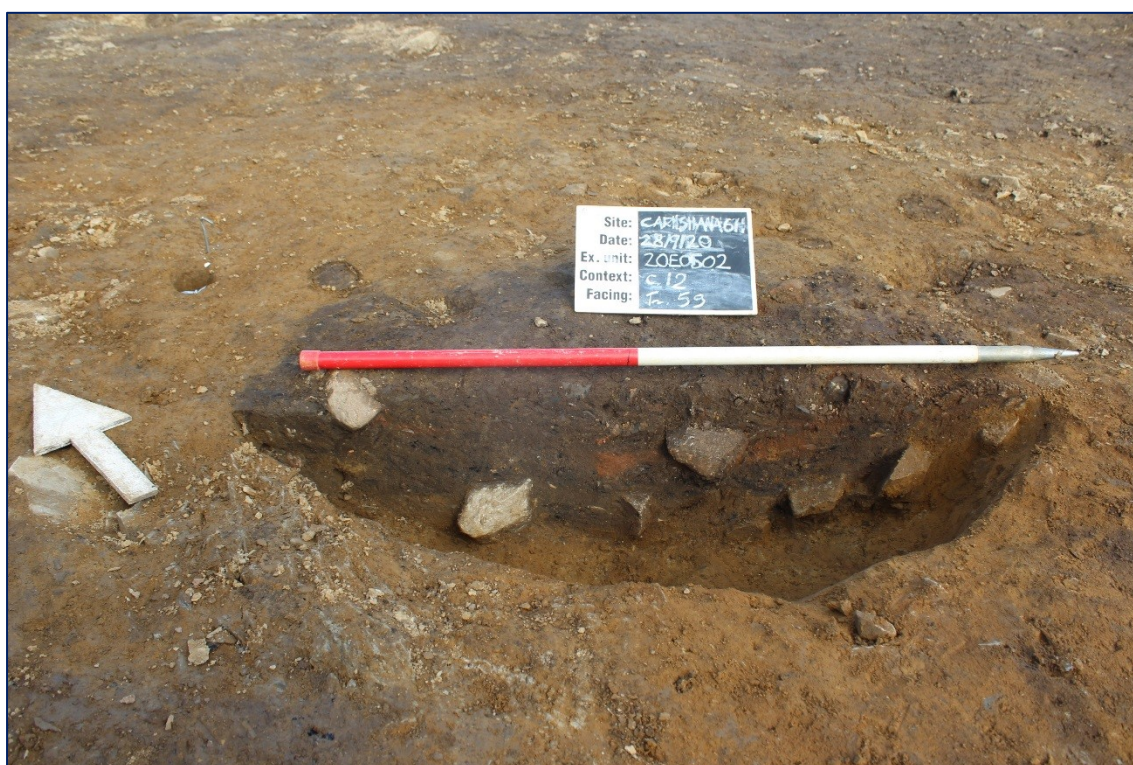
Plate 8: Pit [C.11] in T59; facing northwest

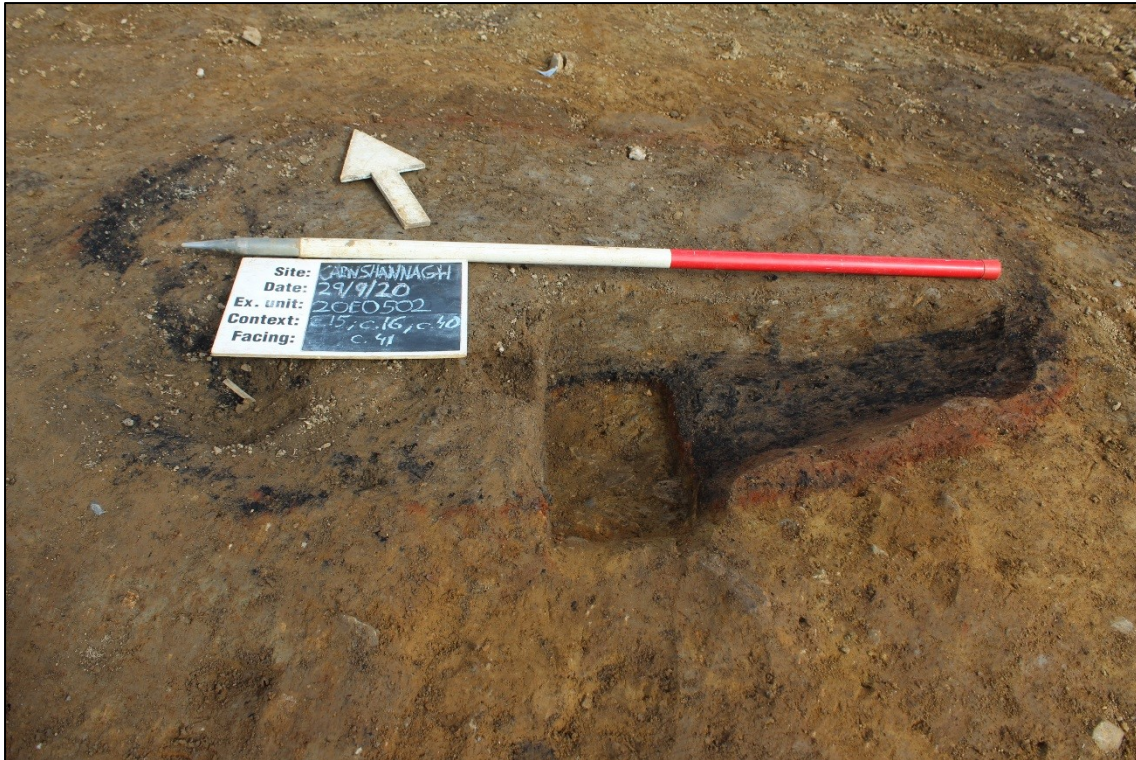
Plate 9: Pit [C.15] in T59; facing northwest

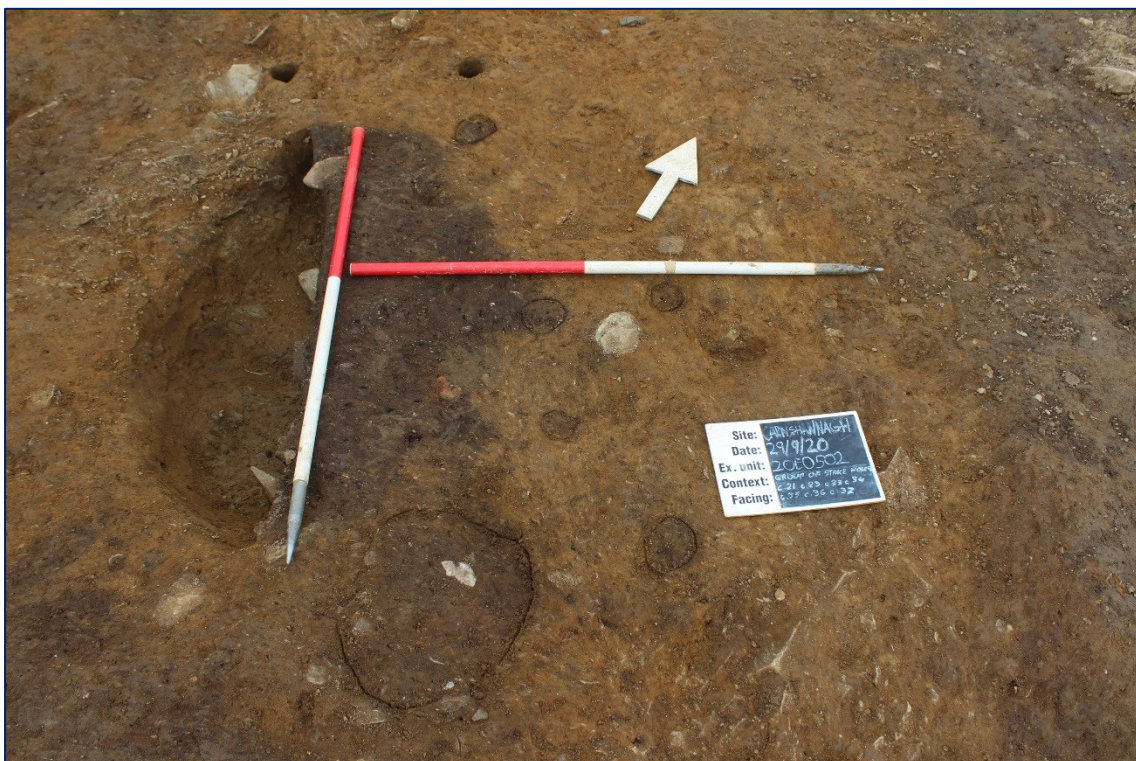
Plate 10: Cluster of stakeholes and a posthole (C.38) around pit [C.11] in T59; facing northwest

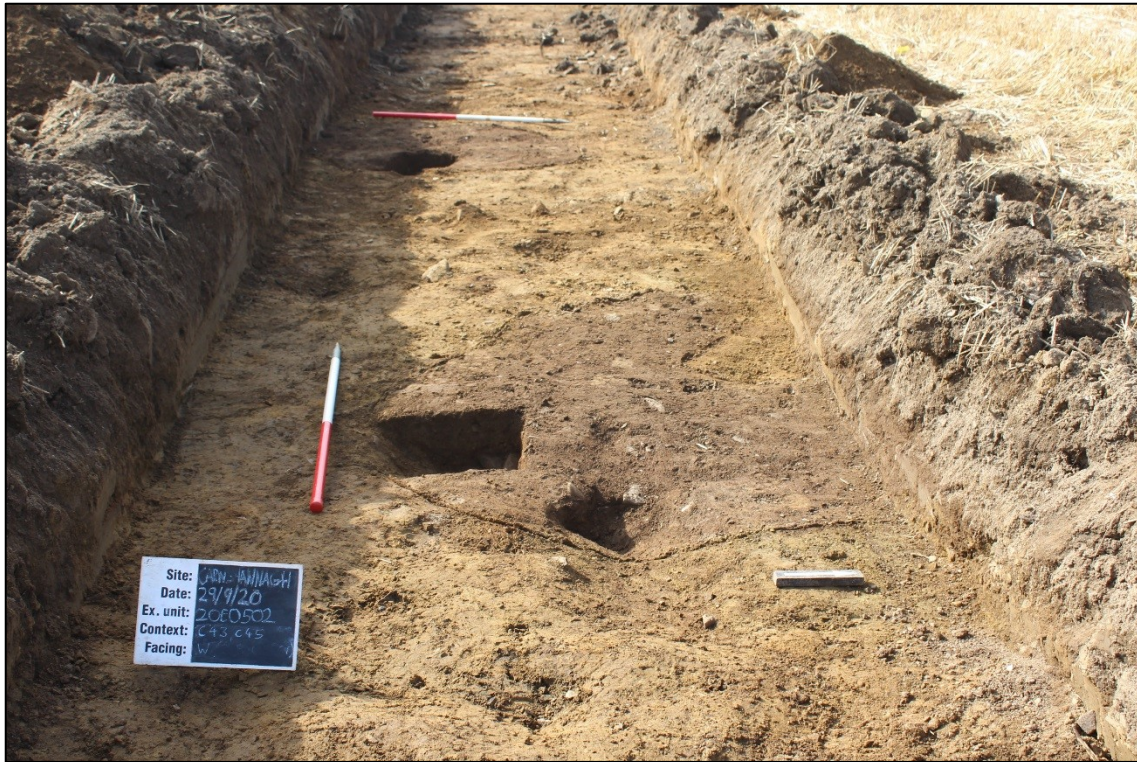
Plate 11: Pit [C.19] and (C.20) in T66; facing south
