Appendix C17.09

Section 1 Detailed Walkover Survey and Photographic Record

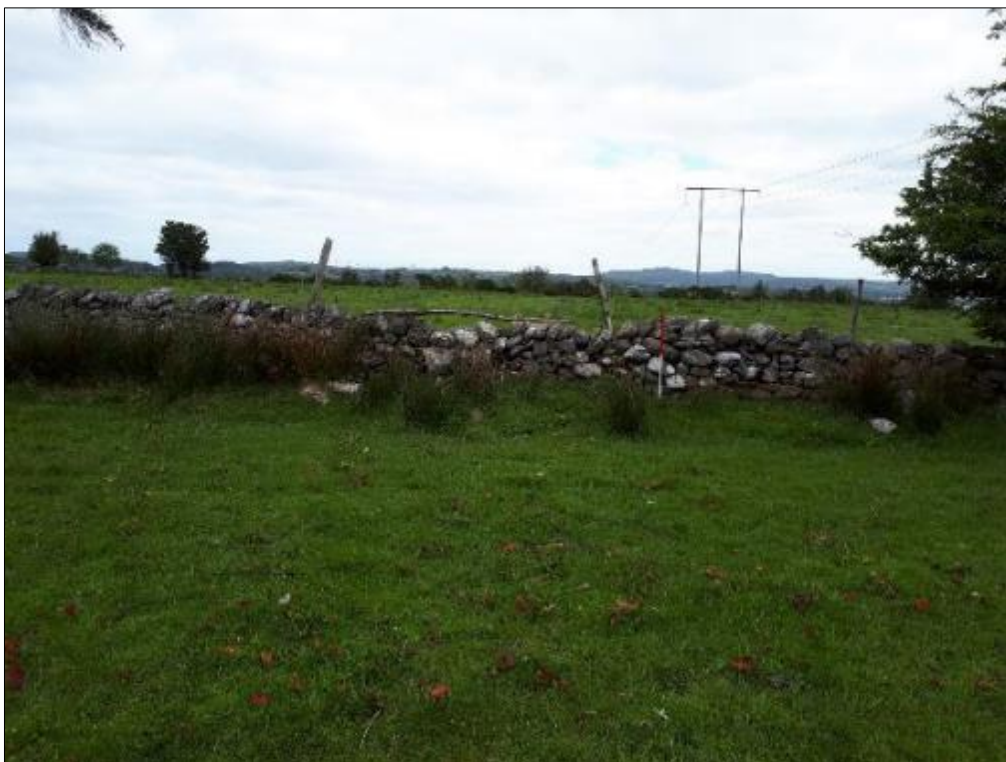
Plate S1-06: View of landscape around Ch. 1 +300 (Cappry), facing northeast

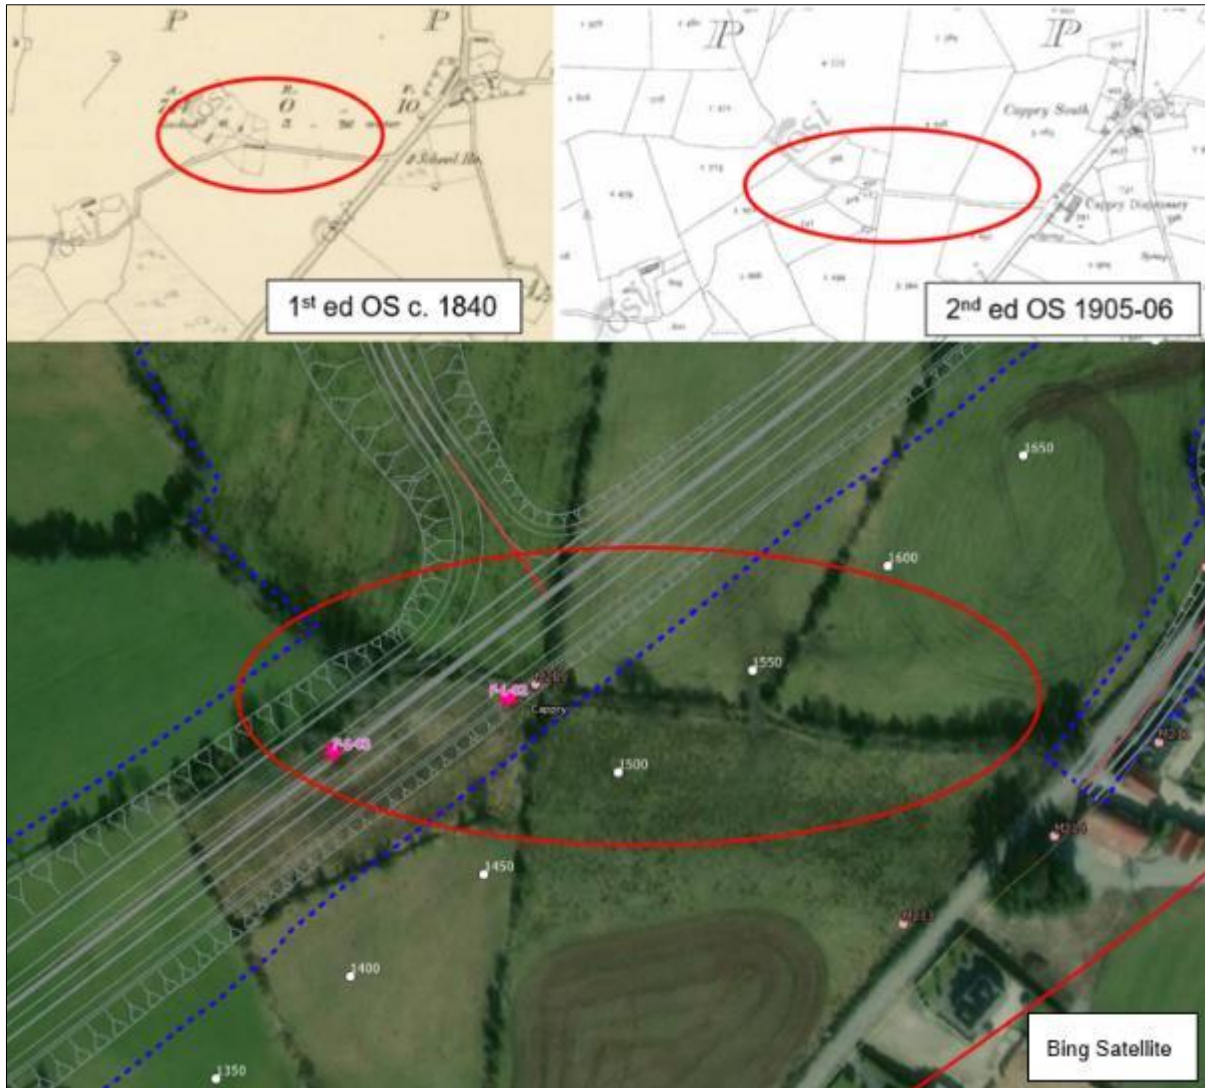
Botharín F-1-02 and vernacular farmstead location at Cappry (ITM 611870, 894356)

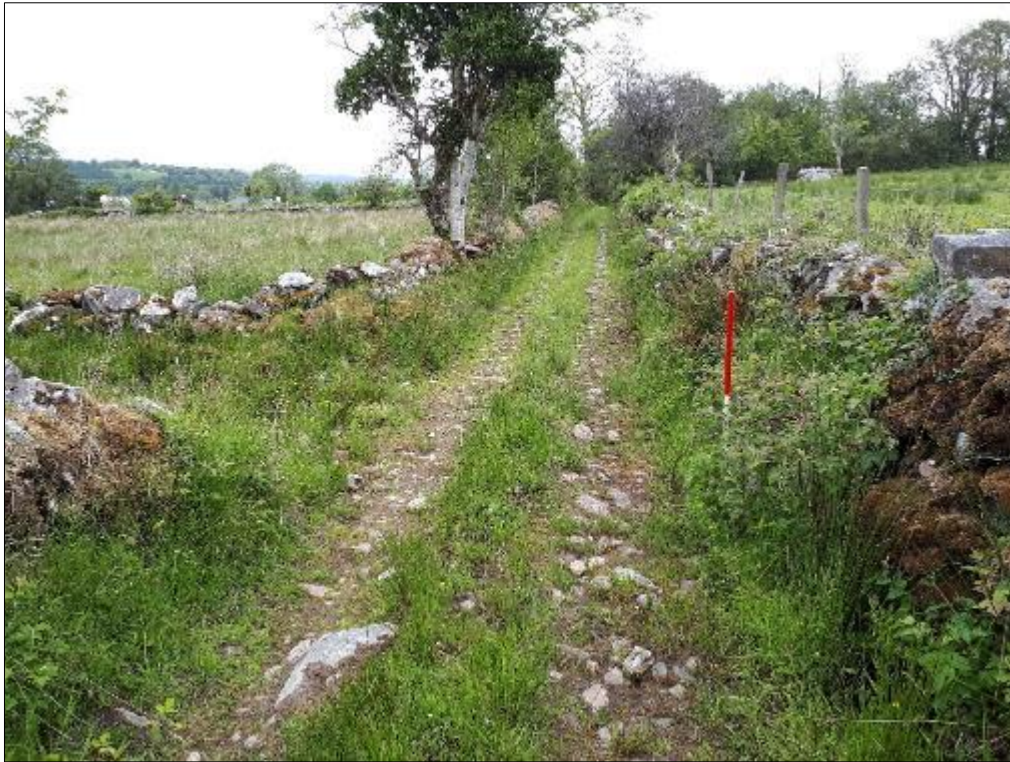
Plate S1-09: Botharin F-1-04 near ch. 350 Ballybofey Link Rd facing east towards outbuilding and farmstead at Capry NIAH 40907720

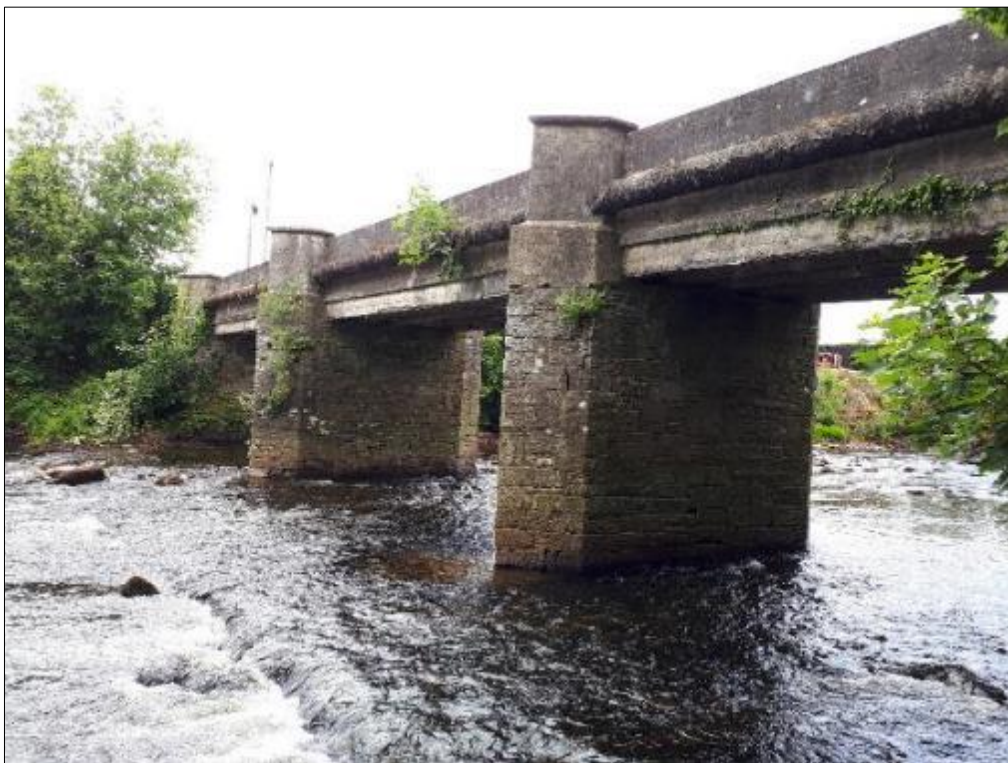
Plate S1-13: View of bridge from riparian area, facing south-southwest

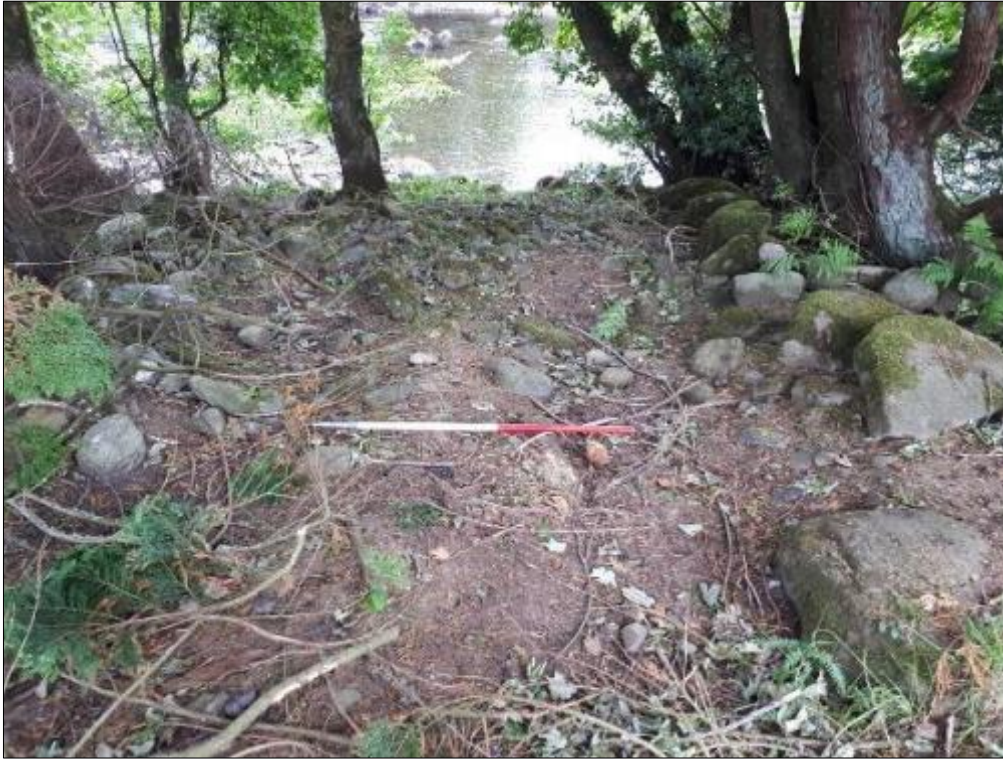
Plate S1-14: View of possible river access path in riparian area (F-1-06) of River Finn, ch. 2+430 facing south

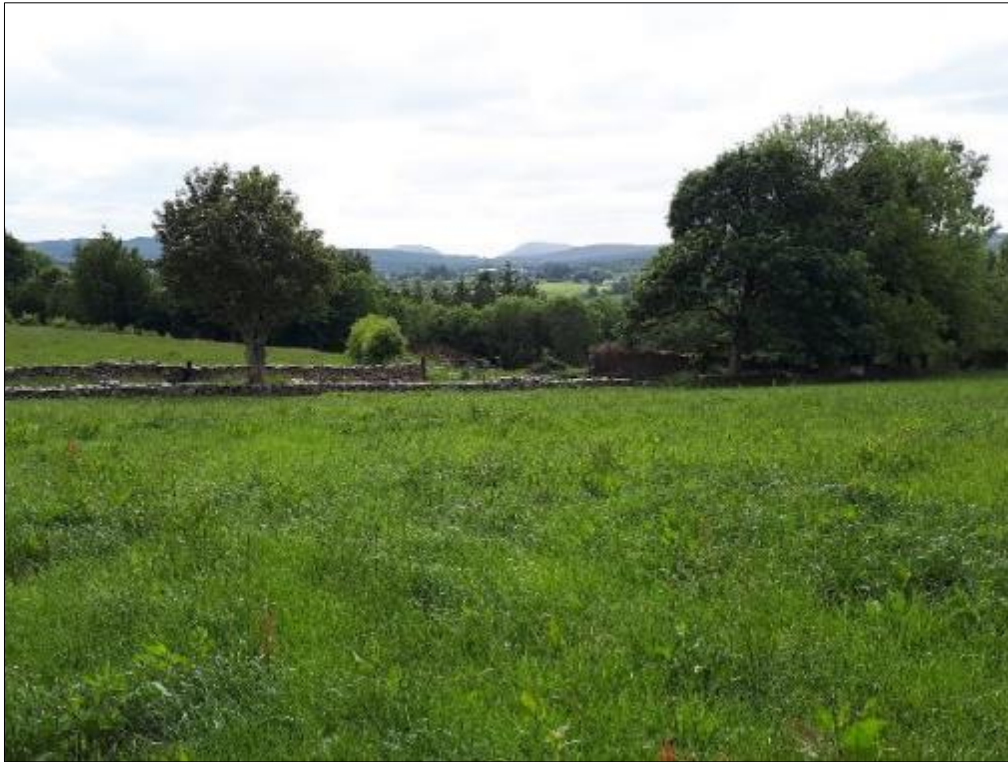
Plate S1-21: View southwest from the 'Abbey field', showing Barnesmore Gap in background (note walled avenue F-1-12 located to south of field boundary)

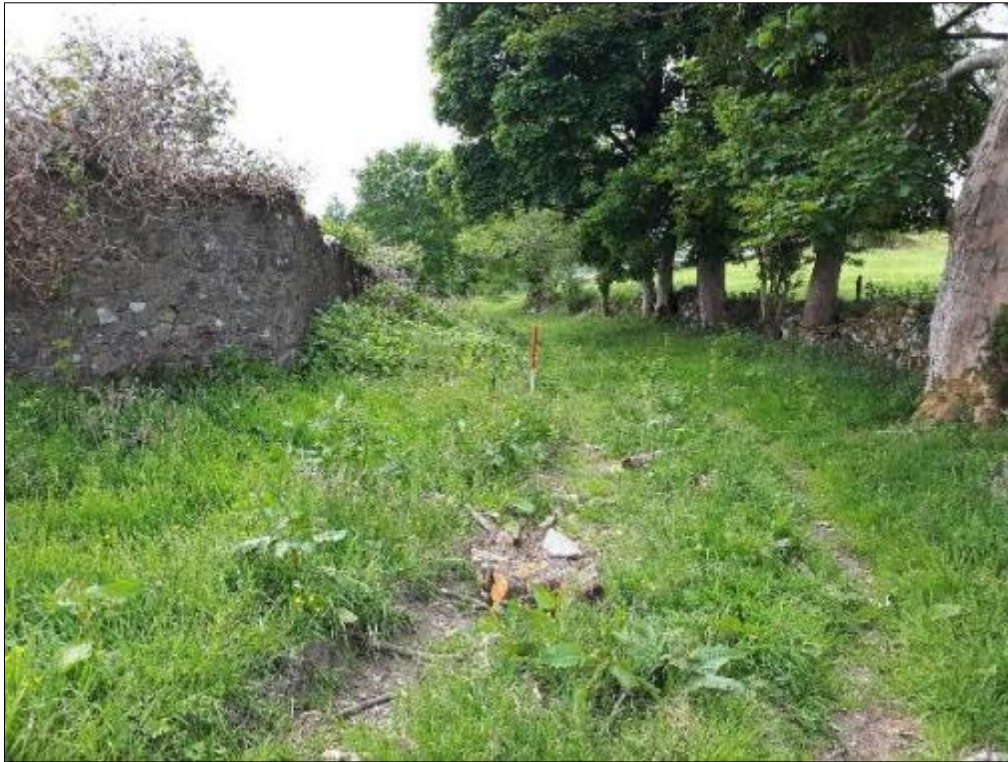
Plate S1-22: View of wall-lined avenue F-1-12 to the south of the 'Abbey field', facing west

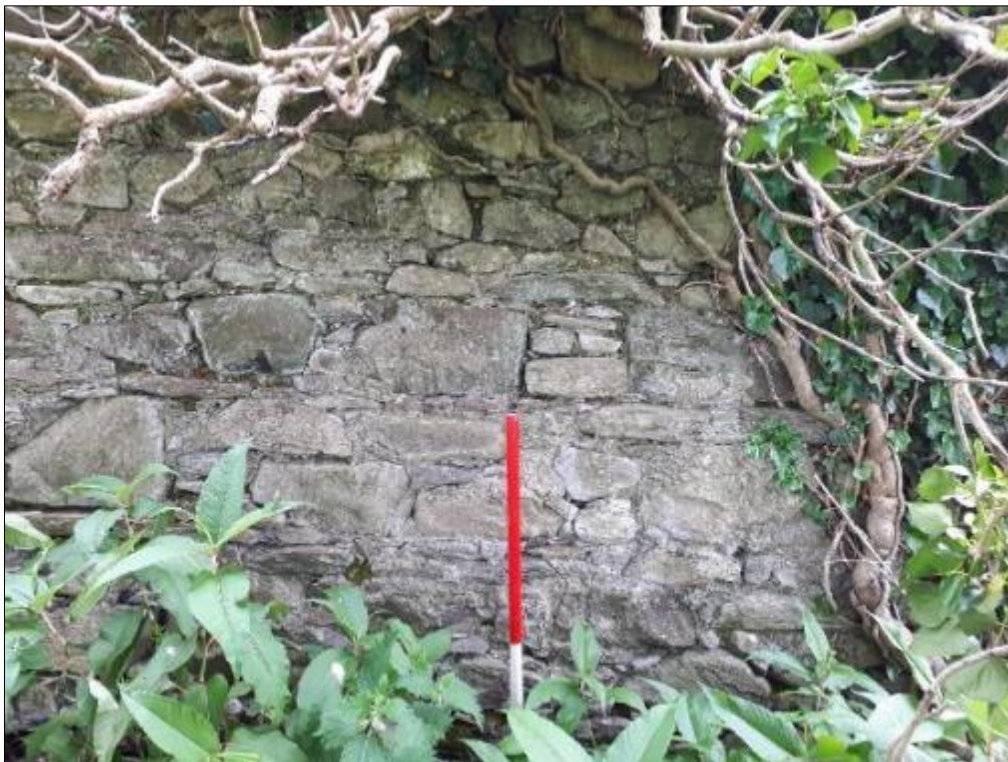
Plate S1-23: View of a putlog hole to northern wall of avenue, F-1-13, Drumboe Lower, Ch. 3+300

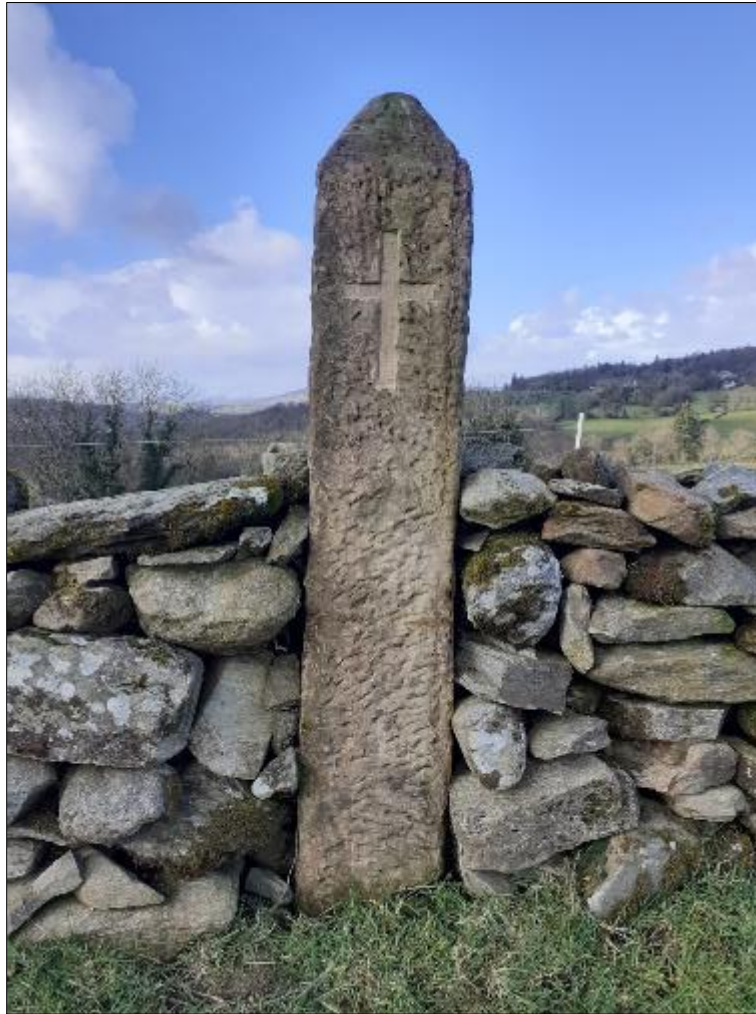
Plate S1-27: View of cross-inscribed pillar-stone (F-1-15) inserted along western stone wall field boundary to the 'abbey field'

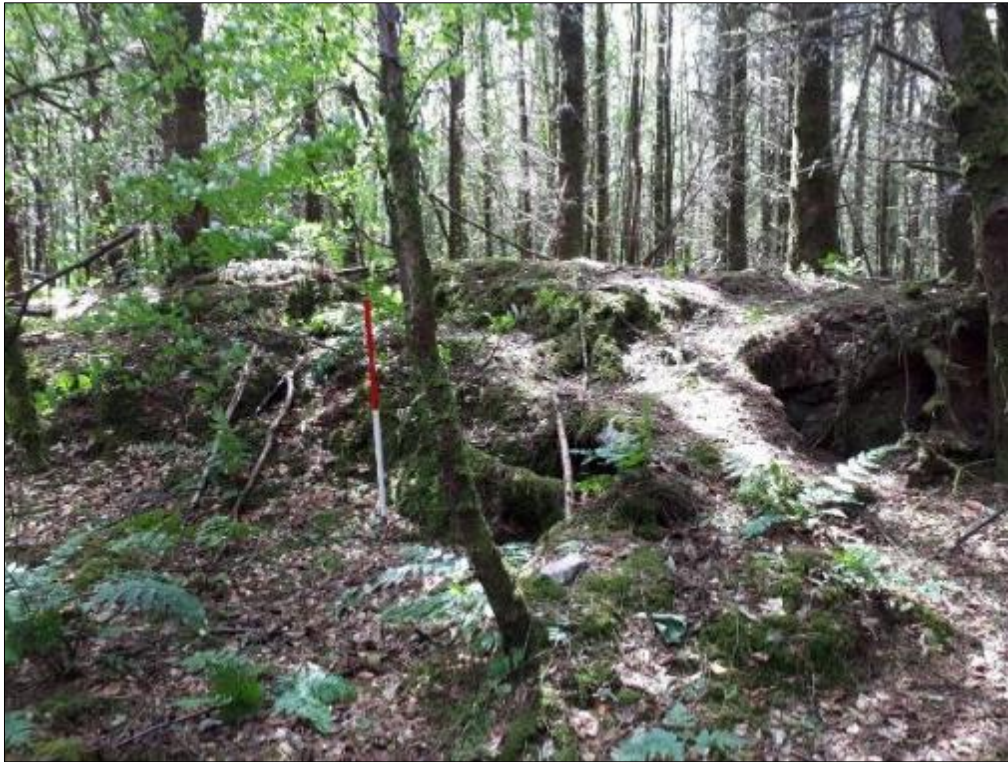
Plate S1-28: View of anomaly L123-4, within woodland northwest ch. 3+600, facing west

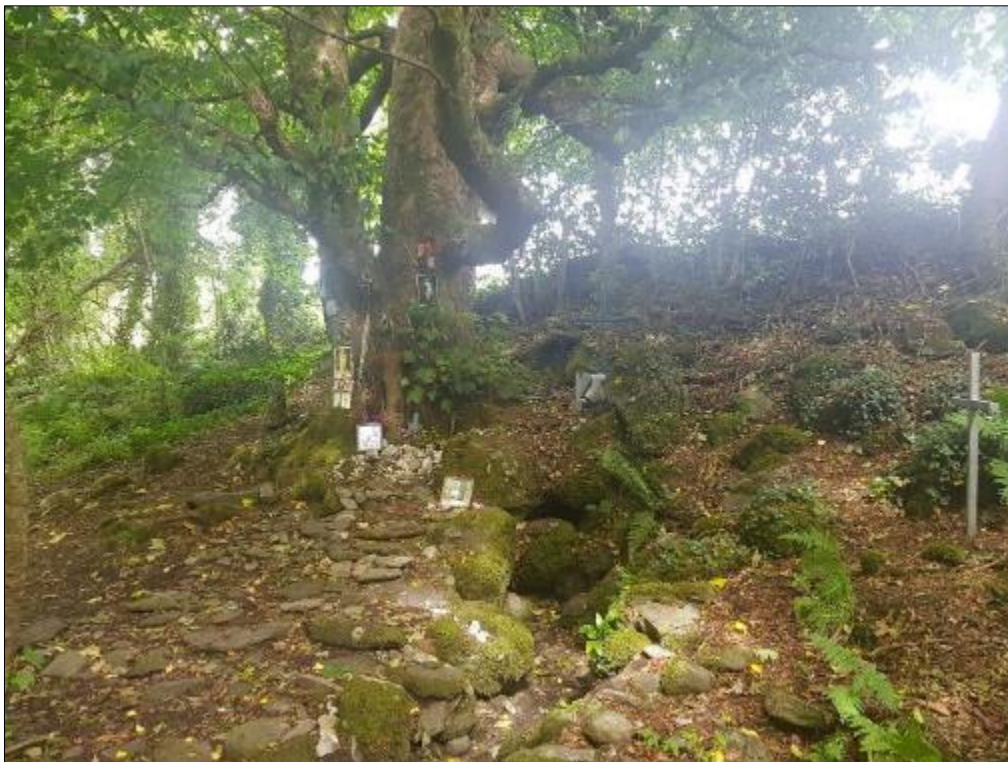
Plate S1-29: View of the 'Abbey Well' S1-CH01, facing northeast, Ch. 3+400

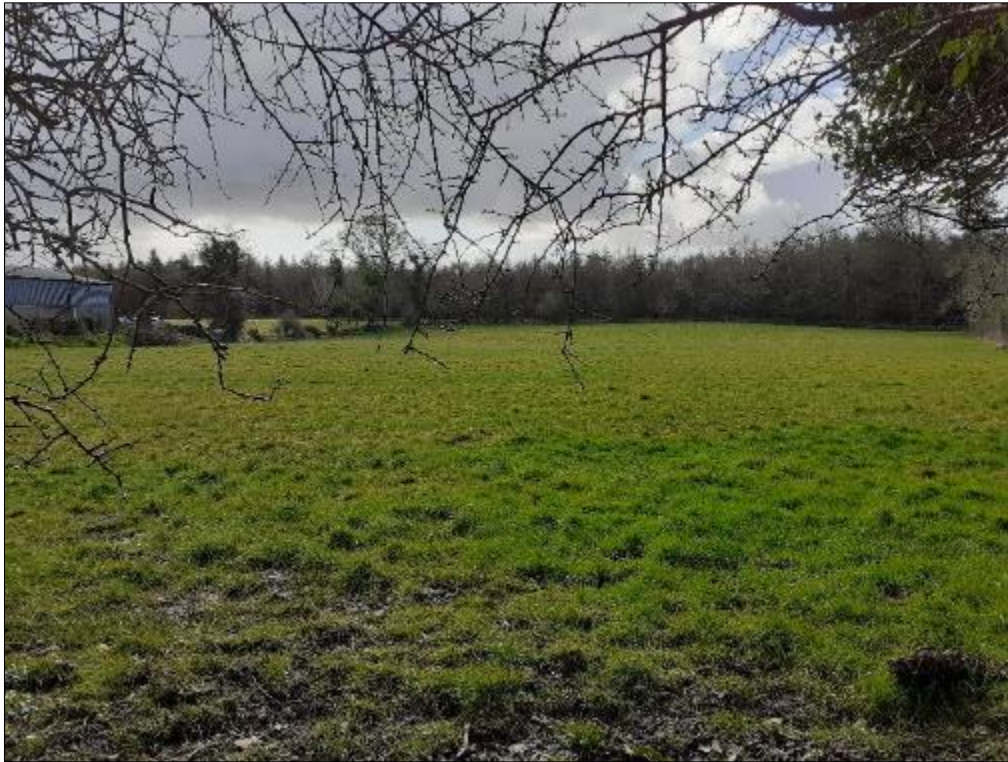
Plate S1-30: View of AP site S1-AP01, facing northeast, Ch. 00 Side Rd

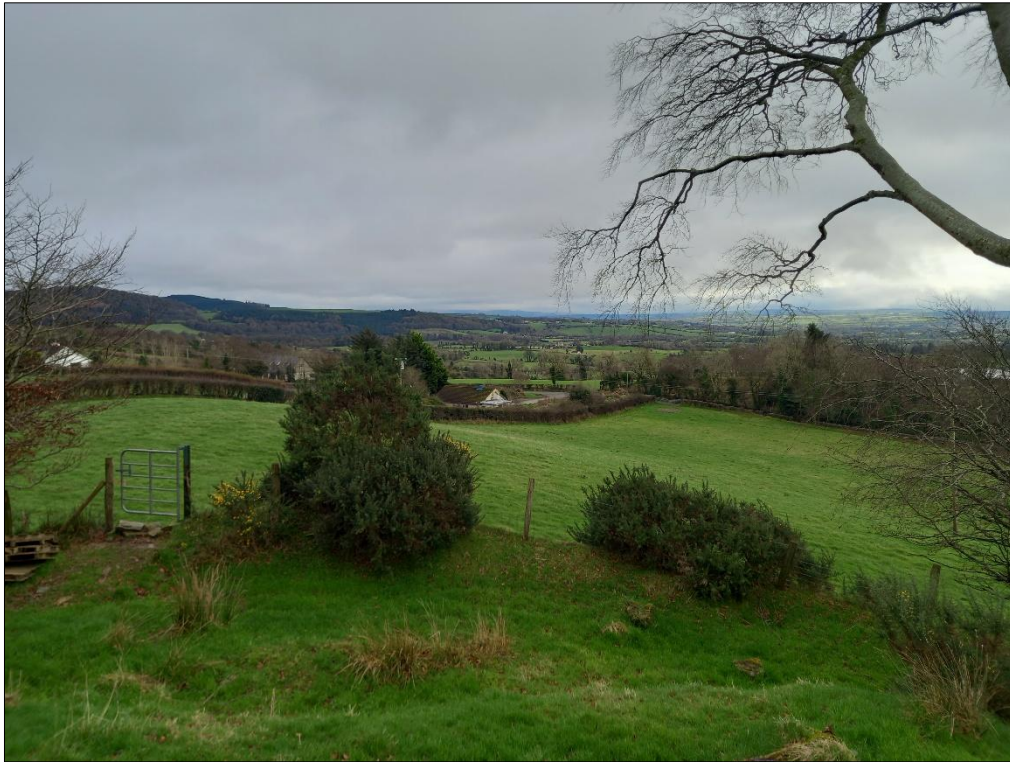
Plate S1-38: View towards east from interior area of Dunwiley Fort

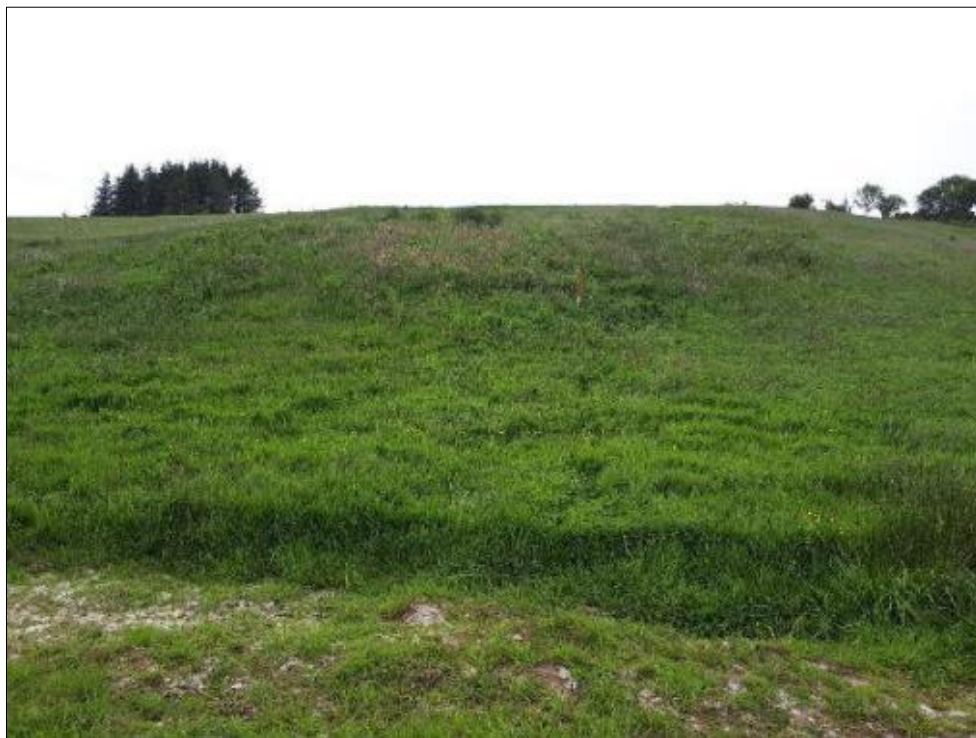
Plate S1-39: View of sub-circular anomaly, F-1-17, northwest of Ch. 5+400, facing north

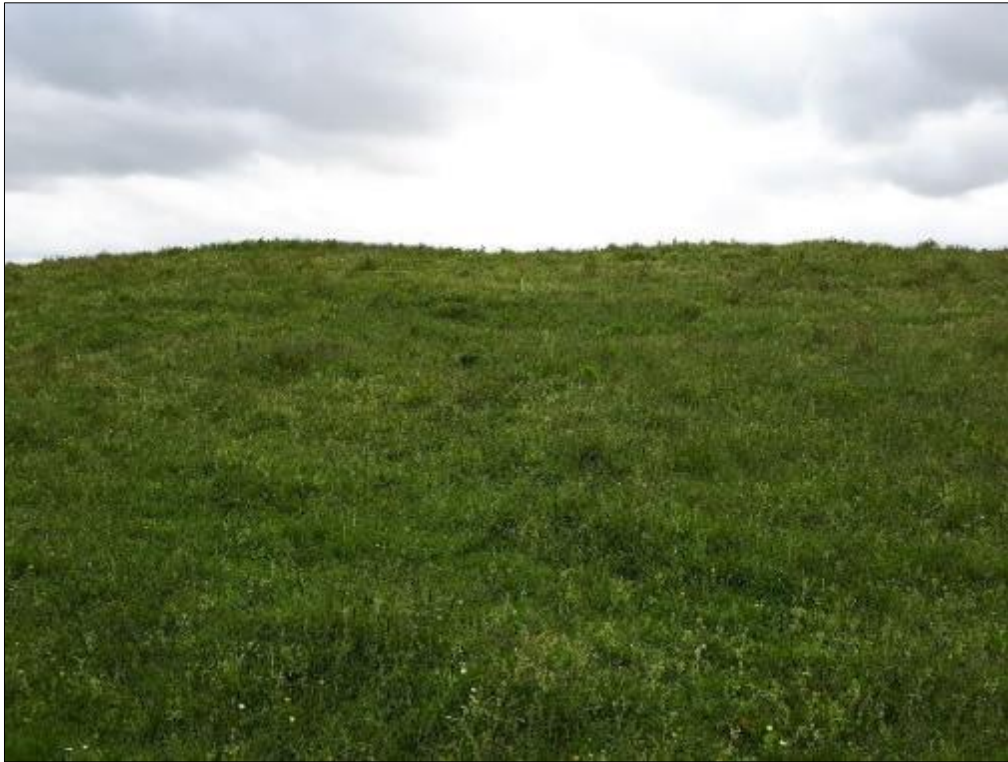
Plate S1-41: View of anomaly L109-1, northwest of Ch. 6+200, facing east

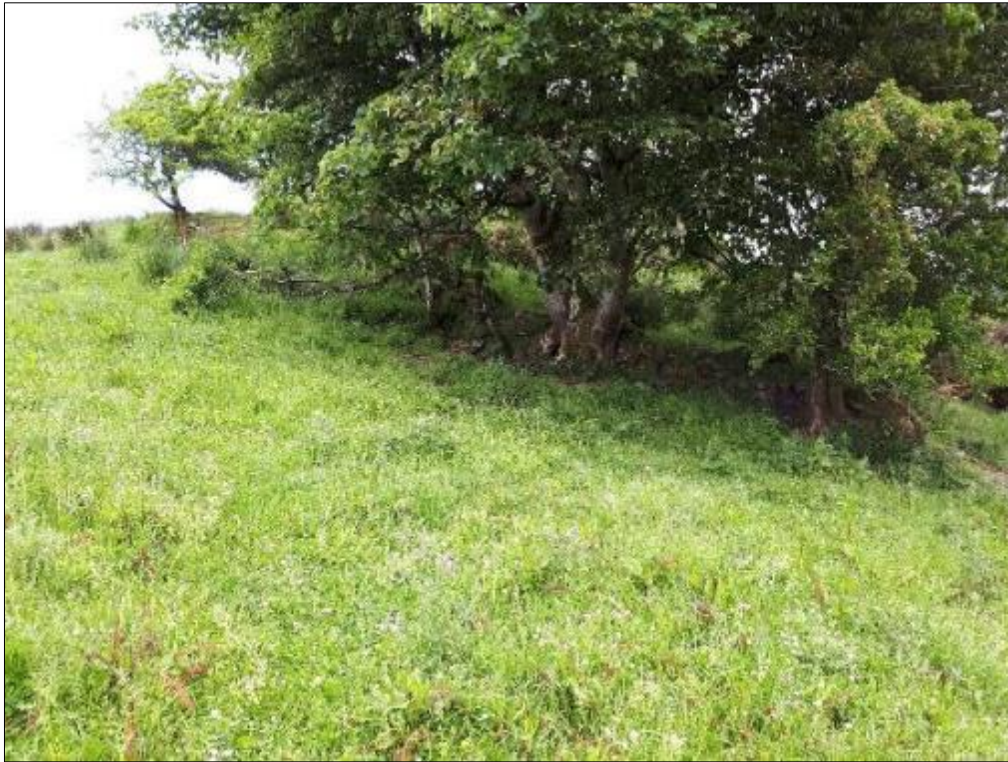
Plate S1-43: View of stone wall F-1-19 to southwest of anomaly L109-1, Ch. 6+200, facing northeast

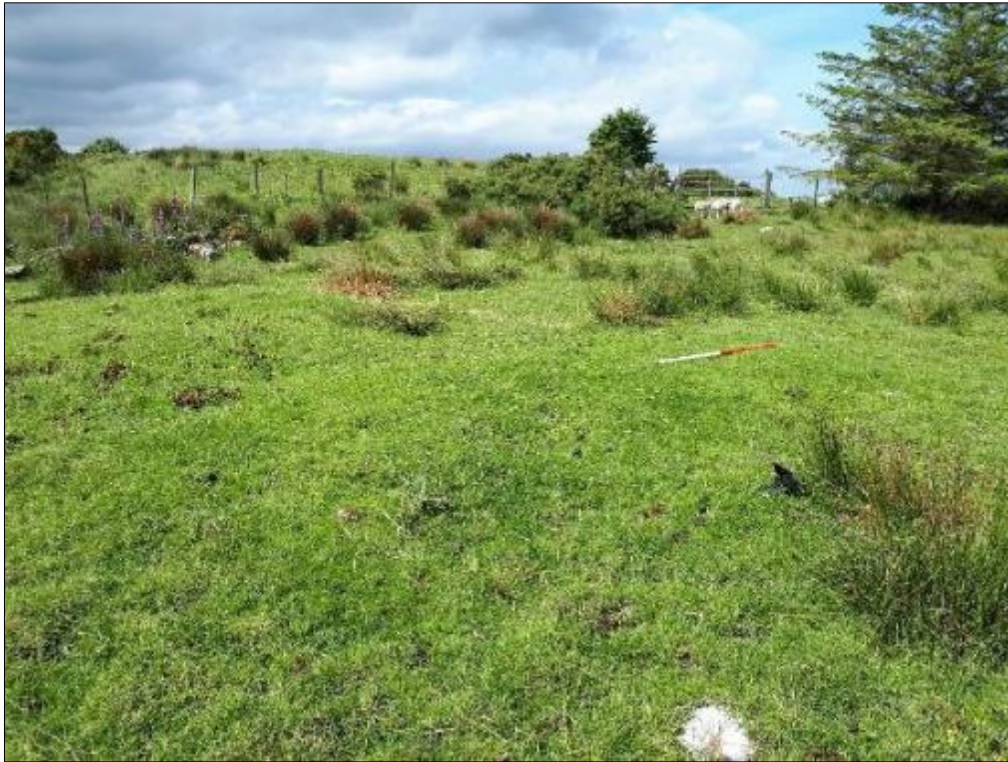
Plate S1-44: View of anomaly F-1-20 Ch. 200, (Mullandrait Link Rd) with anomaly L109-1 in background, facing southwest

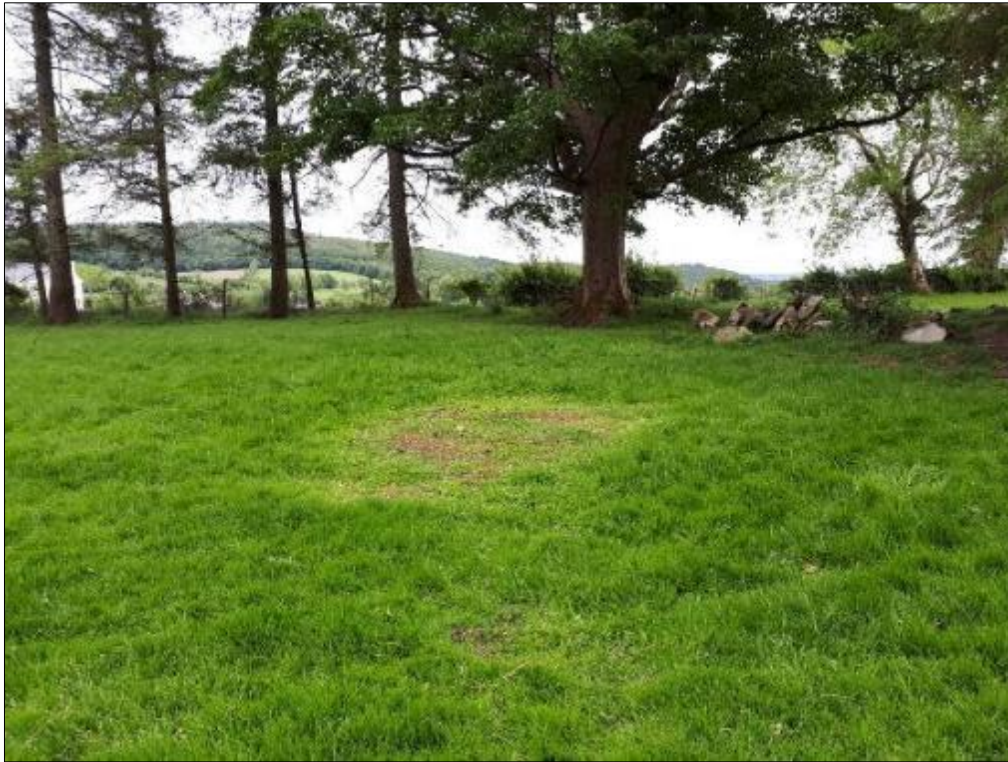
Plate S1-48: View of location of DG069-028---, Ch. 7+200, facing east

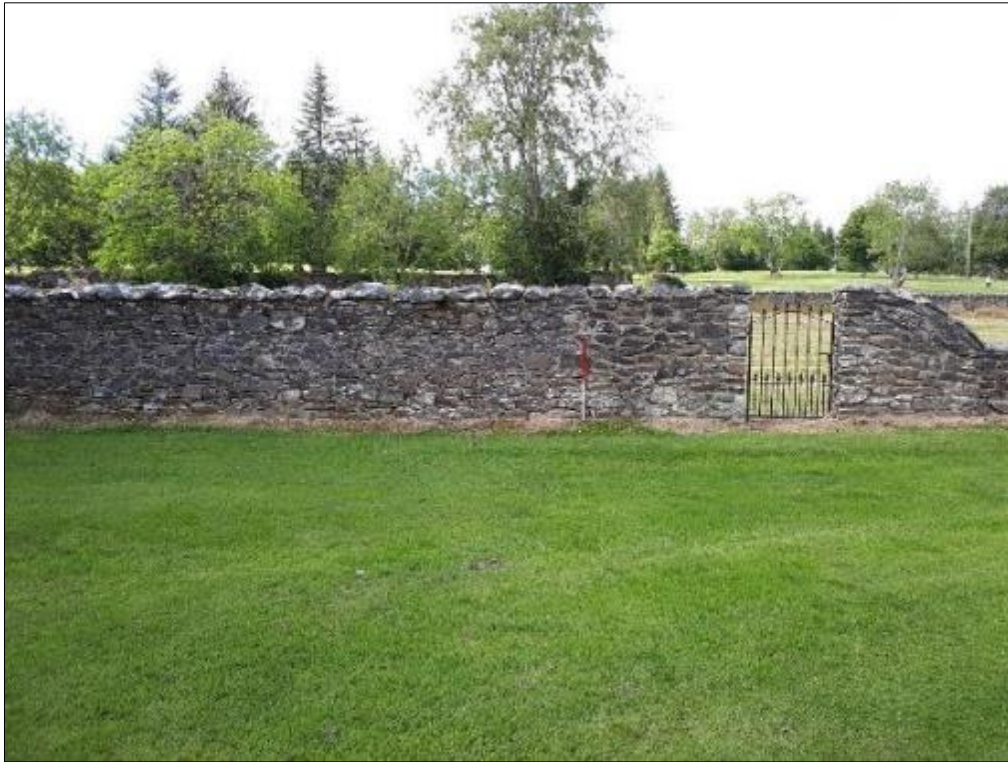
Plate S1-49: View of workhouse/famine graveyard (RPS/NIAH 40907836) to rear of St. Joseph's Hospital, facing north

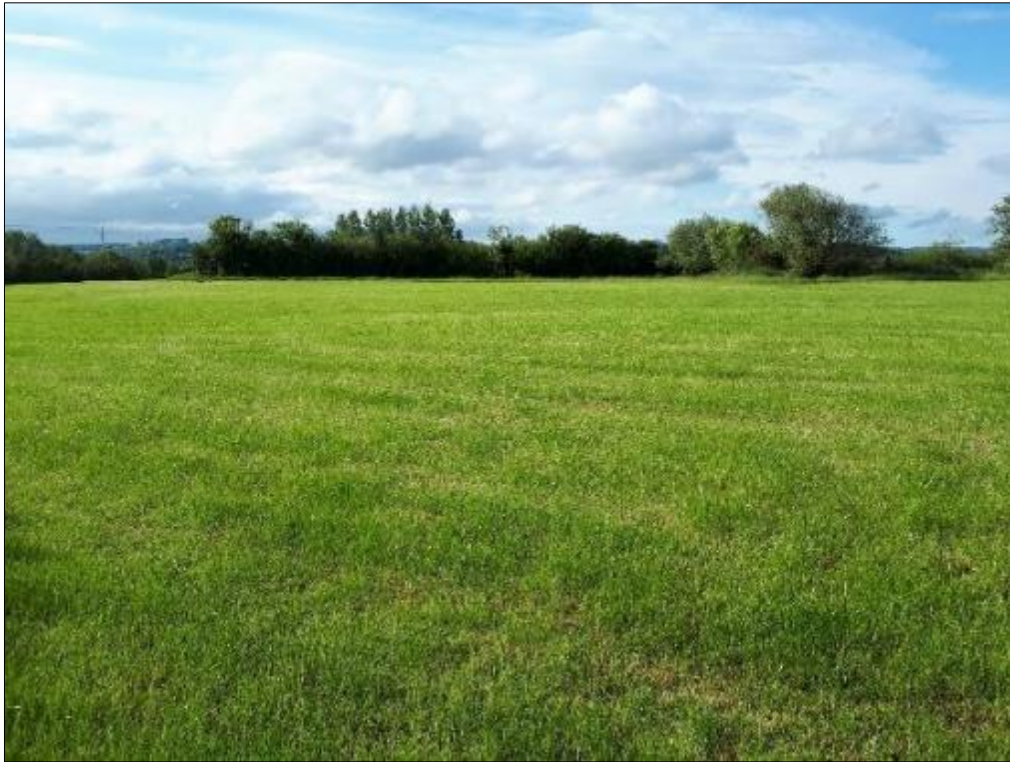
Plate S1-50: View from Ch. 3+200 towards Ch. 3+350, Mullandrait Link Rd, facing south
