Appendix C17.13

Section 3 Detailed Walkover Survey and Photographic Record

Ten-T Section 3, Manorcunningham to Lifford, Co. Donegal

(8th – 10th, 16th, 20th & 21st July 2020, 21 Jan 2022, 21 Sep 2022)

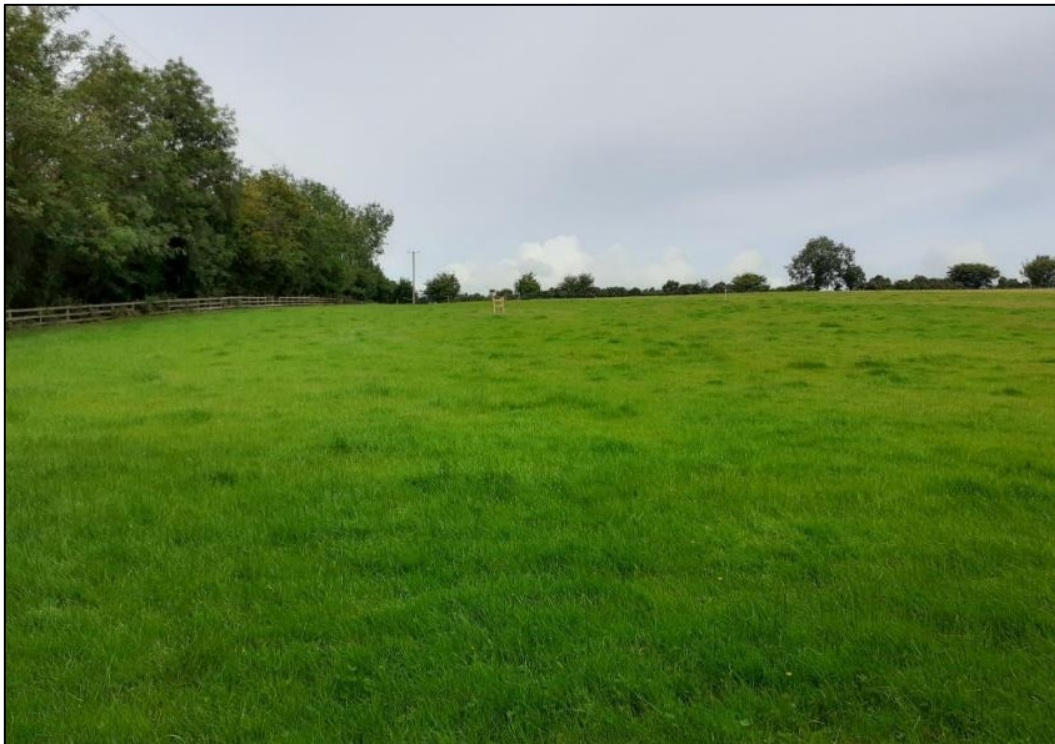
Plate S3-01: View to west/northwest at Glebe/Raymoghly Ch 0+250 – Ch. 0+300

Ch. 0+000 to 0+300 comprises an area of well-drained and managed pasture with a gradual southeast slope, bounded by a mature tree-line to the existing N14 road carriageway to the south (**Plate S3-01**). Located to the north of Ch. 0+350 (ITM 623693, 910767) is 'Gort Presbyterian Manse' (NIAH 40827011) (**Plate S3-02**) and its attendant grounds which is approached from a gated entrance and tree-lined laneway to the east (**Plate S3-03**). Located within Raymoghly townland, it is noted that a recorded early medieval ecclesiastical church site (DG054-032001-) is sited c. 600m to the northeast of the edge of the proposed alignment (ITM 624167, 911050) (outside the assessment area). In addition, Pluck standing stone (DG054-038--- National Monument Ref. 453) sited on the southern banks of the Corkey River, is located c. 430m southwest of Ch. 0+200, (ITM 623311, 910275) outside the Study Area (**Plate S3-04**). Vernacular outbuildings 'Black Bush' (M501) are located at the link road area in Raymoghly, south of the main alignment and are directly impacted (**Plate S3-05**), whilst Connaghan's Bridge (NIAH 40905456) is located further to the south (**Plate S3-06**).

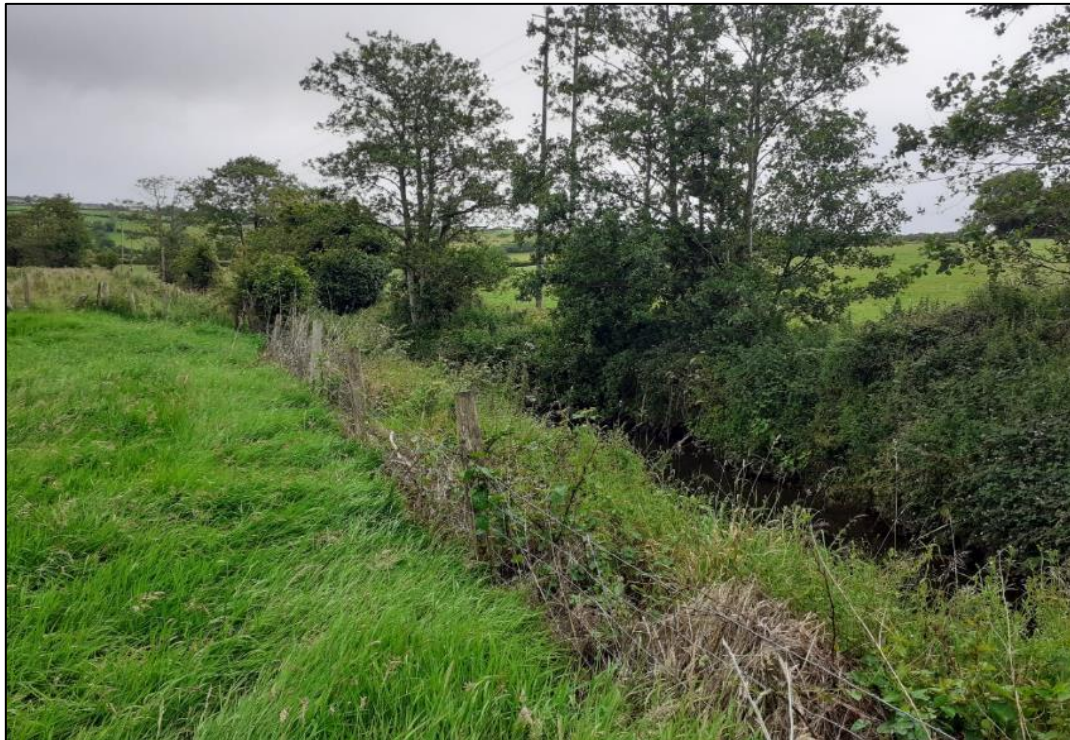
Plate S3-07: View to northeast of river and Raymoghly/Labbadish townland boundary, Ch. 0+750 – Ch. 0+800

Ch. 0+400 to Ch. 0+800 comprises an area of well-drained but rough pasture with a gradual southeast slope leading down to wet marshy land bounded by a river, which forms the townland boundary of Raymoghly/Labbadish (ITM 624092, 910537) (**Plate S3-07**) to the southeast, and by a mature tree-line to the existing N14 road carriageway to the south. The wet marshy land between Ch. 0+600 to Ch. 0+800 (ITM 623979, 910458) has the potential to reveal site types such as *fulachta fiadh* and burnt spreads due to ground conditions and proximity to the existing river (**Plate S3-08**) (and forms part of S3-AAP01).

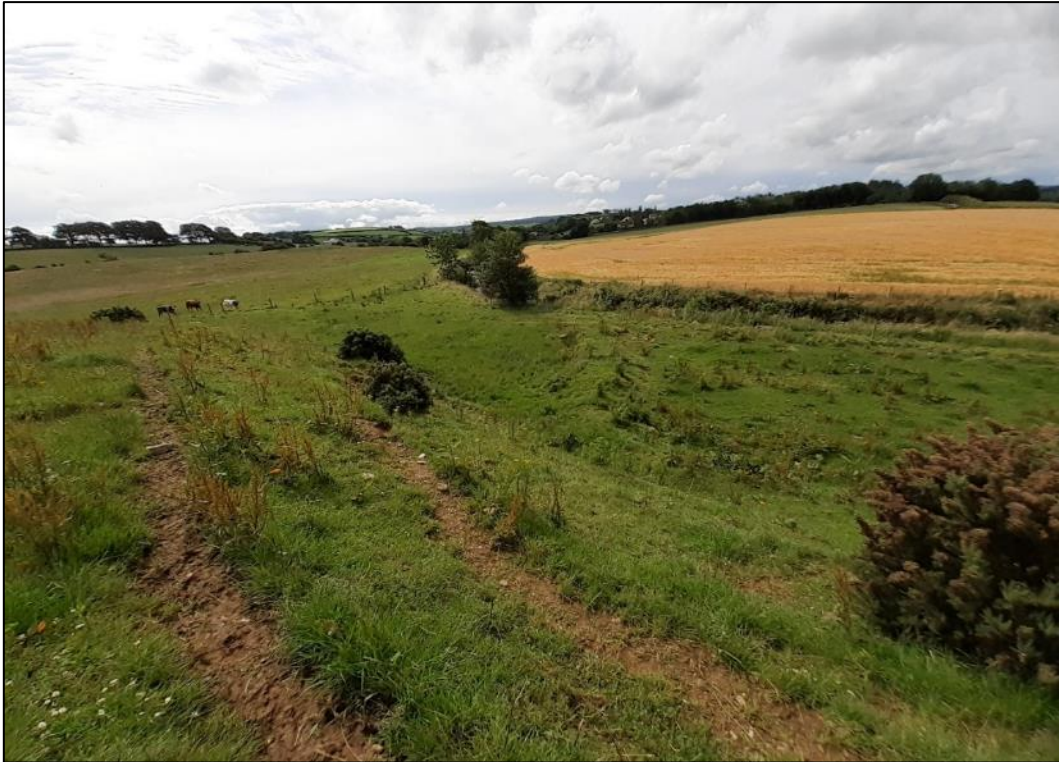
Plate S3-09: View to southwest of mill race location (L306-1), north of Ch. 1+000

Ch. 0+800 to 1+900 comprises of a mixture of well-drained, undulating and managed pasture and tillage, along with patches of wet marshy land near river and streams. Located north of Ch. 1+000 is the location of an excavated cist (DG054-039----) (ITM 624343, 910582). To the north of Ch. 1+000, LiDAR anomaly L306-1, a possible mill race (ITM 624390, 910745) (also marked as a weir on 1st ed OS map (c. 1840) was identified, and upon inspection the field in question was heavily disturbed, however a possible location for a portion of the (infilled) mill race was identified by a raised area of land close to the river (**Plate S3-09**). This feature is located outside the Study Area. A patch of low-lying wetland was identified south of Ch. 1+100 close to a stream and may retain archaeological potential.

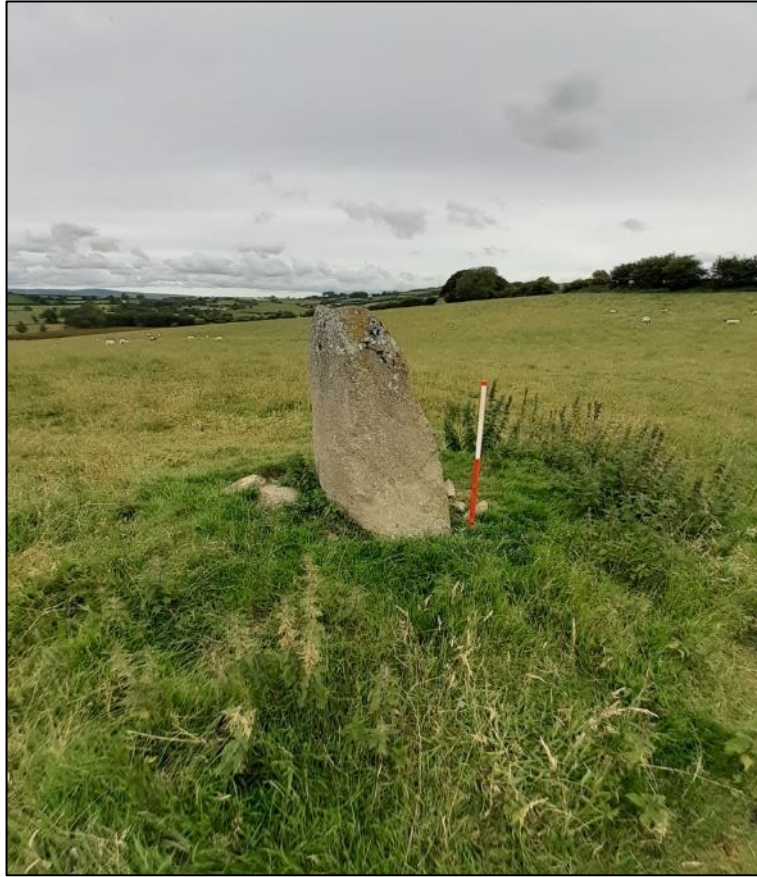
Plate S3-10: View to northwest of standing stone (DG054-040----), south of Ch. 1+400

South of Ch. 1+400 just outside the Study Area are the locations of a standing stone (DG054-040----) (**Plate S3:10**) and a cist (DG054-041----) (excavated - no visible trace) (ITM 624719, 910164). At Ch. 1+300 – Ch. 1+400 a large pasture field is bounded to the south and northeast by a mature treeline and large bank and ditch (**Plate S3:11**) and (**Plate S3-12**) which previously formed a laneway (Ch. 1+450) accessing a now removed farmstead (with a well) to the west at Ch. 1+300 (ITM 624585, 910362) named 'Holme' (Ref. F-3-01) and 'Carrickballydooley' (Ref. F-3-02) farmstead to the south at Ch. 1+580 per the 1st ed OS map (c. 1840) (ITM 624856, 910326) (see **Plate S3-12**). There is rock outcropping noted to the north of the 'Holme' farmstead location at Ch. 1+250.

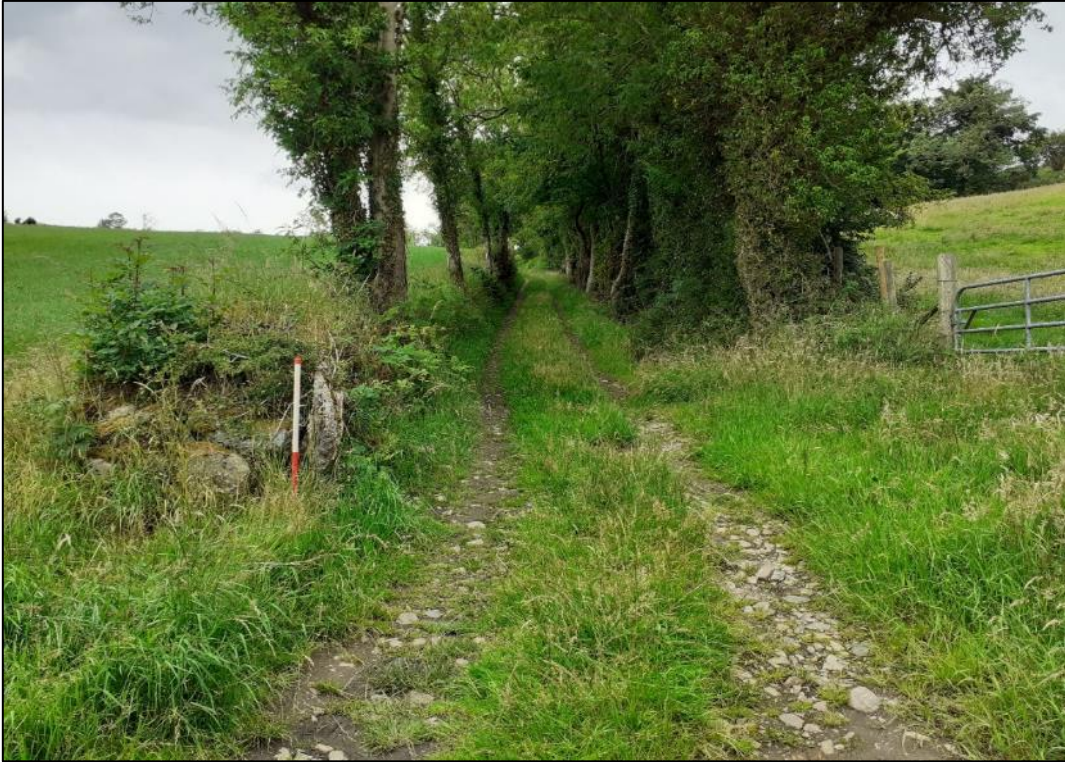
Plate S3-13: View to north of laneway with mature trees that forms townland boundary of Carrickballydooley/Ballyboe between Ch. 1+800 – 1+850

Between Ch. 1+800 – Ch. 1+850 there is a former path lined with mature trees was identified (**Plate S3-13**) which forms the townland boundary of Carrickballydooley and Ballyboe. At Ch. 1+900 within the townland of Ballyboe the location of a possible 'fairy tree' (landowner pers. comm.) (Ref. F-3-03) (ITM 625134, 910177) (**Plate S3-14**) was inspected at the foot of a steep sloped hill near the local road. No votive offerings were observed at the time of visit and the tree is a mature sycamore (typically native hawthorn is the preferred species). The elevated ground to the rear of the tree was assessed but nothing of archaeological potential was observed on ground surface levels.

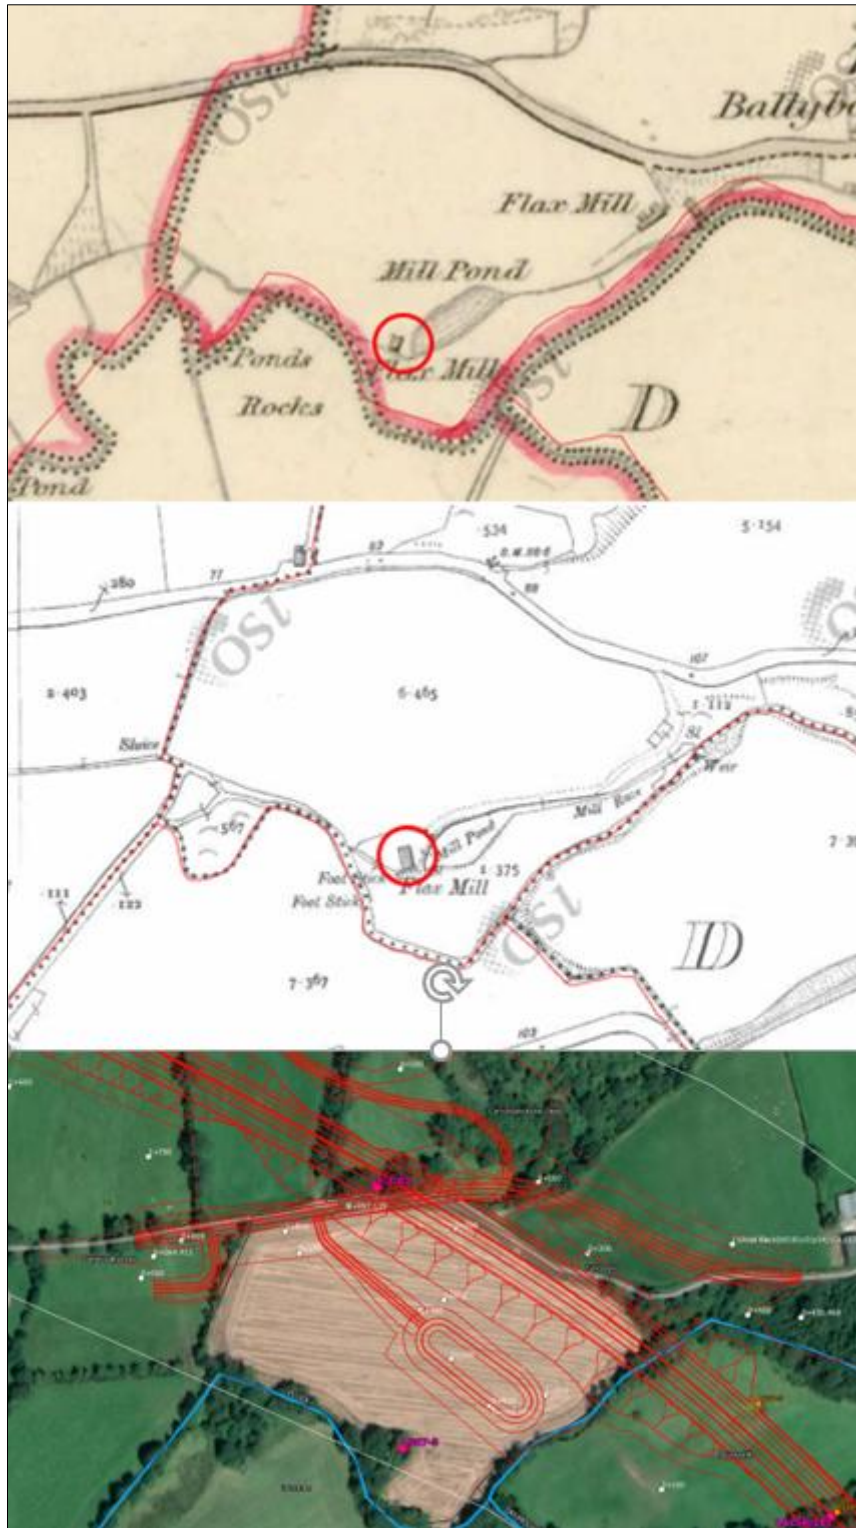
Flax mill (M532) identified south of Ch. 2+000 – Ch. 2+100 (ITM 625150, 910013) could not be accessed due to during survey due to the presence of crops and non-landowner permission within this field. However satellite (Bing) imagery appears to indicate extant partial ruins of the flax mill at this location.

1st ed OS (c. 1840) (top) and satellite imagery (bottom) of flax mill M532

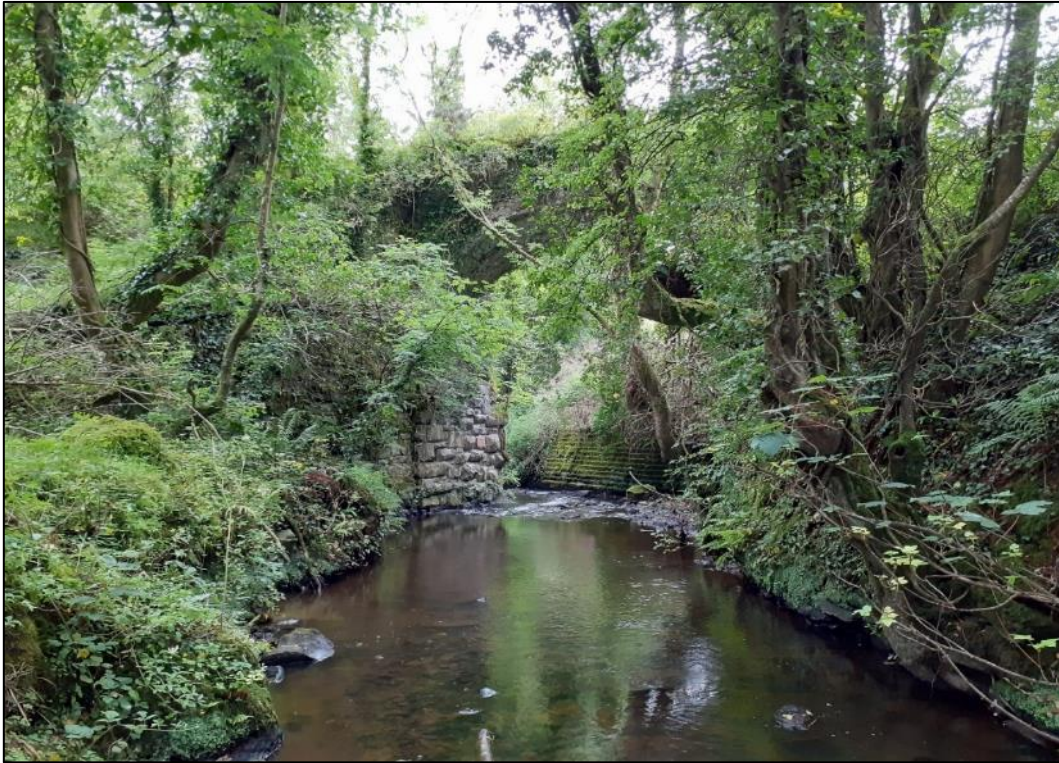
Plate S3-15: View to northwest of disused railway bridge (NIAH 40905447) northeast of possible mill race (L307-4), Ch. 2+300

The area of Ch. 2+200 – Ch. 2+600 comprises of a mixture of well-drained undulating and managed pasture/tillage. Just beyond the 300m design corridor, northeast of Ch. 2+300, LiDAR anomaly (L307-4), a possible mill race, was inspected during field survey at ITM 625618, 910062. Noted on the south bank of a stream/river that forms the townland boundary of Ballyboe/Drumoghill, it is also close to a disused railway bridge (NIAH 40905447) (**Plate S3-15**). The site is not easily identifiable due to vegetation overgrowth, but a portion appears to be that of a stone lined mill race, horseshoe in shape and running from a southeast to northwest direction for approximately 2 meters (**Plate S3-16**). These features are located outside the Study Area, although remains of the former Londonderry & Lough Swilly Railway (Letterkenny Branch) railway line embankment traverses the alignment at Ch. 2+250 at Drumoghill (ITM 625418, 909970).

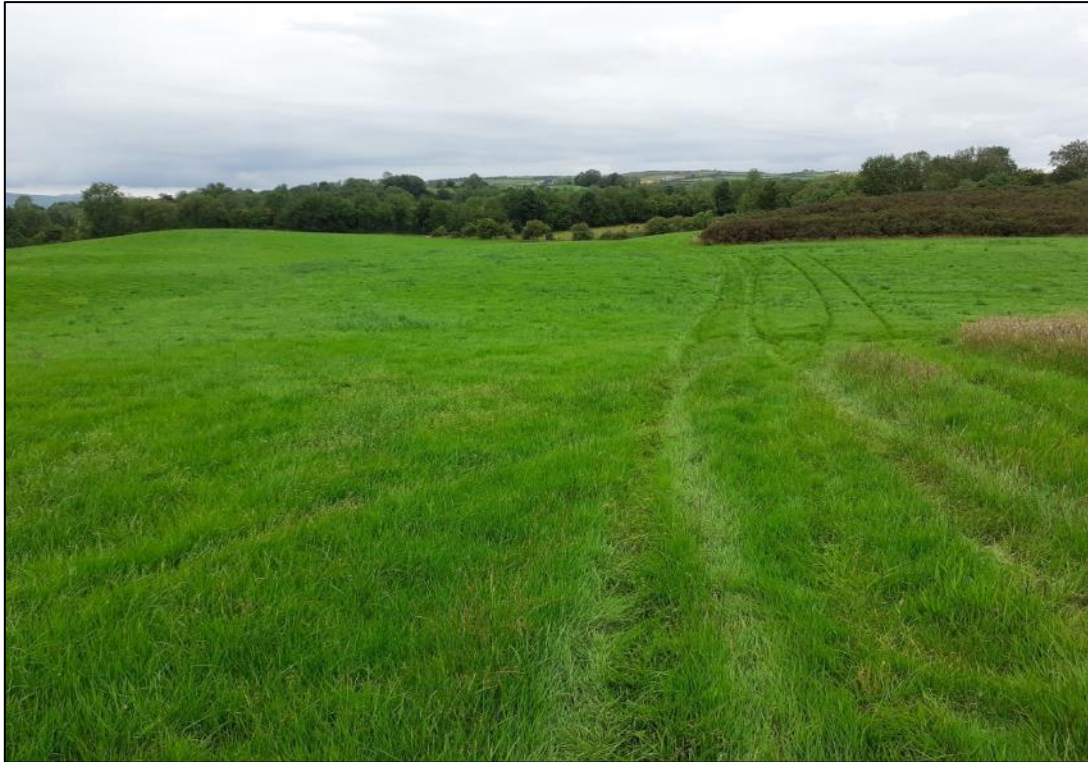
Plate S3-17: View to north of undulating pasture at Ch. 2+400

The area between Ch. 2+300 – Ch. 2+500 is considered to have a high level of archaeological potential due to the undulating and well-drained pastureland and southerly aspect of same (**Plate S3-17**) (forms part of S3AAP01, central ITM 625492, 909853). In the northeast corner at Ch. 2+400 are the possible remains of a lime kiln (F-3-04) (per 1st ed OS map) (ITM 625516, 909875) (**Plate S3-18**), stone wall (**Plate S3-19**) and a disused laneway, lined with mature trees on both sides (**Plate S3-20**) blocked up by large boulders, all of which were heavily overgrown with vegetation during field survey.

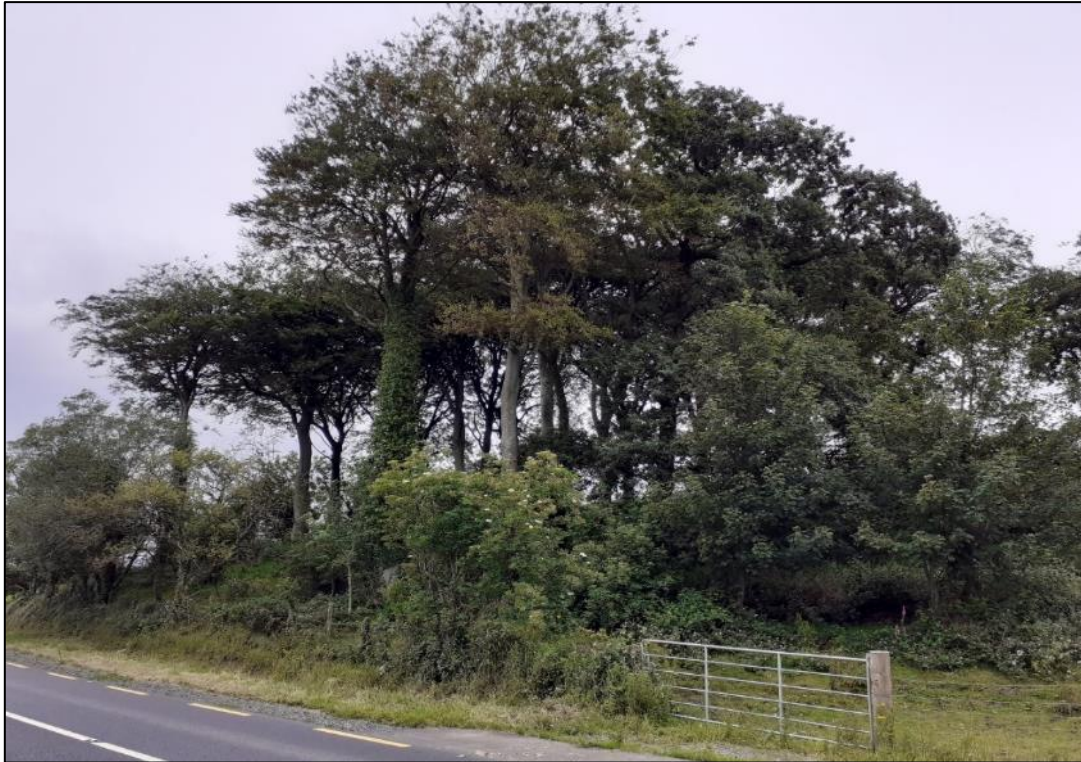
Plate S3-21: View to northwest of tree stand at Ch. 2+650, from N14

At Ch. 2+650 there is a tree stand (Ref. F-3-05) along the proposed alignment (ITM 625624, 909642) (**Plate S3-21**) which is sited on an elevated platform and bounded by the existing N14 to the south/southwest, and a stream to the south/southeast which also forms the townland boundary of Drumoghill/Drumcarn. Upon inspection the mature trees form a plantation not representative of a defined tree-ring *per se*. The curving line to the southeast respects the stream orientation at that point. The site occupies a discreet but prominent elevated platform and does afford good views of the surrounding rolling countryside.

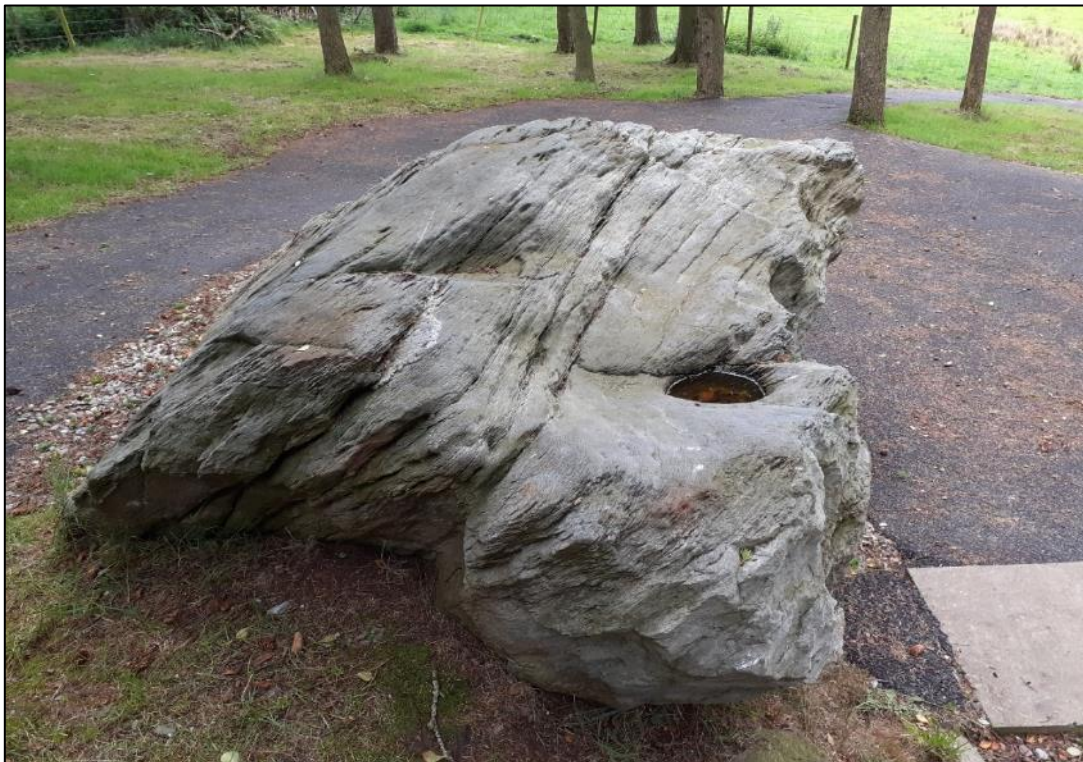
Plate S3-22: View towards northeast of mass rock, Drumoghill, northeast of Ch. 2+600

Located northeast of Ch. 2+600, outside the Study Area is a local venerated (unrecorded) Mass Rock (Ref. F-3-06) (**Plate S3-22**) (ITM 625827, 909803) within the townland of Drumoghill, Access is by way of the “The Moss” football pitch for Drumoghill FC and along a tarmacadamed pathway.

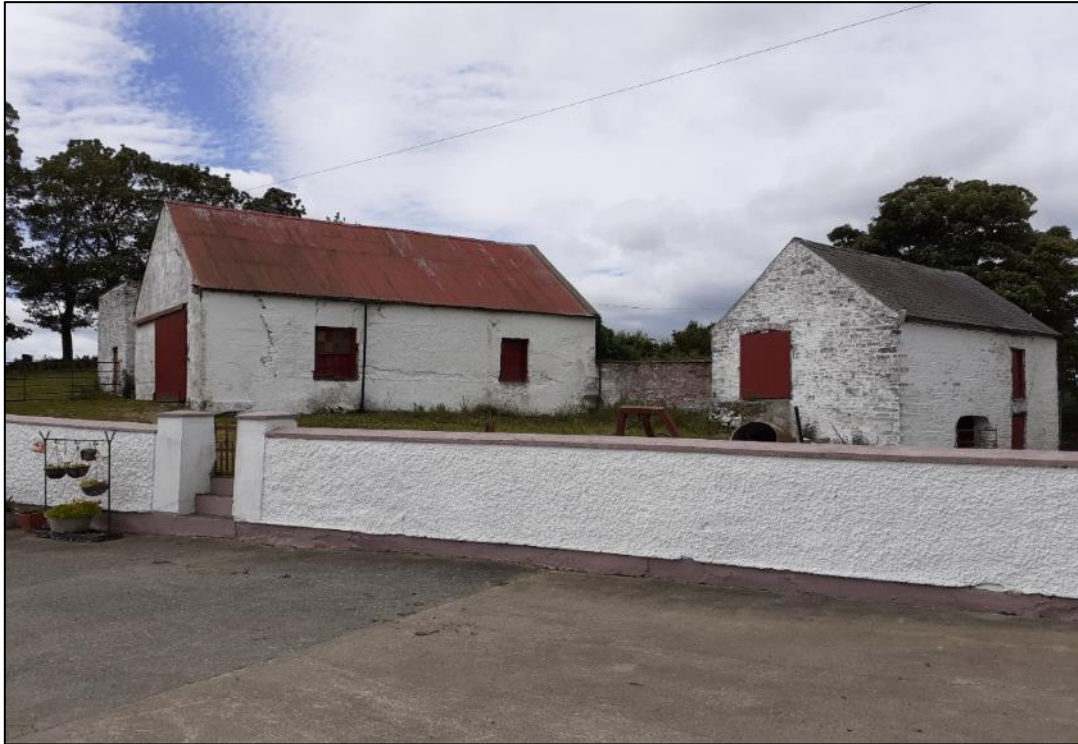
Plate S3-24: View to west of outbuilding (NIAH 40906245), northeast of Ch. 3+600

Northeast of Ch. 3+600 are farm outbuildings (NIAH 40906245) at Mondooy Lower (ITM 625893, 908742) (**Plate S3-24**). The surrounding boundary to these building is comprised of thick vegetation and small trees to the west, and a line of mature trees to the south (**Plate S3-25**).

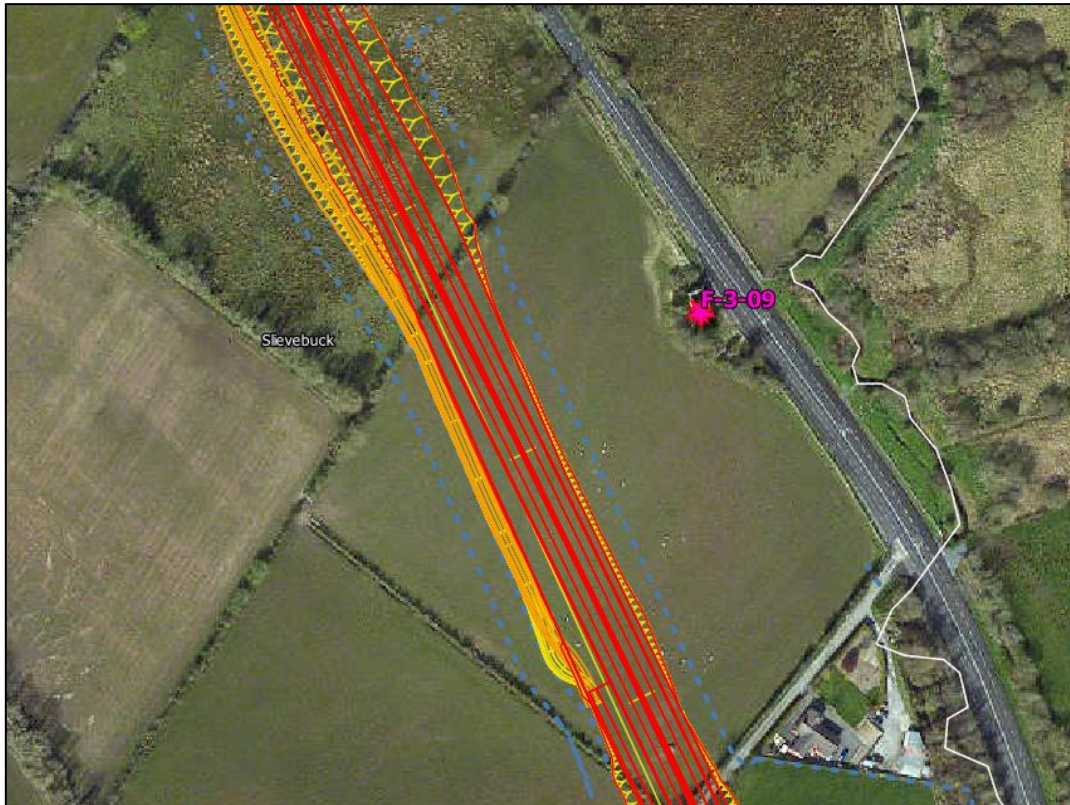
The area of Ch. 7+000 – Ch. 7+200 comprises of flat well-drained and maintained pasture which gradually changes to undulating pasture at Ch. 7+300 towards the southeast (**Plate S3-41** and **Plate S3-42**). A two-storey ruinous vernacular house structure (Ref. F-3-09) surrounded by trees and bushes is located towards the northeast between Ch. 7+000 and Ch. 7+100 on the verge of the N14 road carriageway (ITM 627941, 906201) (**Plate S3-43**). The house is indicated on the 2nd ed OS map (c. 1905) and a flax mill complex is also noted to the south at ITM 628012, 906039. Nothing of further heritage note was identified during field survey.

Satellite imagery showing ruined vernacular structure F-3-09

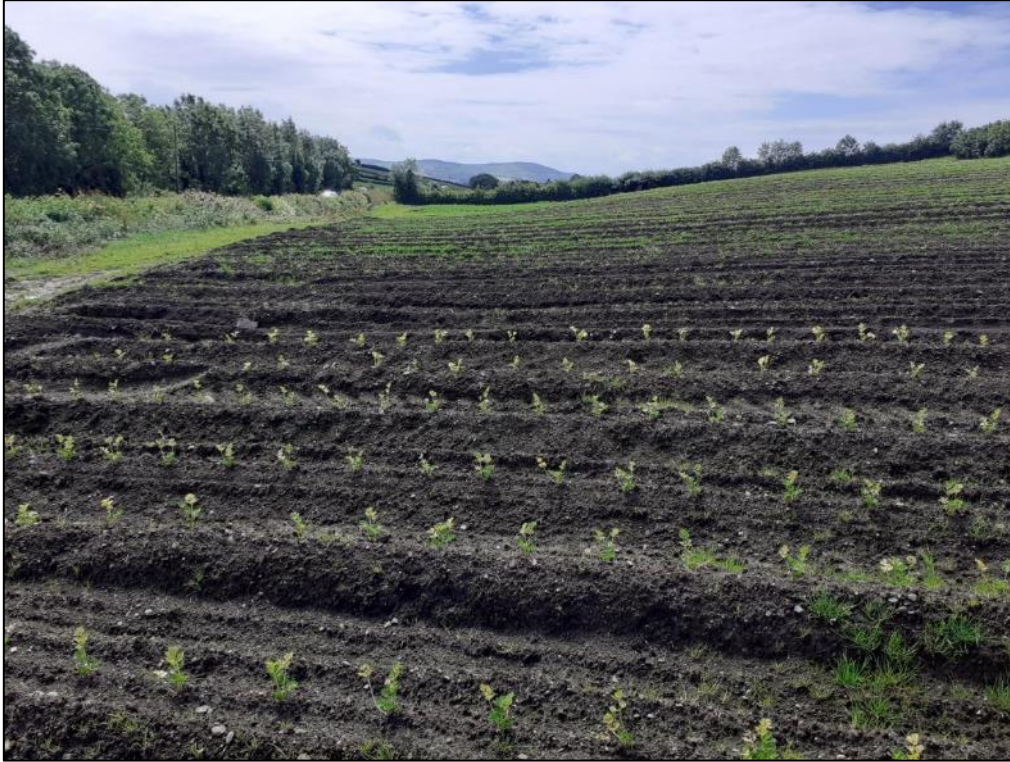
Plate S3-48: View to southeast at Ch. 8+150

The area of Ch. 7+900 – Ch. 8+200 comprises of a mixture of both well drained and improved pasture and tillage, gradually changing from flat pasture at Ch. 8+000 to northeast sloping/undulating terrain, extending towards the N14 road carriageway and a commercial forestry plantation (**Plate S3-48**). The proposed alignment crosses the N14 road carriageway at Ch. 8+250 into flat, wet rough pasture (ITM 628357, 905068)

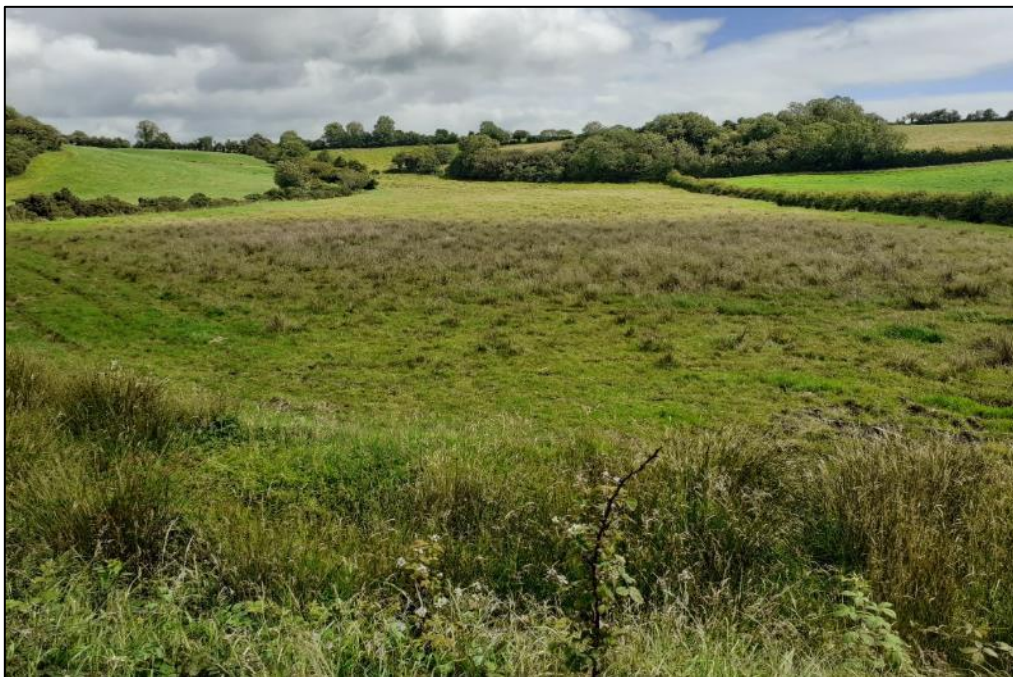
Plate S3-49: View to west at Ch. 8+250

which is considered an area of archaeological potential (Ref. F-3-11), given ground conditions conducive to the presence of *fulachta fiadh* including proximity to the nearby stream which also forms the townland boundary of Dromore Big and Carnshannagh (**Plate S3-49**).

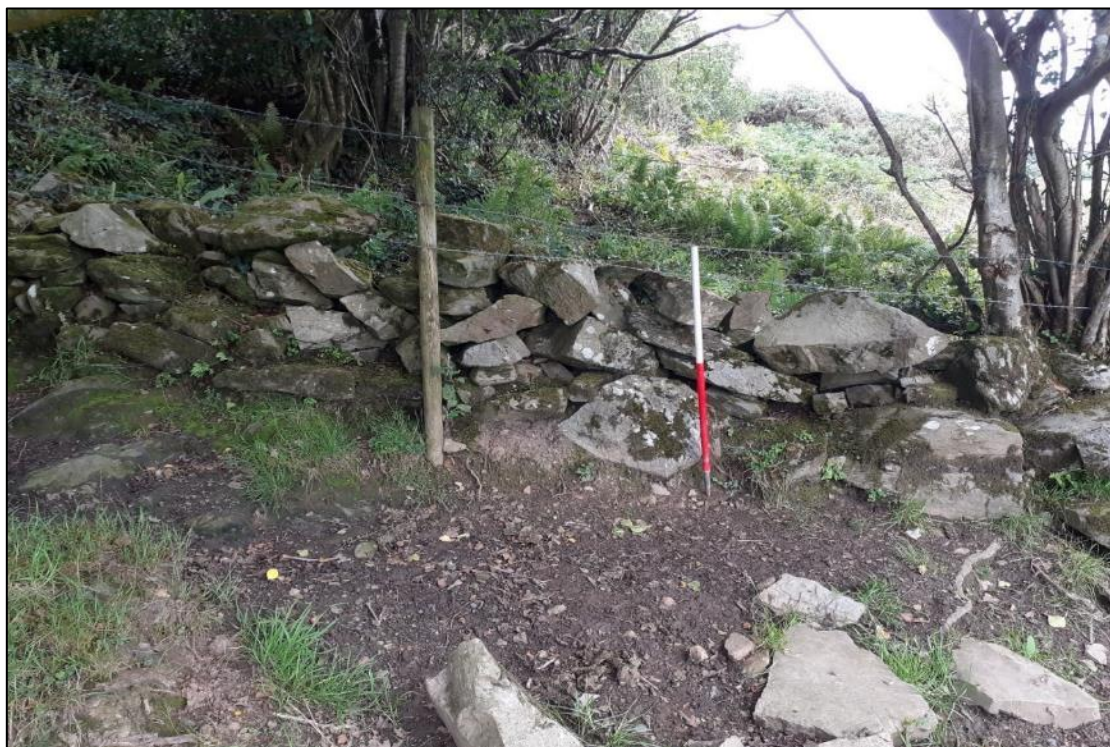
Plate S3-53: View to east of drystone wall at Ch. 8+800

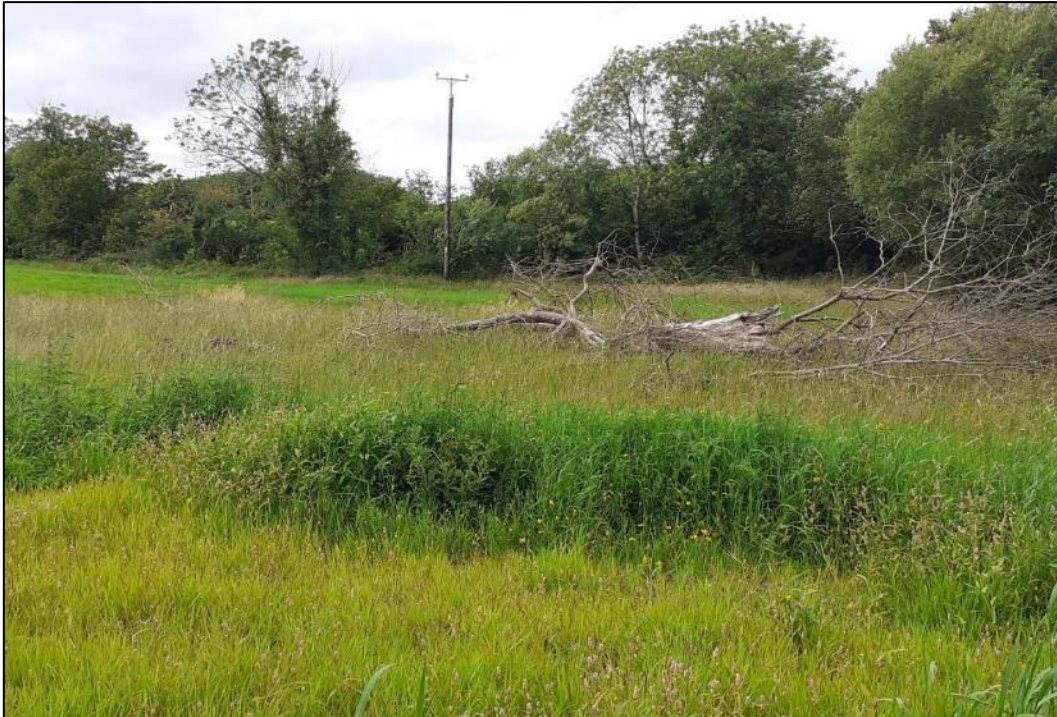
Ch. 9+000 – Ch. 9+400 consists of well-drained, undulating pasture which becomes wetter towards the southeast and the location of a stream/river which also forms the townland boundary of Carnshannagh/Drumbeg (**Plate S3-54**) and (**Plate S3-55**) as well as the site of a mill pond and former flax mill (ITM 628866, 904029). A ruined single-storey former cottage/building (Ref. F-3-13) is located at Ch. 9+400 (ITM 628866, 904004) at the former flax mill complex (**Plate S3-56**) whilst a road over river single arch masonry bridge (Ref. F-3-14) is located west of Ch. 9+300 at ITM 628737, 904066, representing a former road carriageway, indicated on the 1st ed and 2nd ed OS, which has been realigned on the N14 at this location (**Plate S3-57**).

Plate S3-55: View to northwest and former mill pond/flax mill at Ch. 9+400

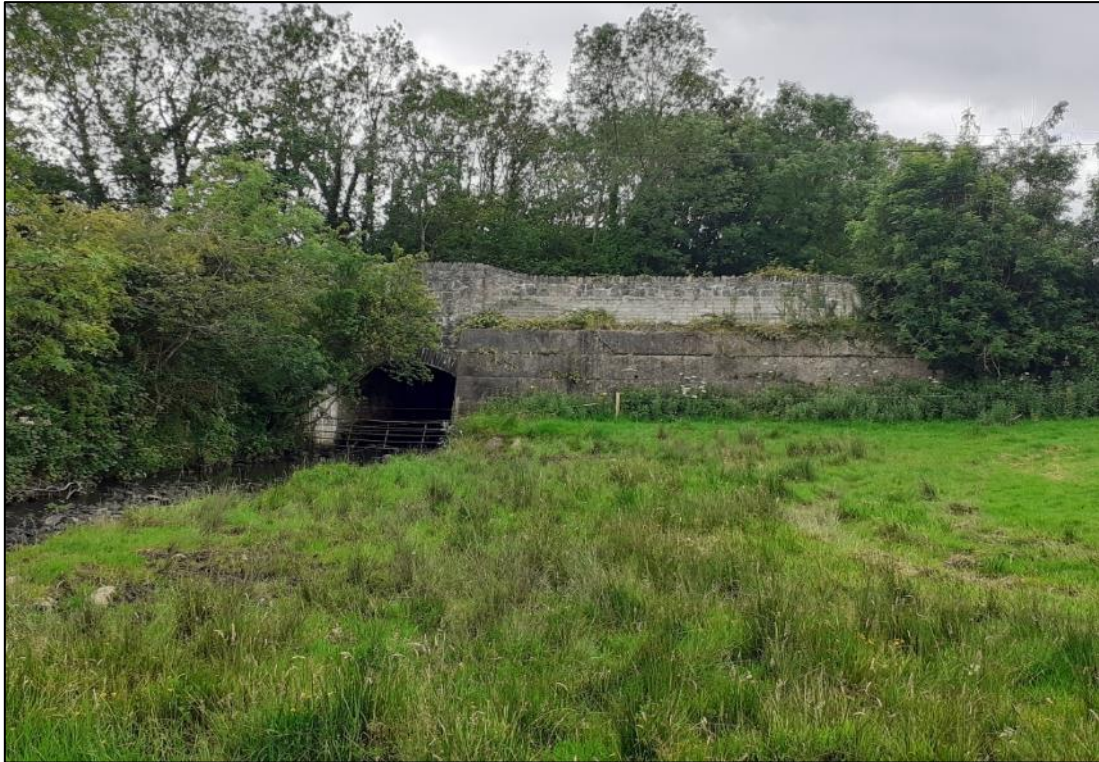
Plate S3-57: View to west of road bridge at Ch. 9+380

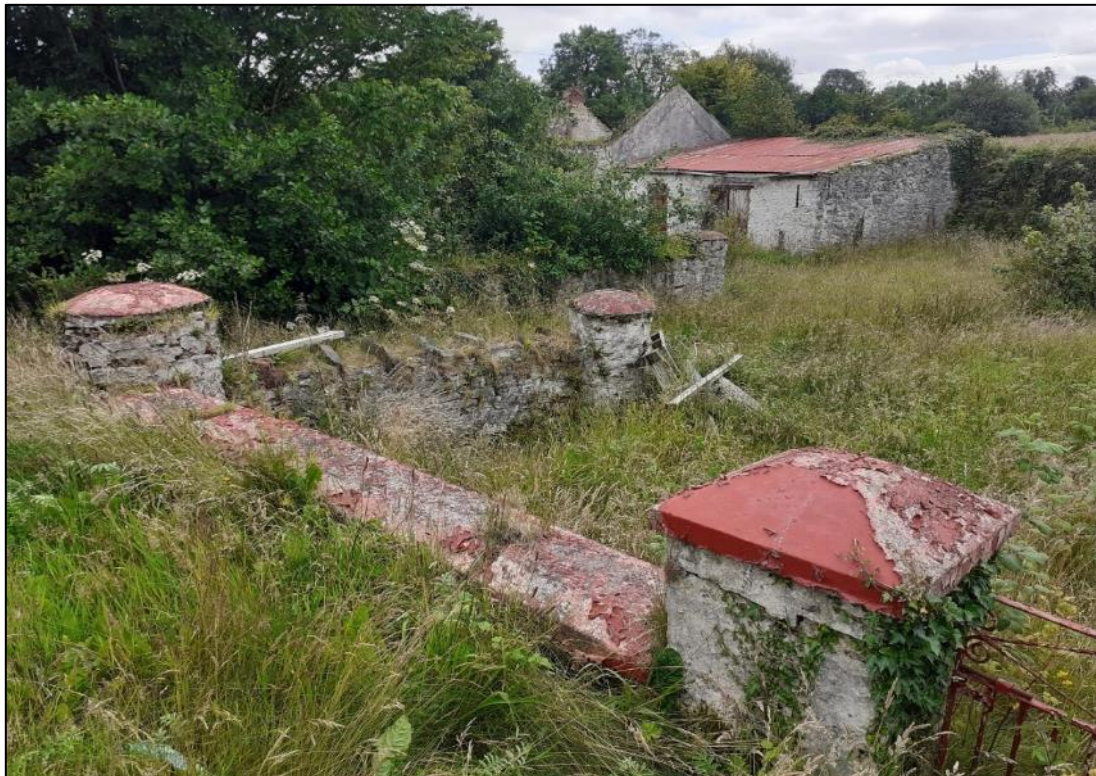
There is a recorded vernacular cottage along the N14 southwest of Ch. 9+250 (NIAH 40906262) (ITM 628673, 904128) which is in a derelict state with another derelict cottage and outbuildings complex to the northwest of same (**Plate S3-58**). The former Annie Tourish's pub, (RPS/NIAH 40906203) a former thatched cottage, located at White Cross-Roads ITM 628768, 903986 southwest of Ch. 9+450 has been entirely removed (above ground) (**Plate S3-59**).

Plate S3-58: View to southwest of part of ruined vernacular complex along N14 (to northwest of cottage NIAH 40906262) southwest of Ch. 9+250

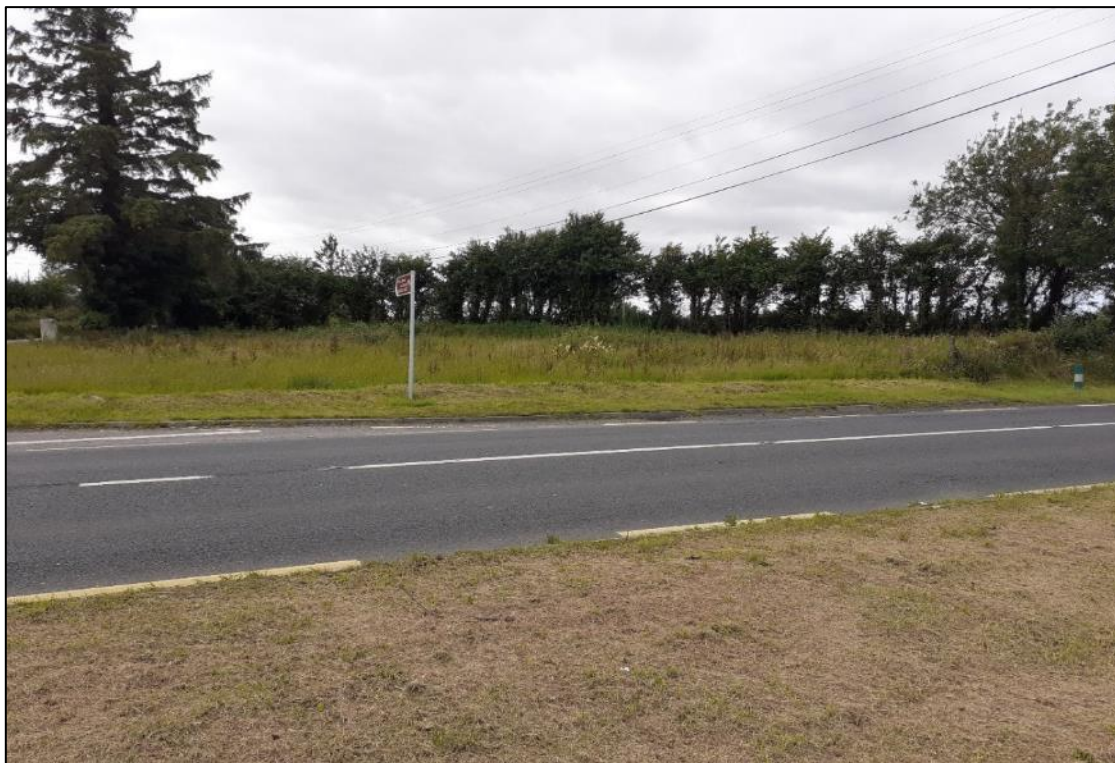
Plate S3-59: View to northwest of former location of Annie Tourish's Pub (RPS/NIAH 40906203) at southwest of Ch. 9+450

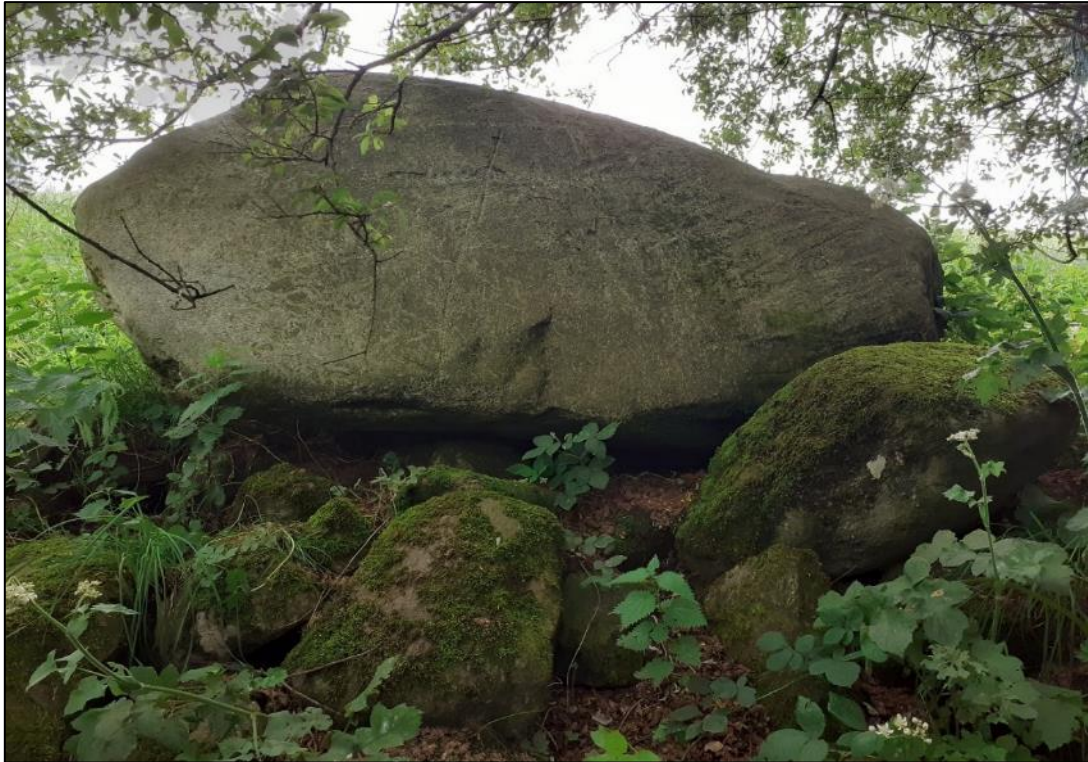
also the location of a former Mill Pond (L-338-1) and mill race (L-338-2) (1st and 2nd ed OS) (ITM 629372, 903158 and ITM 629373, 903199) at Ch. 10+400 – Ch. 10+450. The latter mill features were not discernible due to heavy vegetation and crop growth during survey. A large boulder set on edge atop a loose stone boulder wall, had notable 'wear' pattern, possibly due to plough action, suggesting that it had been previously removed as field clearance and set at the boulder walling (ITM 629353, 903147) (**Plate S3-64**) and (**Plate S3-65**).

Plate S3-64: View to southwest of large boulder at Ch. 10+500 Tullyrap mill pond and mill race location

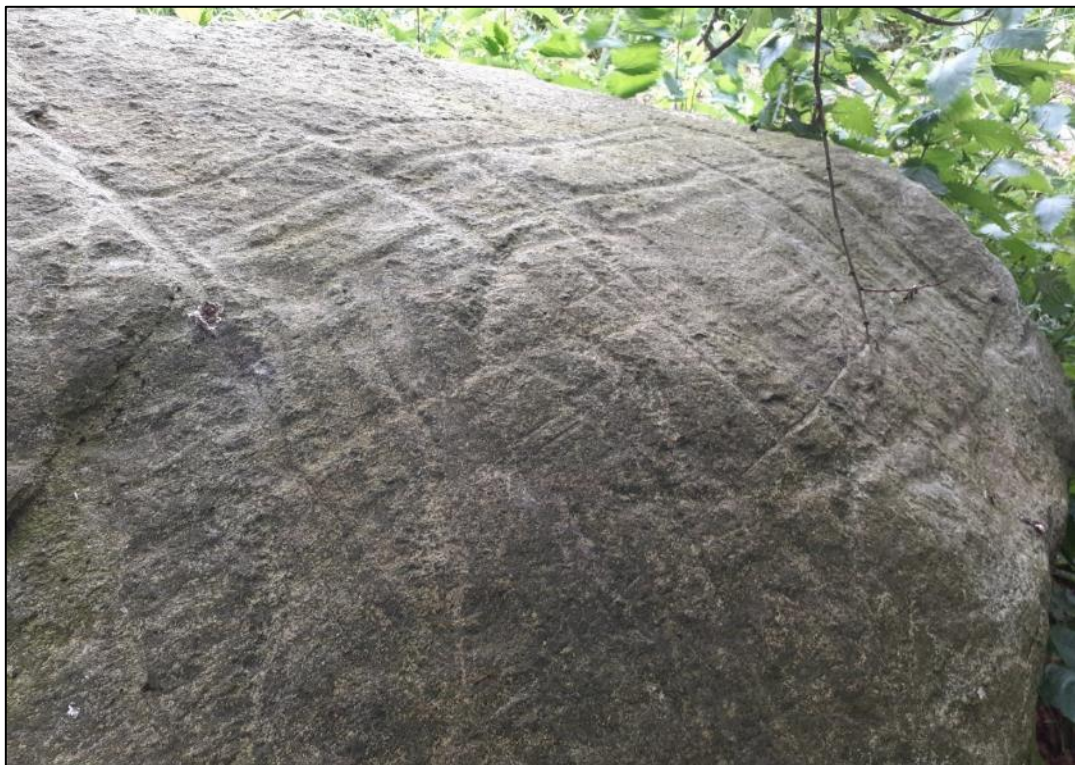
Plate S3-65: View of possible plough markings on large boulder at Ch. 10+500 mill Pond and mill race location, Tullyrap

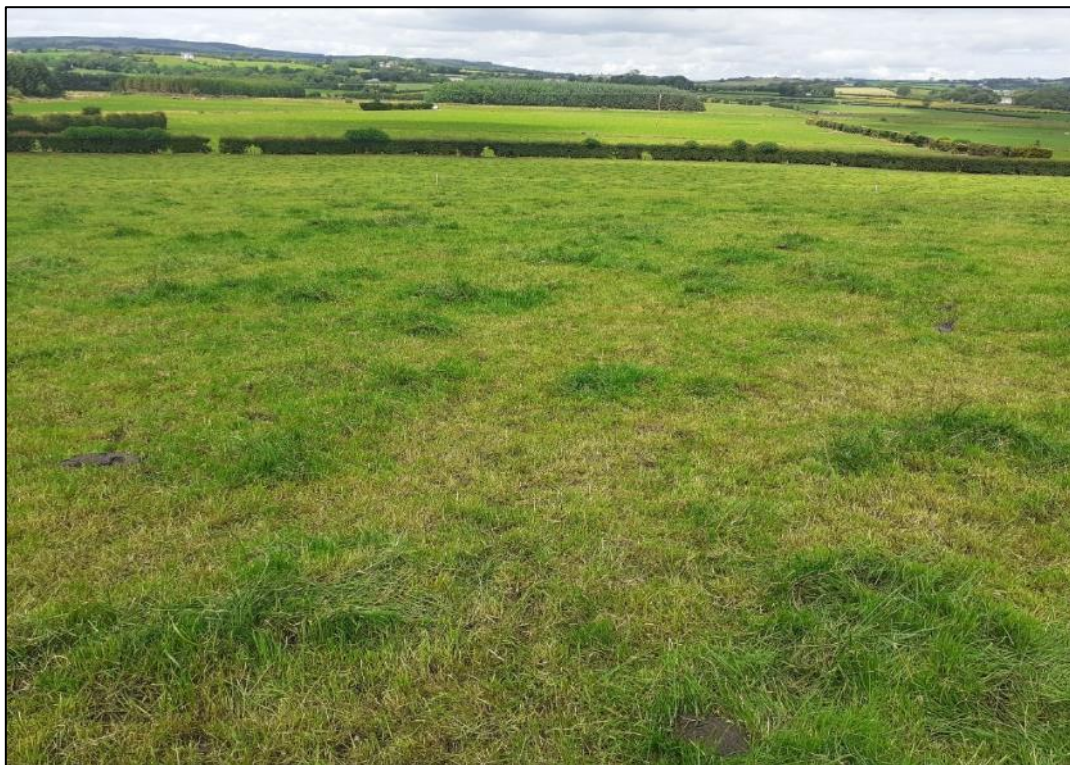
Plate S3-71: View to NW, northeast of Ch. 12+100

LiDAR anomaly L345-2, a possible enclosure, was identified northeast of Ch. 12+100 (ITM 629917, 901767) as a large curving field boundary, as well as a possible barrow L345-1 (ITM 629905, 901752). The area is represented by a natural elevated platform, occupied by a farmstead, with gradual sloping ground which reaches a curving field boundary at the northern portion comprising mature trees and vegetation (**Plate S3-71**), and which is indicated as a former laneway on the 1st and 2nd ed OS mapping.

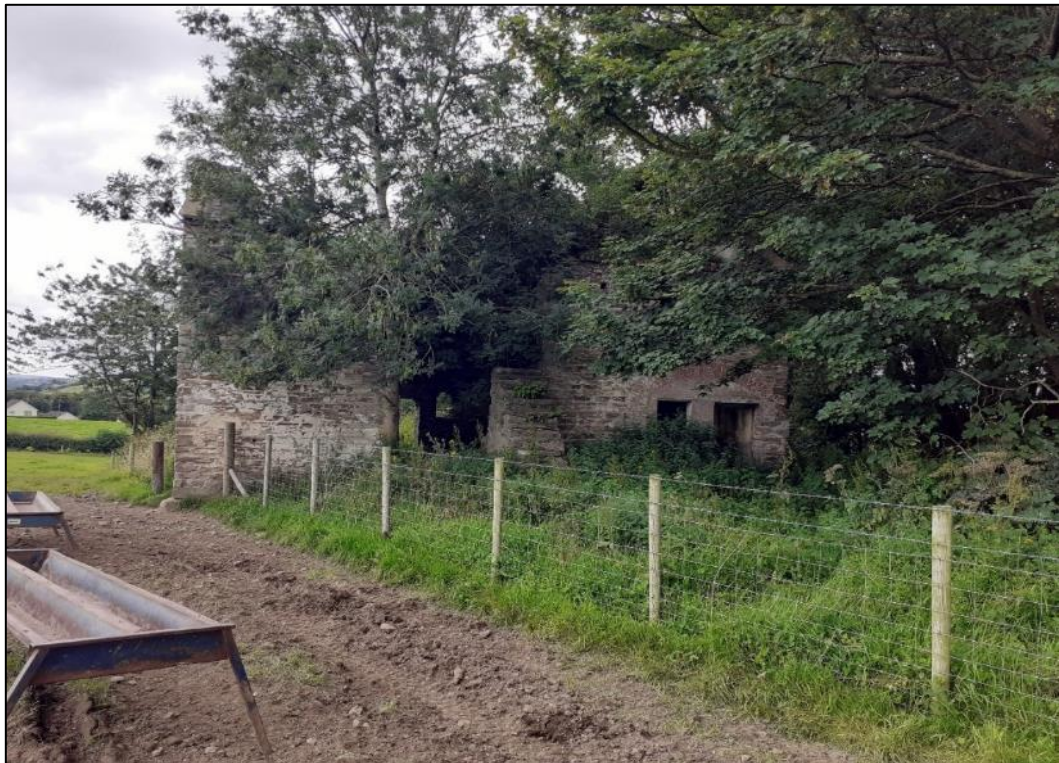
Between Ch. 12+300 – Ch. 13+100, the topography consists of undulating, well-drained pasture (**Plate S3-72**). Southwest of Ch. 13+100 just outside the assessment area, a LiDAR anomaly L349-2 identified 'buildings' accessed by a laneway, and which is the remains, in part, of 'Gortin' farmstead and the ruins of a former two-story farm building at ITM 630267, 900809 (**Plate S3-73**).

Plate S3-73: View to southwest of Ch. 13+100 and buildings at 'Gortin' farmstead
