Appendix C17.13

Section 3 Detailed Walkover Survey and Photographic Record

Ten-T Section 3, Manorcunningham to Lifford, Co. Donegal

(8th – 10th, 16th, 20th & 21st July 2020, 21 Jan 2022, 21 Sep 2022)

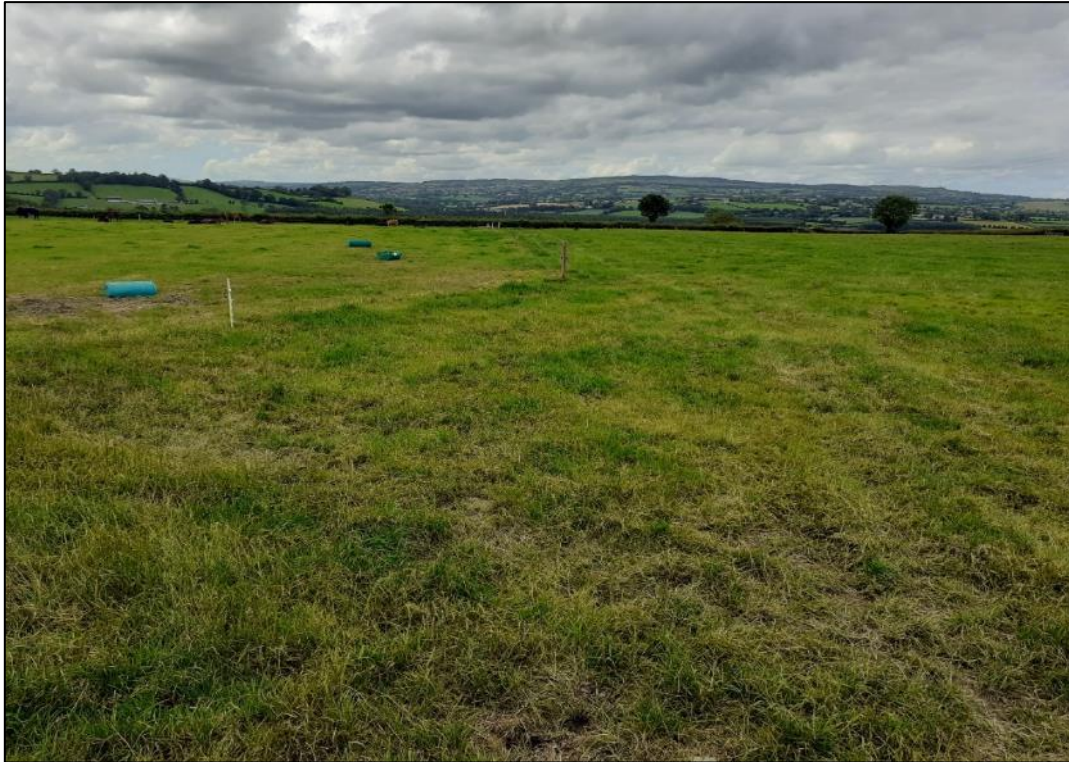
Northeast of Ch. 13+100 - Ch. 13+200 are the recorded locations of two standing stone sites, both of which have been removed (DG070-032----) and (DG070-033----) and confirmed via field inspection (**Plate S3-74**). This area forms part of an area of archaeological potential S3-AAP04 (central ITM 630488, 900843).

Plate S3-74: View towards south of recorded locations of sites of standing stones DG070-032---- & DG070-033----, northeast of Ch. 13+100

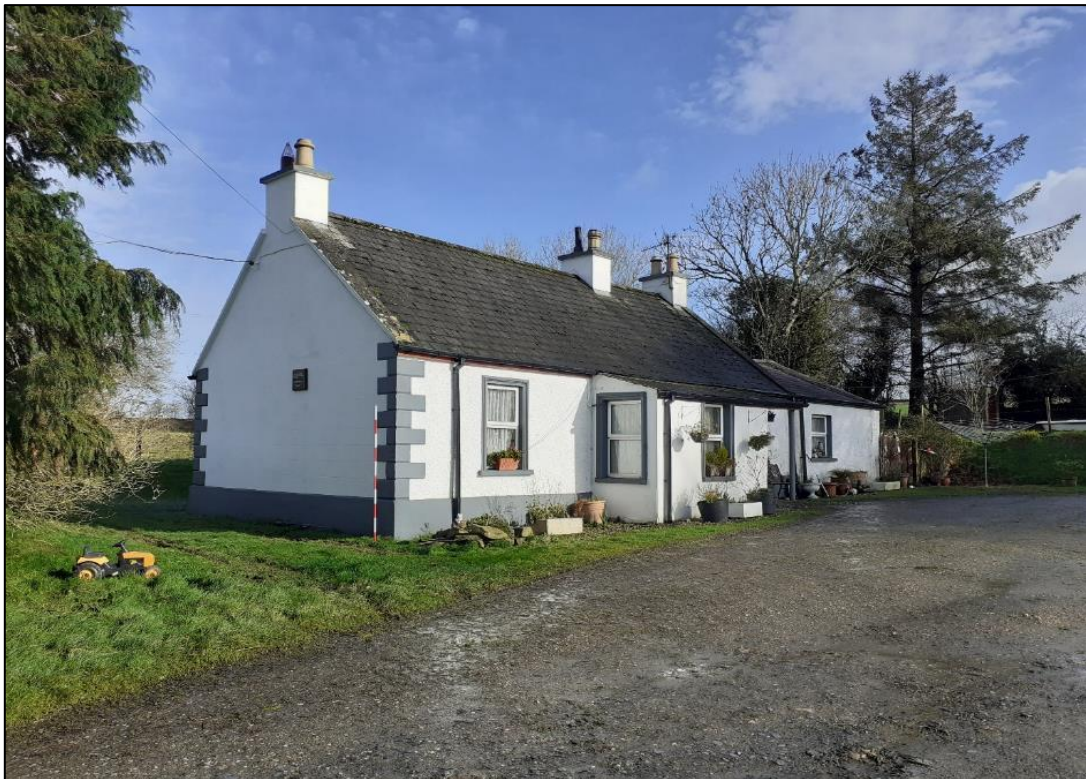
The birthplace of Rev. James Porter (Ref. M698) at Tamnawood (ITM 630462, 900558) at Ch. 00 of a proposed access road, is commemorated by a plaque attached to the gable wall of a modified cottage, within a yard containing vernacular stone outbuildings (**Plates S3-76 – S3-78**).

Plate S3-76: Birthplace of Rev. James Porter, Tamnawood (M698) with attached plaque on gable, facing northeast

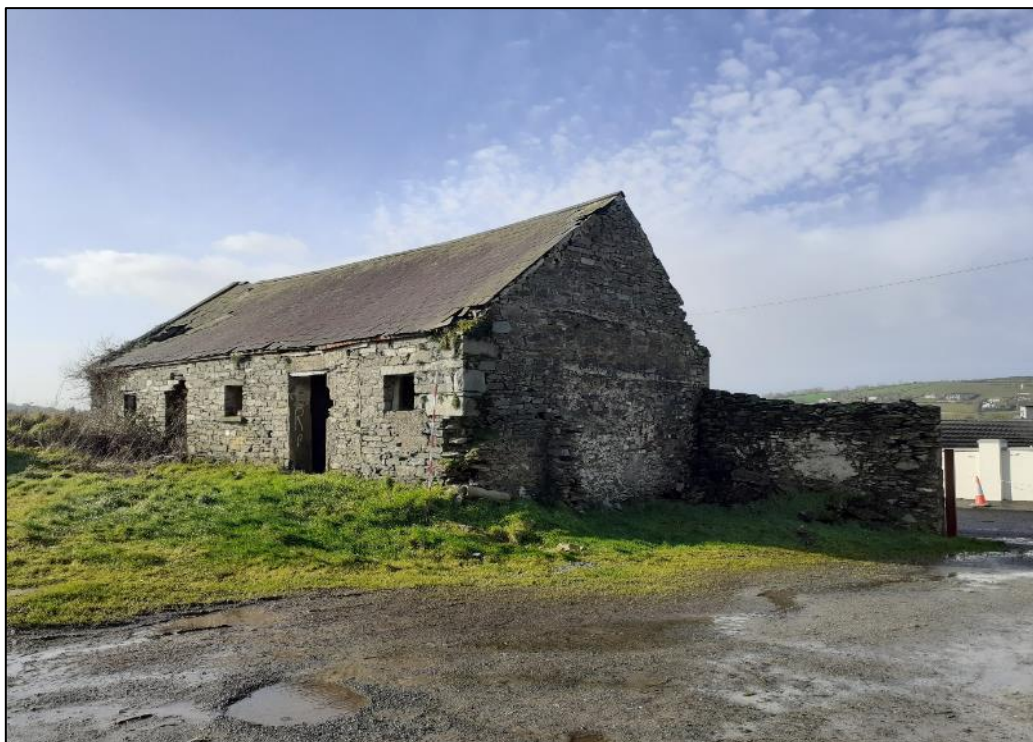
Plate S3-78: Vernacular stone outbuildings, M698 Tamnawood, facing southwest

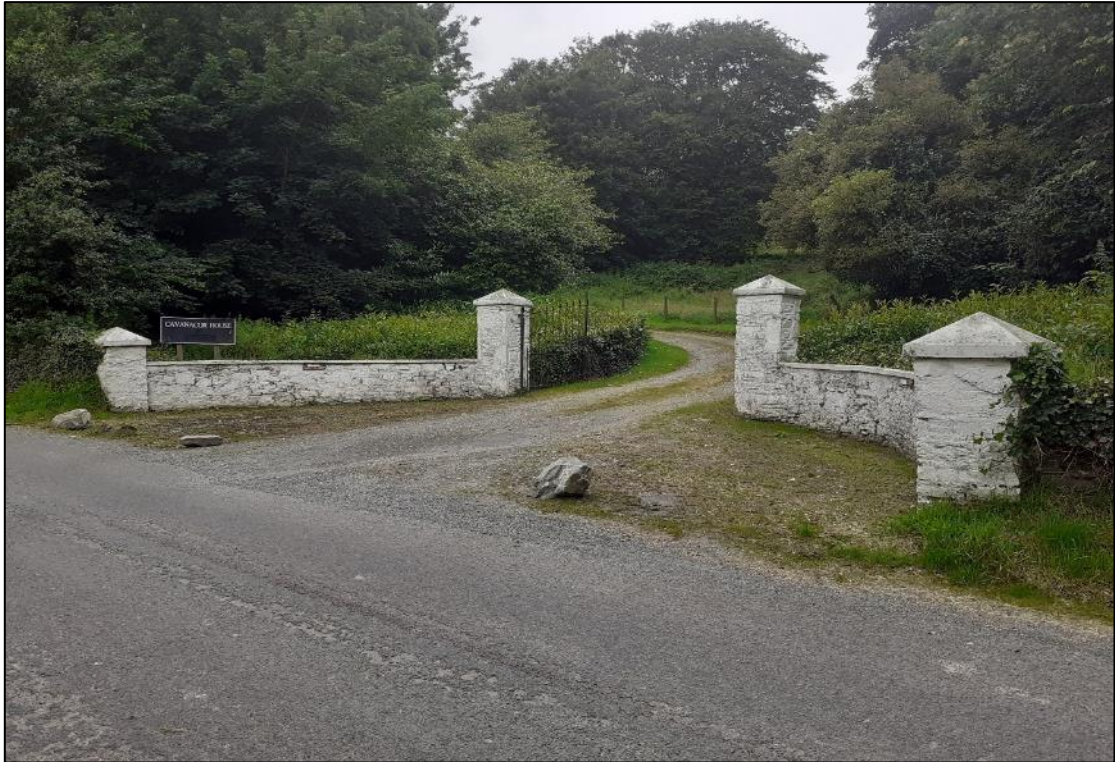
Cavanacor House (**Plates S3-80-S3-85**) is located east/northeast of Ch. 14+100, outside the assessment area, and both the house and immediate attendant grounds are surrounded and enclosed by a mature tree-line. There is a (disused) western entrance gate and an eastern entrance gate accessing the house from the local road network at the south (east/northeast of Ch. 14+100). The east gate (ITM 631454, 900239) has random rubble-built masonry walling and square gate piers with replacement pyramidal coping, whilst to the west the gates have a similar form, although with cast iron gate posts and the walling appears to have been rebuilt with modern blocks in recent years (ITM 631262, 900116). There is a derelict gate-lodge on the roadside, opposite the east gate (ITM 631468, 900227).

Plate S3-80: View to northwest of Cavanacor House east gate entrance

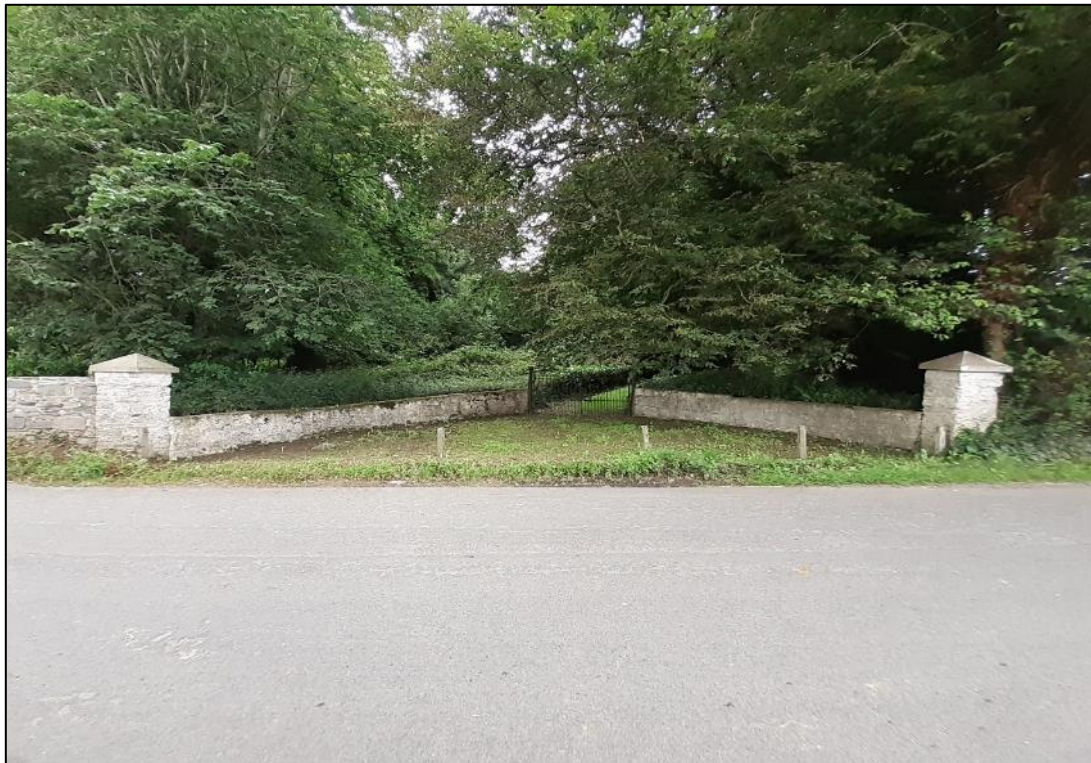
Plate S3-81: View to north of Cavanacor House west gate entrance

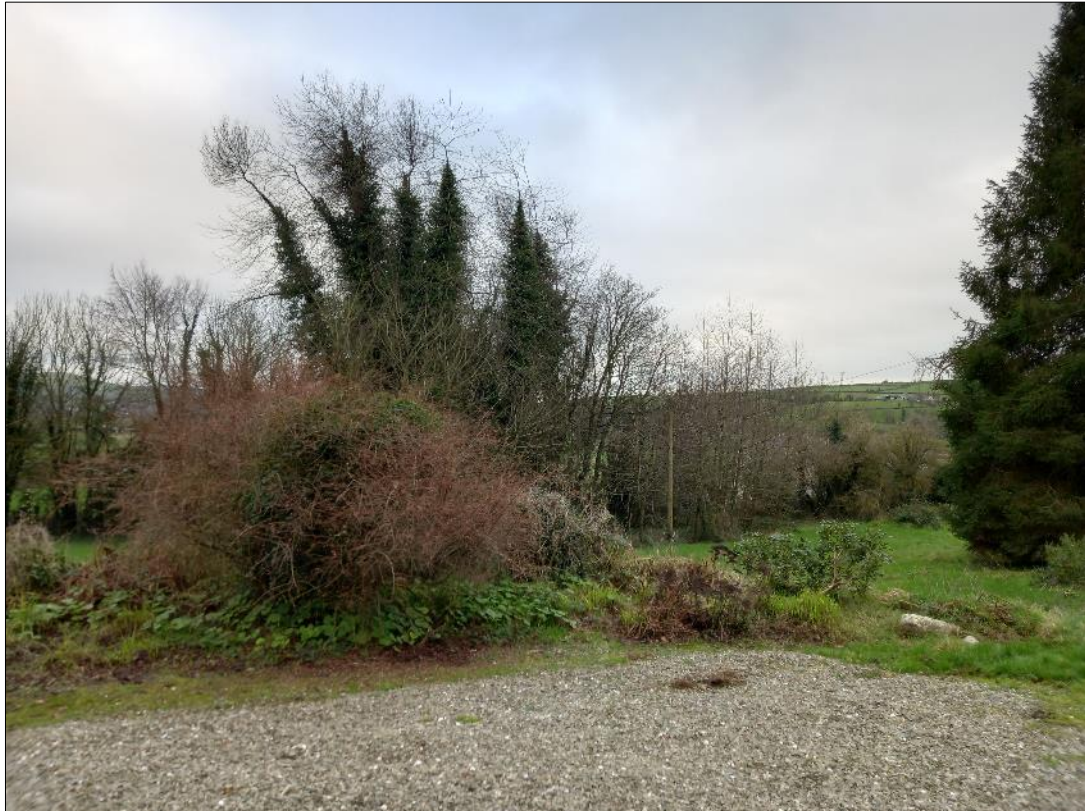
Plate S3-85: View from front elevation of Cavanacor House towards south and proposed development area

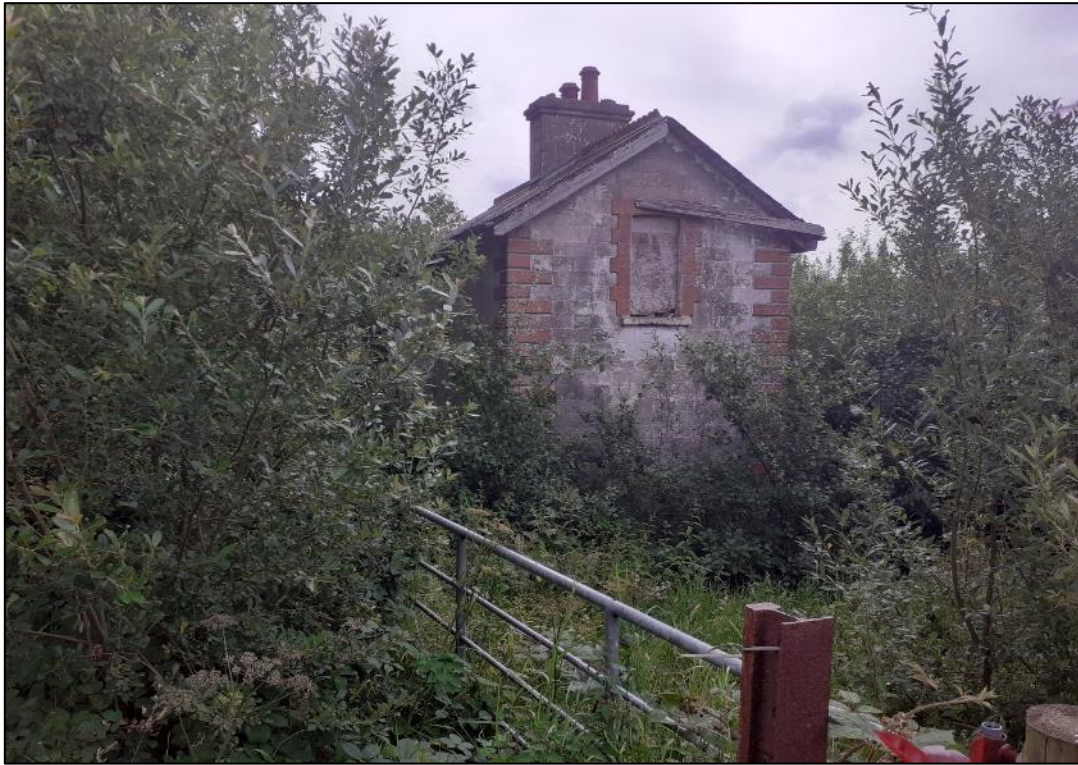
Plate S3-86: View to southeast of Station Masters House (NIAH 40834011) Ch. 14+100

14+100. These include a station master's house and ancillary railway structure (NIAH 40834011) (ITM 623693, 910767 and ITM 630267, 900809), and a goods shed (NIAH 40834017) (ITM630816, 900024) (Plate S3-86, Plate S3-87 and Plate S3-88).

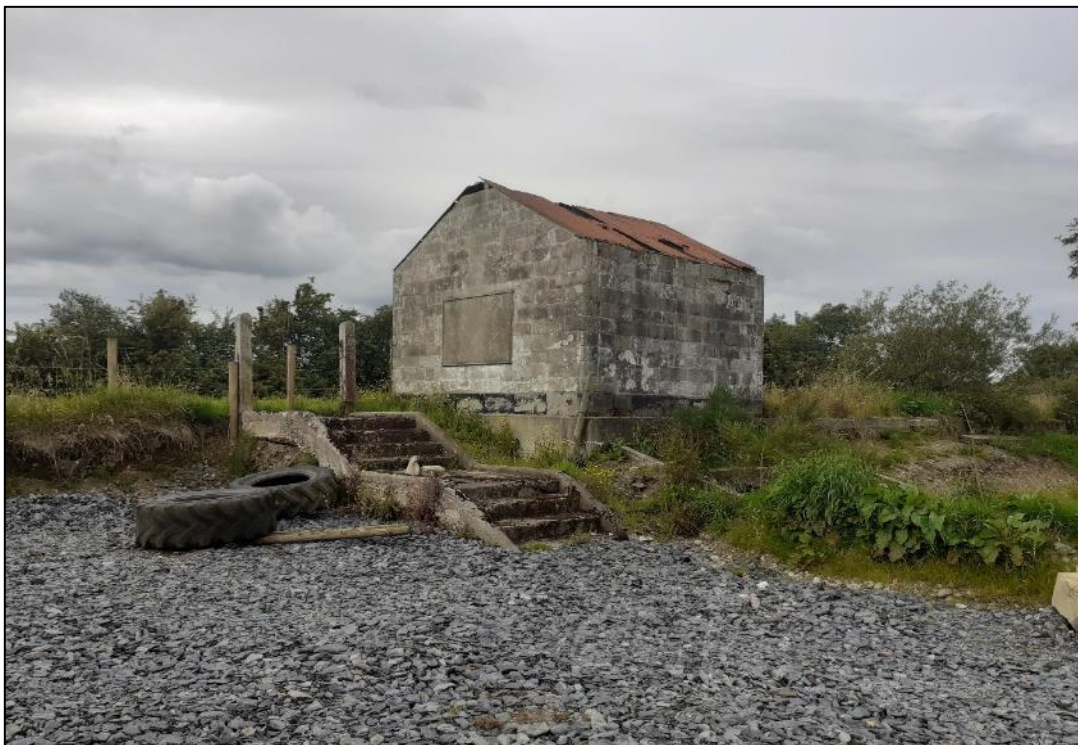
Plate S3-87: View to southwest of ancillary railway structure (NIAH 40834011) Ch. 14+100

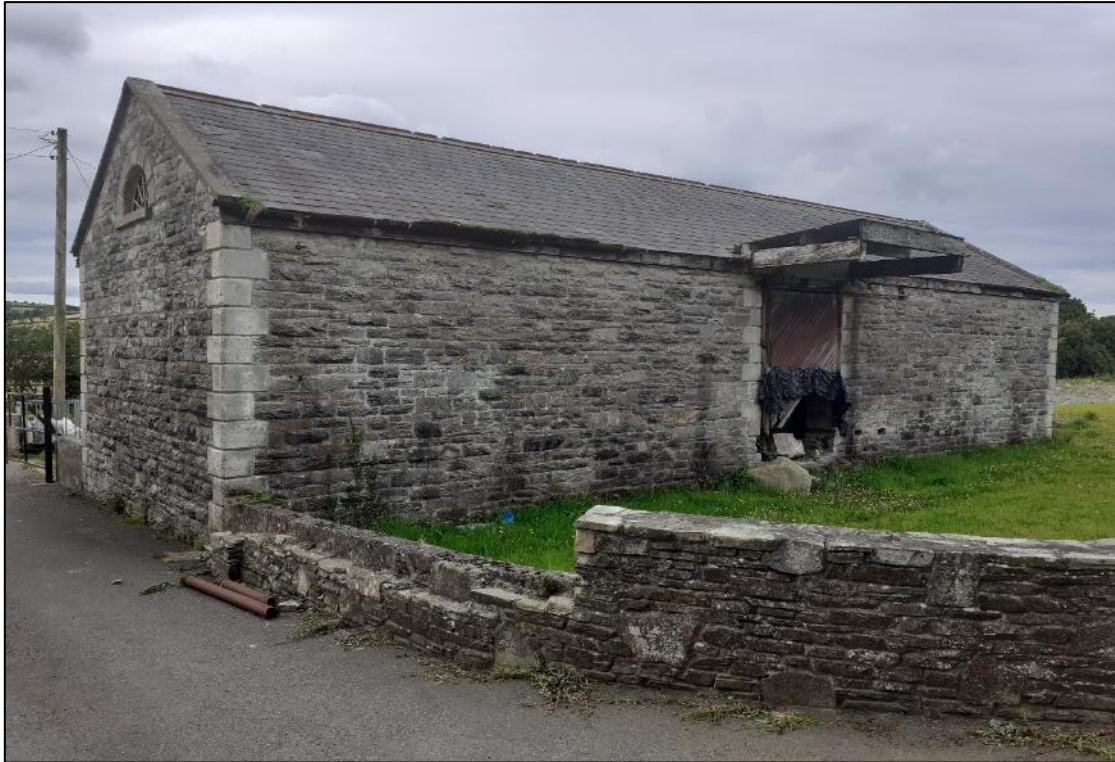
Plate S3-88: View to southwest of Goods Shed (NIAH 40834017) Ch. 14+100

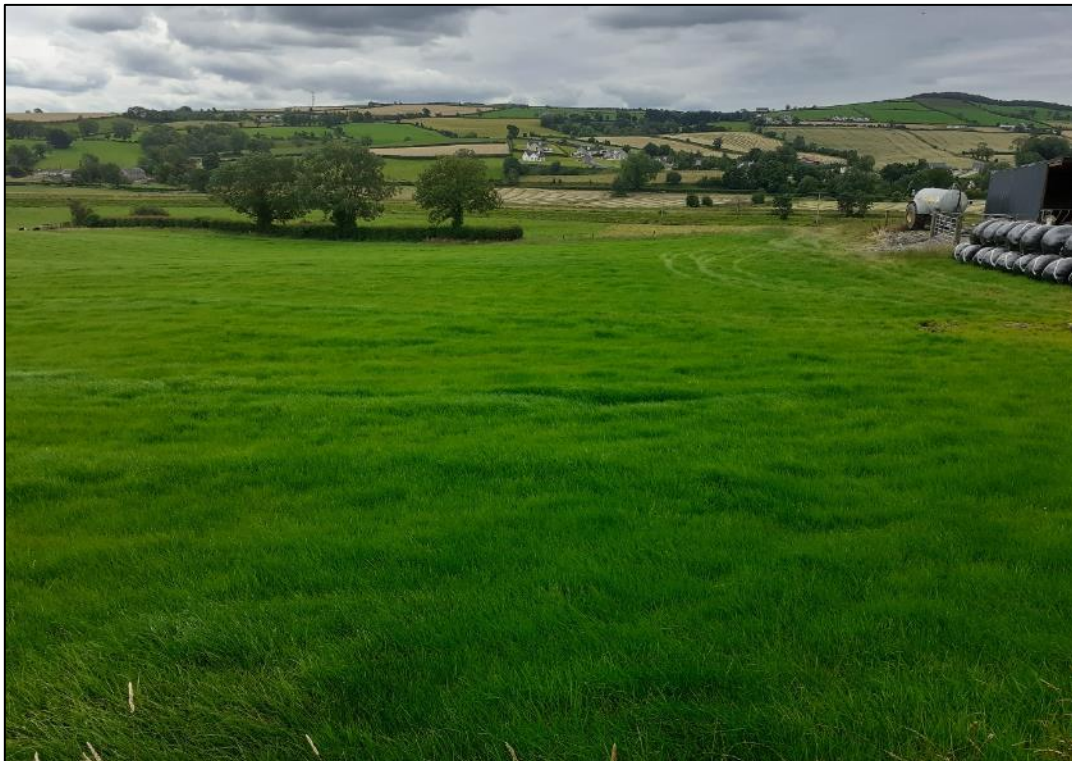
Ch. 14+100 – Ch. 14+700 consists of gently sloping improved pasture with drainage throughout that reaches the banks and floodplains on either side of the River Deele (Ch. 14+400). This is considered an area of archaeological potential and forms part of S3-AAP04 (**Plate S3-89** and **Plate S3-90**).

The former Strabane & Letterkenny Railway Line embankment traverses the alignment at Ch. 14+200 (ITM 630993, 899946) at Cavancor, near the north banks of the River Deele.

Plate S3-89: View to southwest of Ch. 14+200 & Ch. 14+300

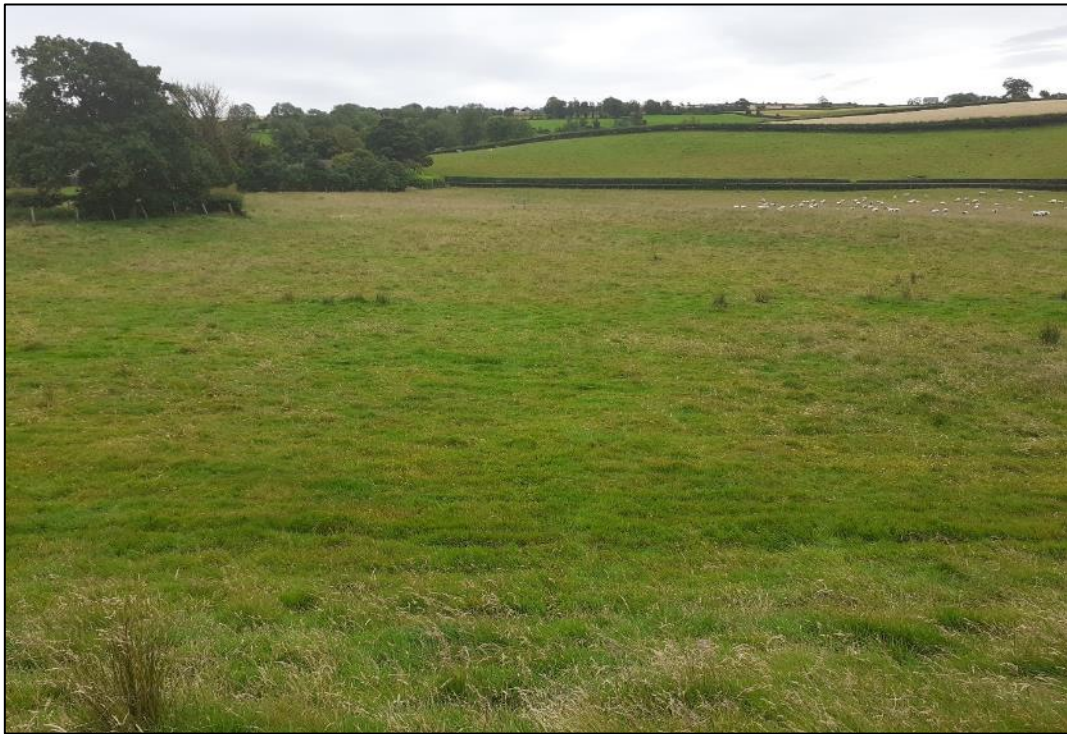
Plate S3-90: View to southwest of Ch. 14+500 to Ch. 14+800

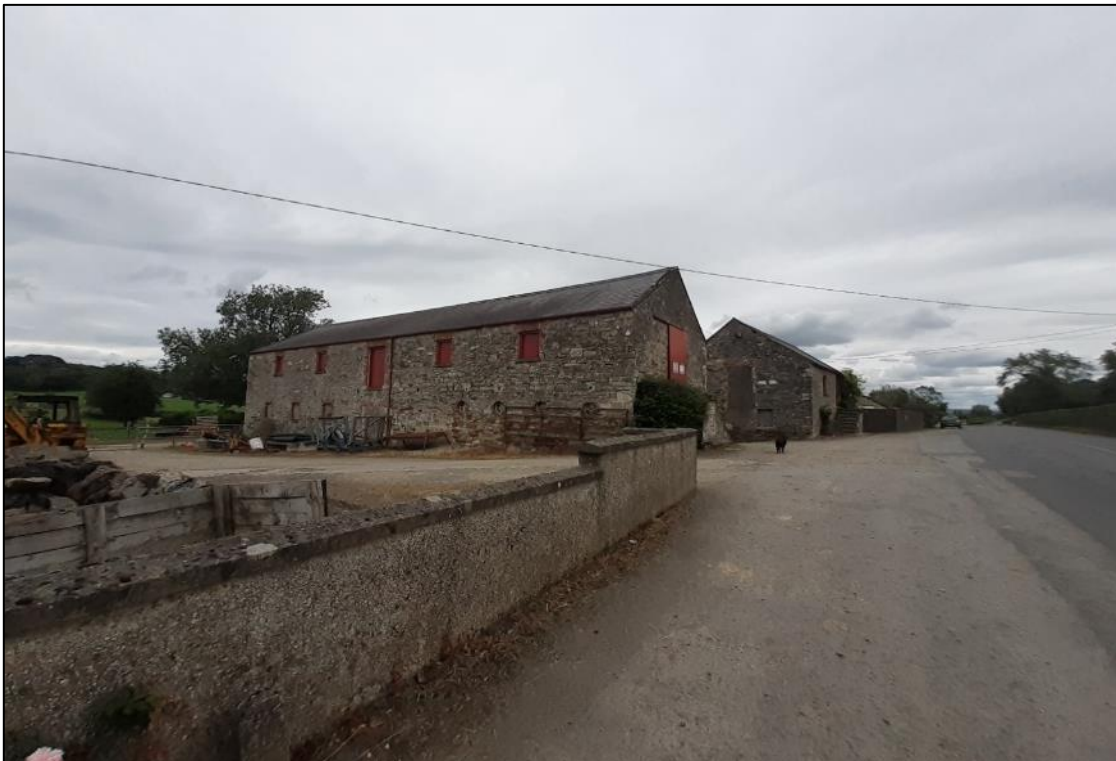
East of Ch. 14+700, fronting the local road network, at Murlough is a farmstead with an NIAH recorded two-storey outbuildings (NIAH 40834006) (ITM 631362, 899576) (**Plate S3-91**). The farmstead is indicated on both the 1st ed and 2nd ed OS mapping.

Plate S3-91: View to northeast of outbuildings NIAH 40834006 at Murlough, Ch. 14+700

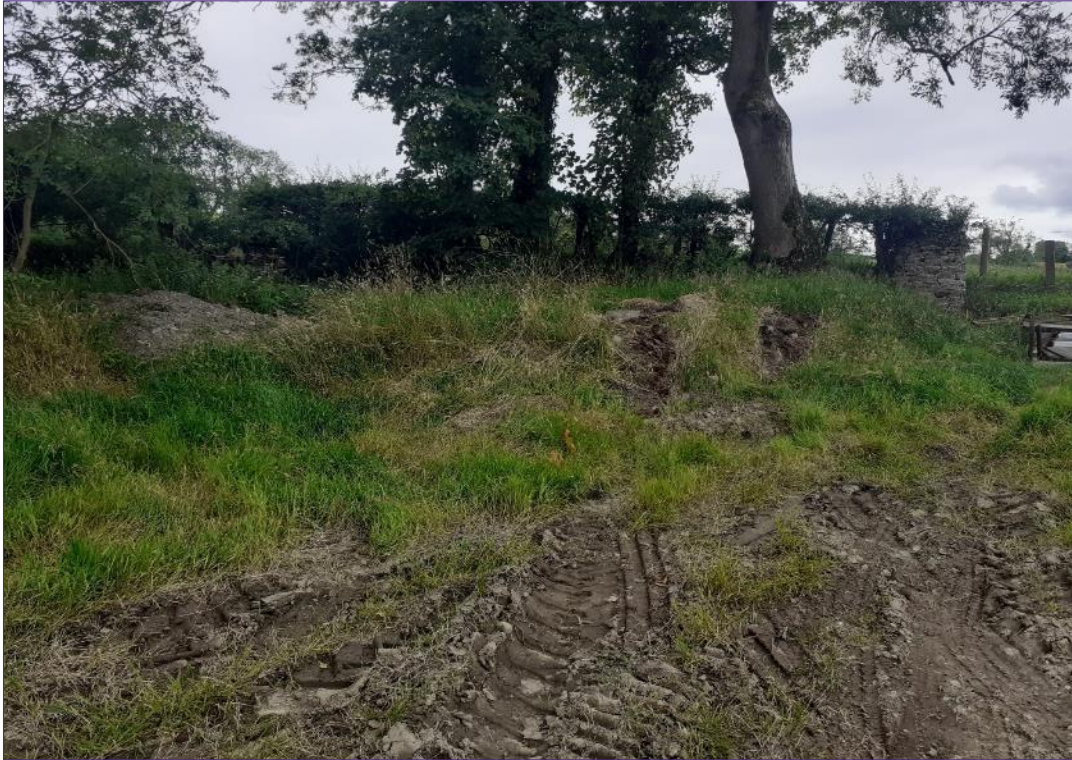
Between Ch. 14+700 to Ch. 15+200 is undulating good quality drumlin terrain, with a stream which forms the townland boundary of Ballynabreen and Murlough located northeast of the proposed alignment at Ch. 14+700 – Ch. 15+000. LiDAR anomaly L354-2 located at Ch. 14+850 (ITM 631415, 899424) a 'farmstead', was inspected and very partial remains a portion of elevation walling, and a vernacular rubble-built circular plan field entrance gate pier was noted at this location (**Plate S3-92**) and (**Plate S3-93**). The farmstead is indicated on the 1st and 2nd ed OS mapping.

Plate S3-92: View to south at Ch. 14+850, farmstead walling field gate pier (L354-2)

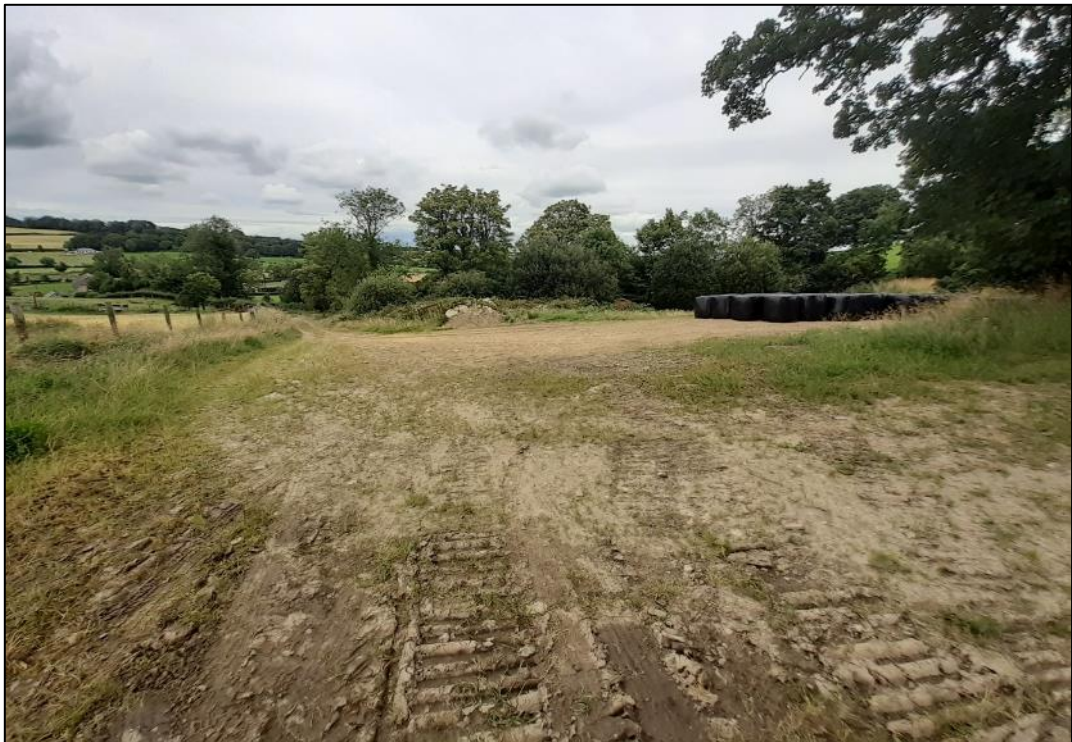
Plate S3-93: View to north at Ch. 14+850, ruined farmstead location (L354-2)

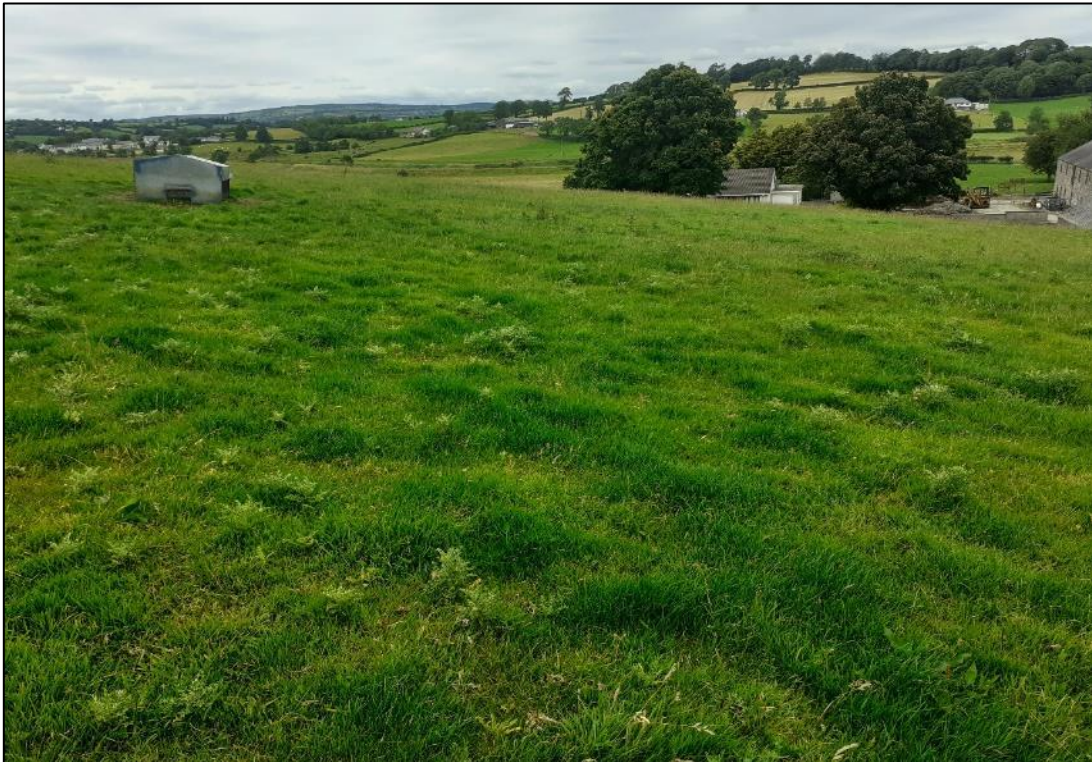
North of Ch.15+100 is the site of a standing stone (DG070-048---) (ITM 631630, 899335) whilst two other recorded 'sites of' standing stones (removed) are located to the south of Ch. 15+100 (DG070-049--- and DG070-050---) (ITM 631595, 899154 and 631562, 899098) (**Plate S3-94**, **Plate S3-95** and **Plate S3-96**). A windmill, 'Snodgrass Windmill' is located within a farm complex to the south of Ch.15+100 (NIAH 40834005) (ITM 631550, 899064) (**Plate S3-97**). This overall area, and in particular the portion of the proposed

Plate S3-94: View to north of Ch. 14+800

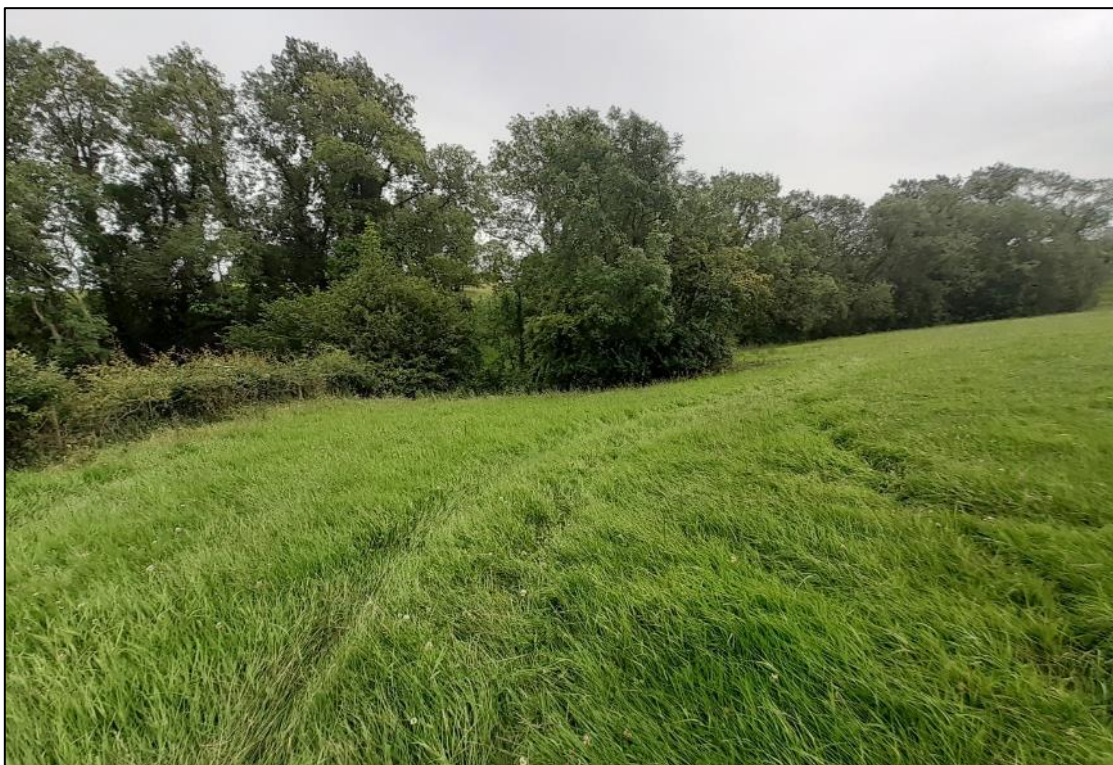
Plate S3-95: View to west at Ch. 14+950, at stream and boundary Ballynabreen/Murlough

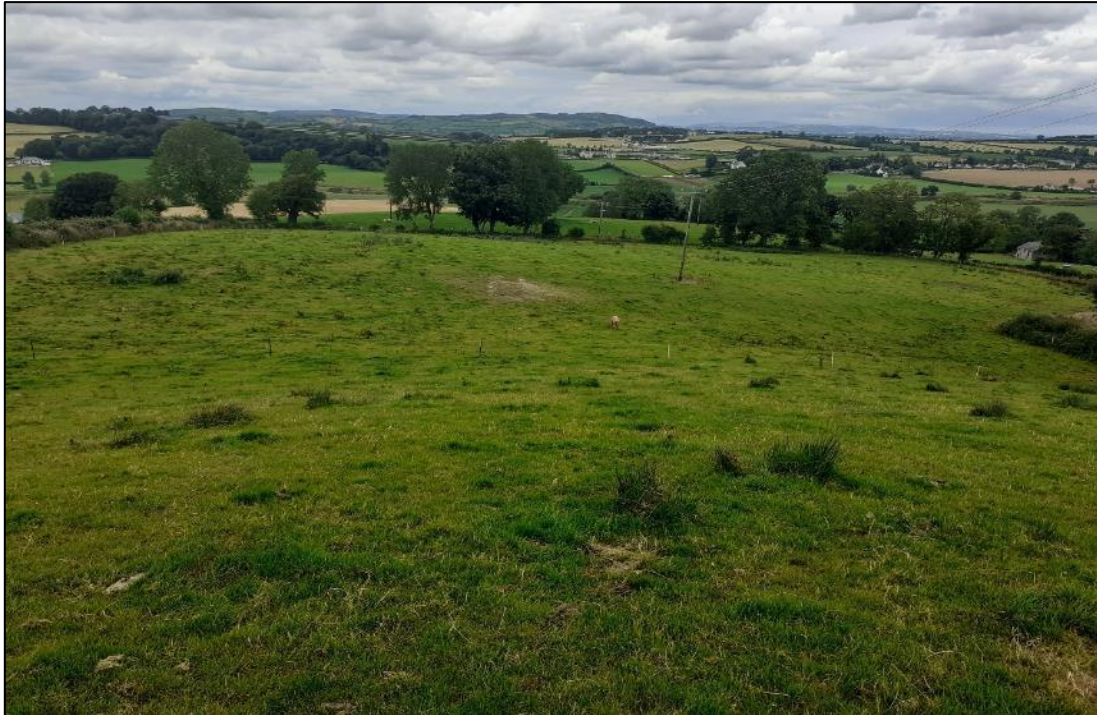
Plate S3-96: View to north of Ch. 15+150, and site of Standing Stone (DG070-048----) (removed)

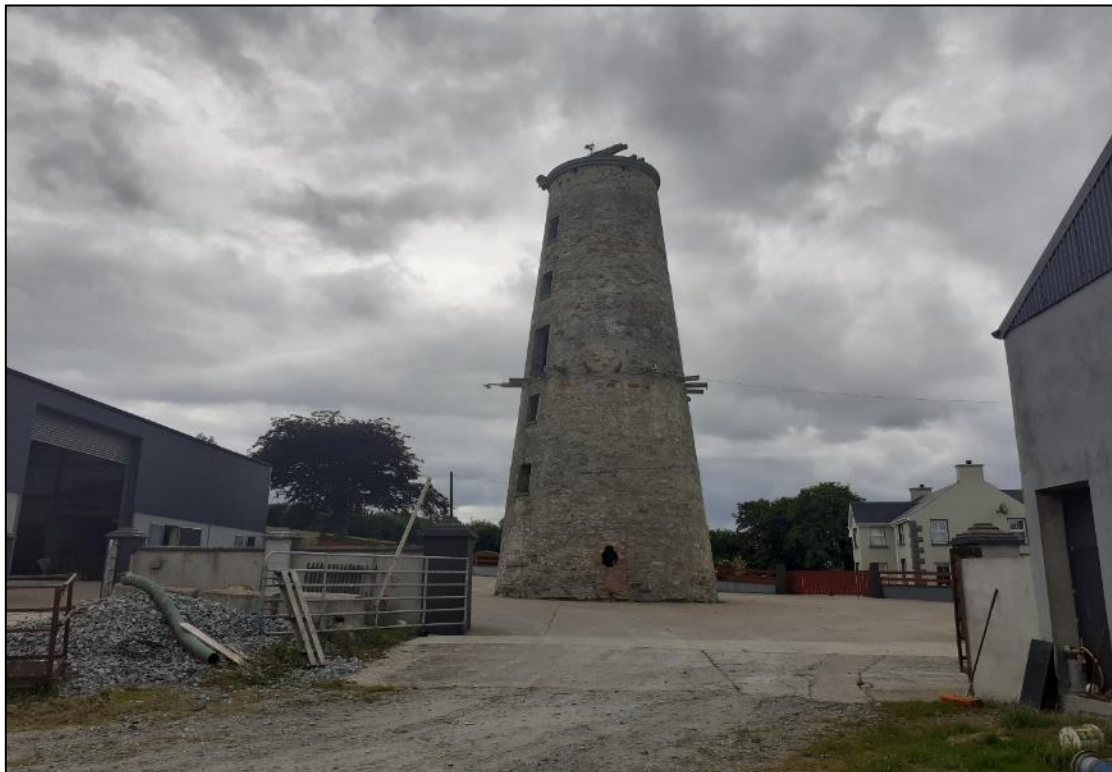
Plate S3-97: View to southwest of windmill (NIAH 40834005), south of Ch. 15+150

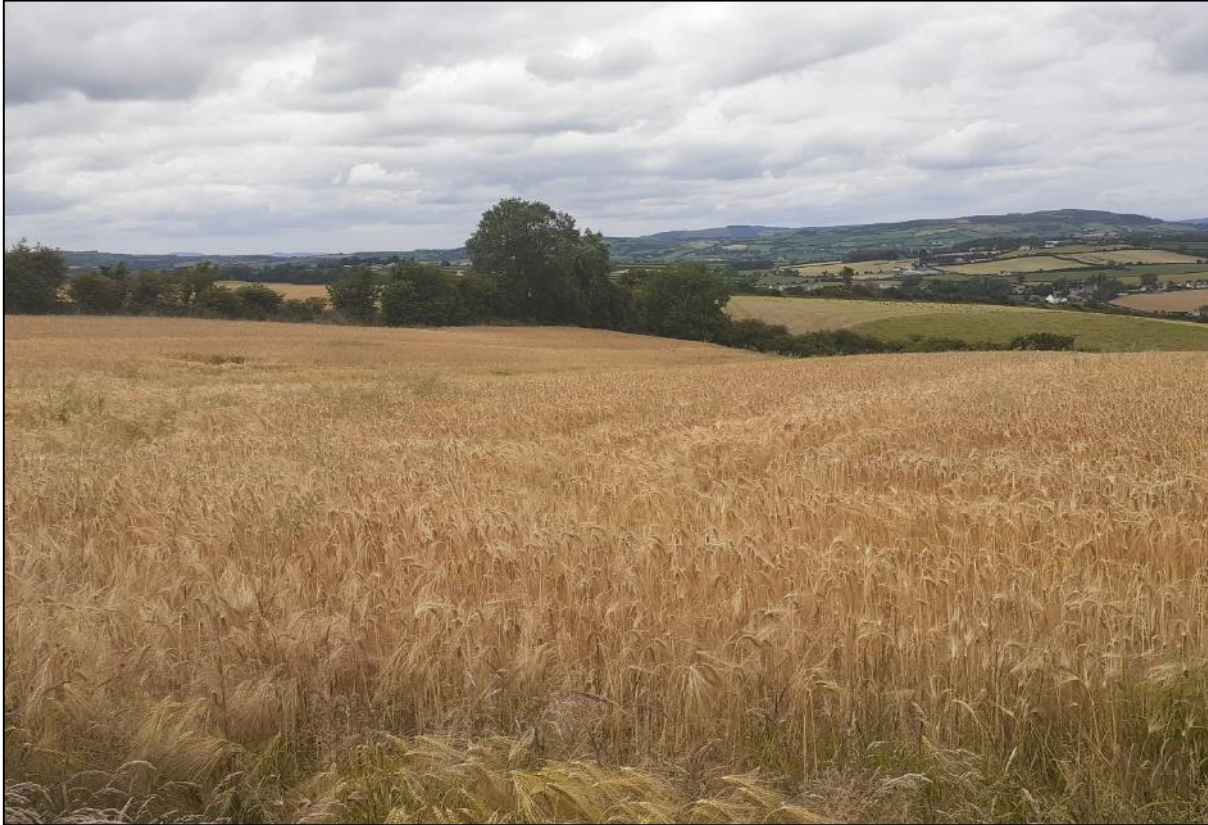
The areas between Ch. 15+200 and Ch. 15+700 were not inspected due to crop growth at the time of survey (**Plate S3-98**) although the undulating well drained soils are considered an area of archaeological potential, forming part of S3-AAP05.

Plate S3-98: View to north from local roadway at Ch. 15+500

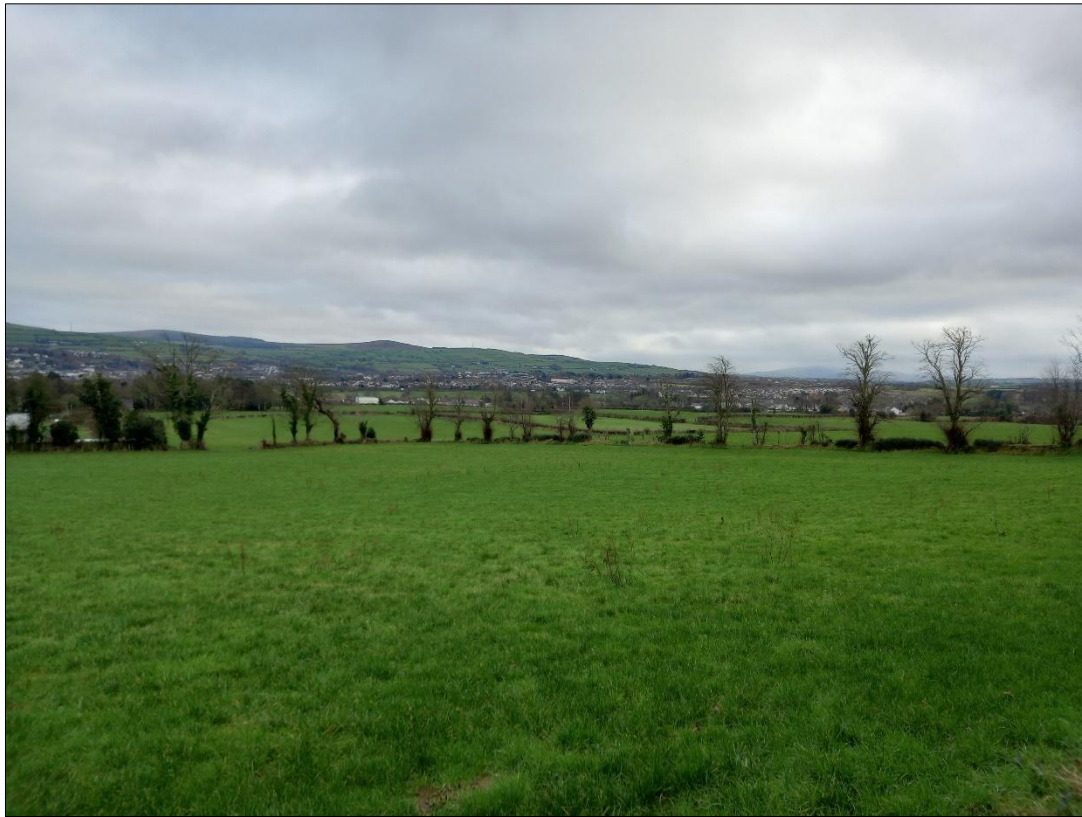
East of Ch. 16+350 – Ch. 16+550 there are 4 no. recorded standing stone sites: DG071-005--- (ITM 632525, 898541), DG071-007--- (ITM 632656, 898508), DG071-006--- (ITM 632681, 898552) and DG071-009--- (ITM 632932, 898360). All of these standing stones have been removed (**Plate S3-103**).

Plate S3-103: View to east of (DG071-006---) & (DG071-007---), E of Ch. 16+300

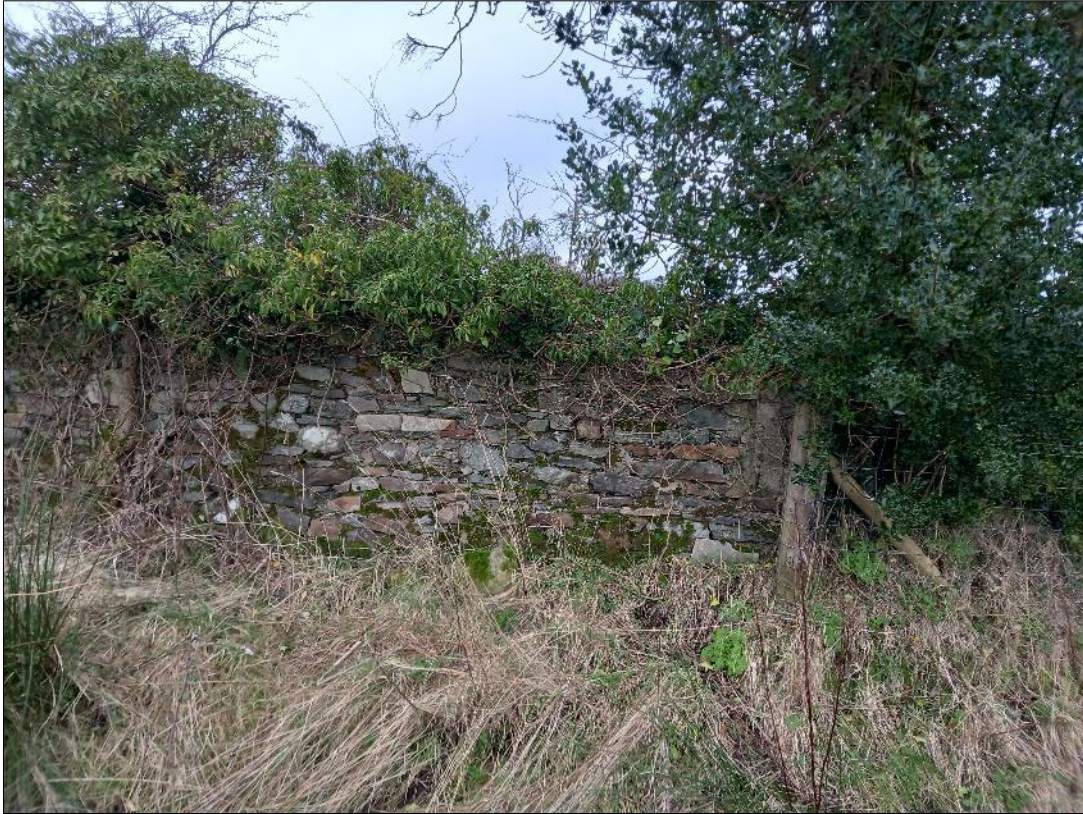
Ch. 16+700 – Ch. 17+100 consists of undulating parkland, in use as pasture, and forming part of the attendant grounds to the front (southeast) of Croghan House (NIAH 40835028 and Historic Garden DG0040) (**Plate S3-104** and **Plate S3-105**) (ITM 632472, 898002 indicative centre-point). The house is accessed via a straight southeast/northwest extending avenue from the east (with a former gate-lodge per the 2nd ed OS mapping) which then turns sharply to the southwest (Ch. 16+800). Demesne stone walling forms the townland boundary of Townparks/Carricknaslate at Ch. 16+700 with a former well (M739) also located in this area (**Plate S3-106** and **S3-107**).

Plate S3-106: View to south of demesne walling (Croaghan House) forming townland boundary
Townparks/Carricknaslate at Ch. 16+650

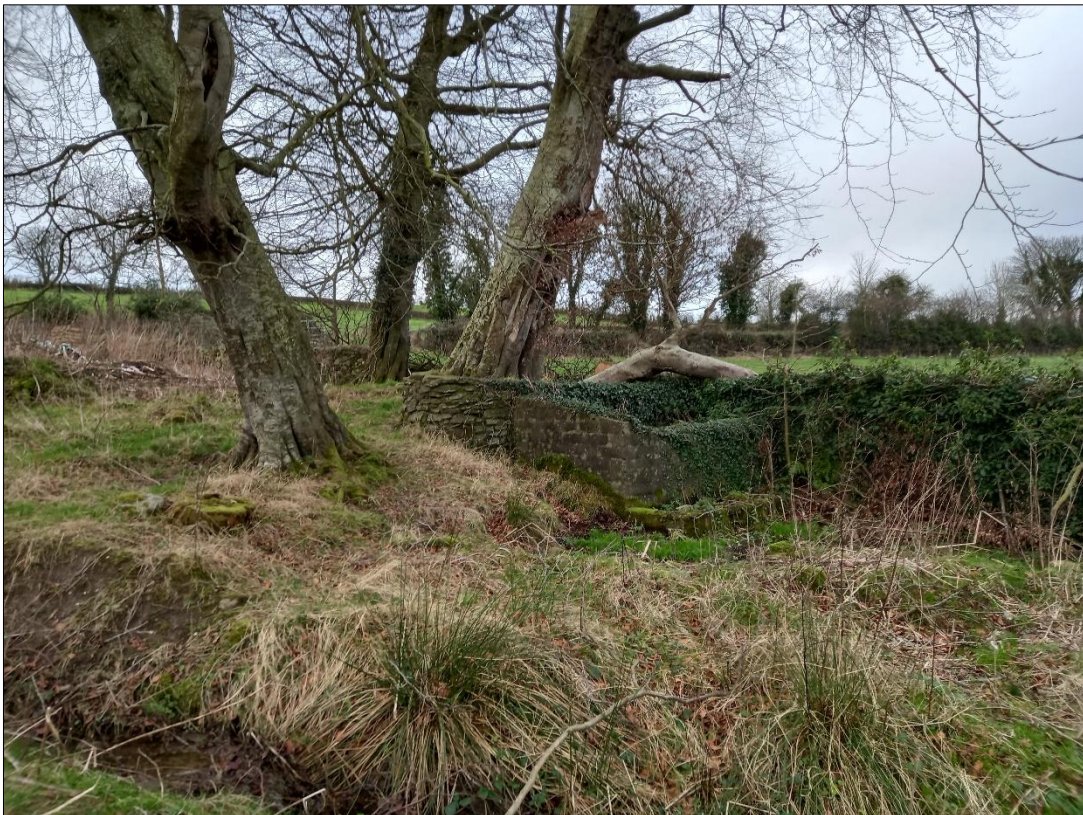
Plate S3-107: View of former well M739 along demesne boundary at Croghan House at Ch. 16+650

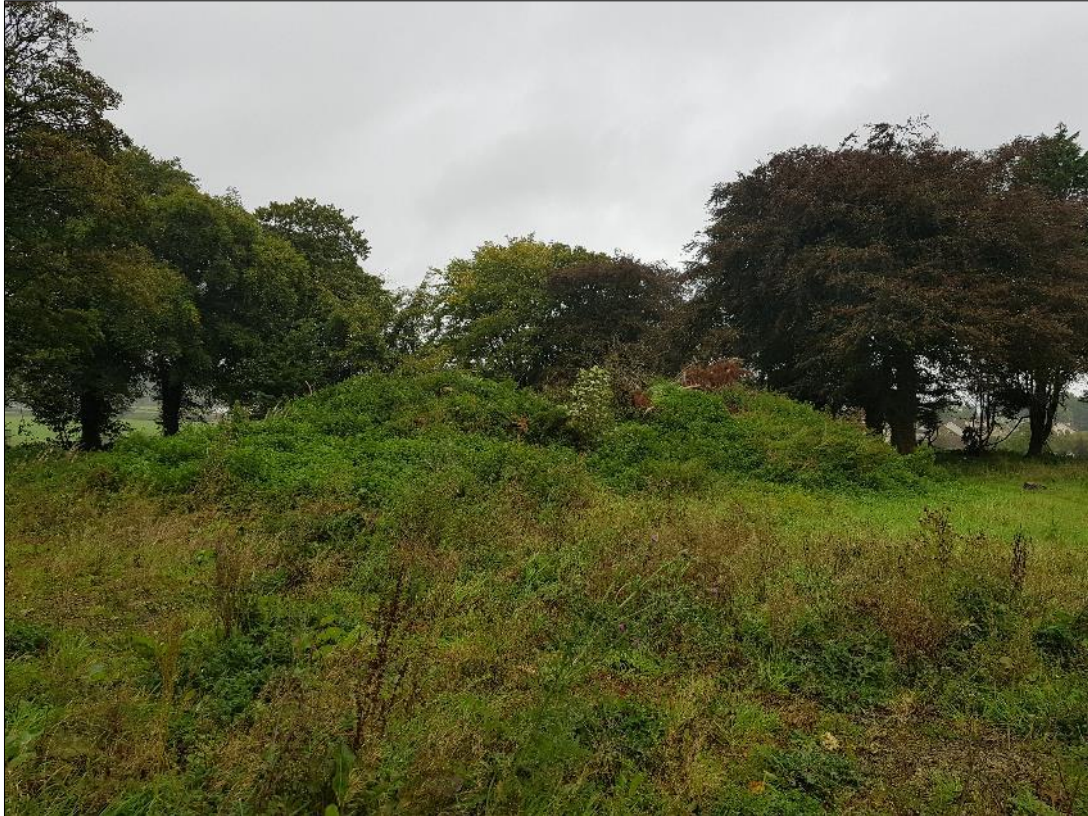
Plate S3-118: View towards NW of grassed over rubble remains of demolished Red House HB10/08/003

Lands opposite the A5 Link tie-in on the south side (Northern Ireland) of the River Finn consists of low-lying improved pasture, with areas of dense vegetation, which reach the banks of the River Finn (**Plates S3-112, S3-115 - S3-117**). The A5 bridging point on the Lifford side of the river similarly consists of low-lying improved ground although rough grazing pasture is noted near the riverbanks (**Plate S3-113 and S3-114**). Lands immediately west of the tie-in location on the southern (Northern Ireland) banks are host to a former refuse dump, (closed 2014) and managed by Derry City & Strabane District Council. The former railway line (*Finn Valley Railway*, opened 1863) traversed through these lands but has been removed. In 1892 the railway company merged with *West Donegal Railway* into the *Donegal Railway Company* and the line from Stranorlar to Strabane was reconstructed to 3ft gauge shortly afterwards. Steep embankment drop is noticeable along Urney Road to the southeast, where the railway line ran directly parallel/abutting same. Heavy mature tree-growth along Urney Road at this location also screens any views towards the tie-in point to the north-east. Historic OS mapping refers to the lands being liable to flooding and flood embankment are in place along the river edge. It was noted during field survey that historic building HB 10/08/003 Red House and gate lodge have been entirely demolished and the site is now derelict (**Plate S3-118**).

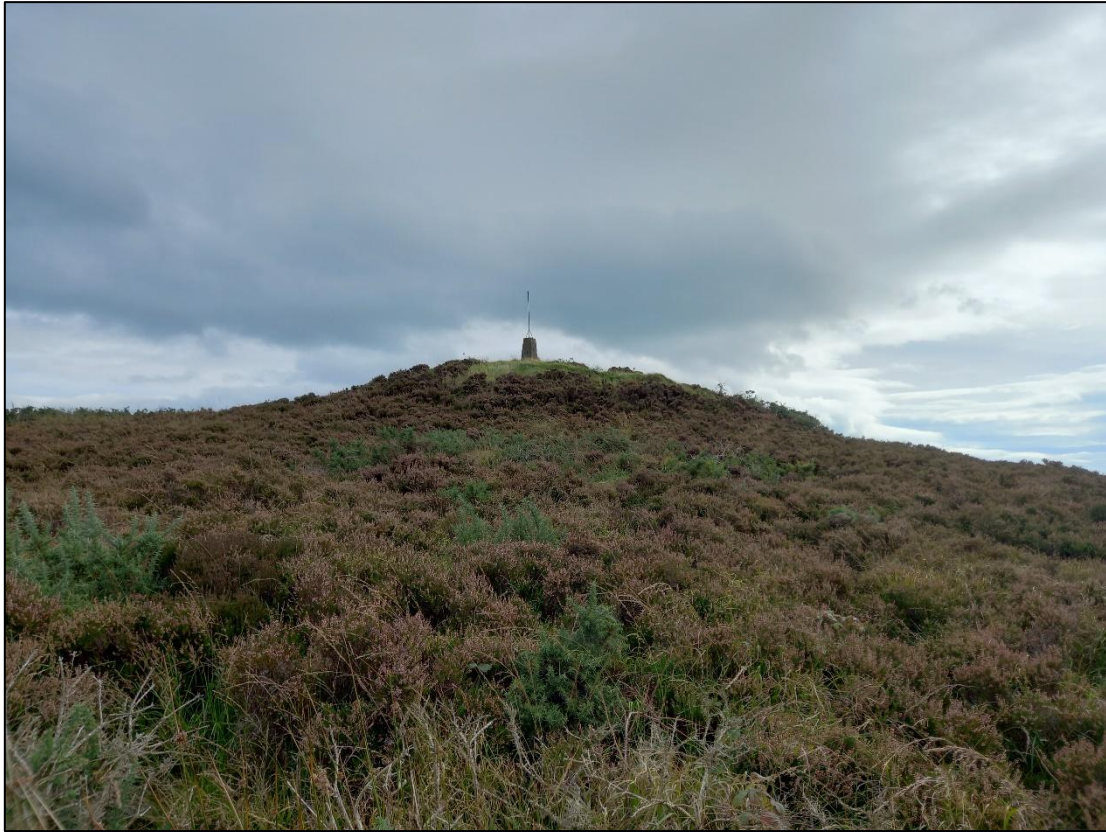
The hillfort (DG070-074001-) with a passage tomb site within its enclosing bank (DG070-074002-) is located at the summit (217 m OD) of the broad SW-NE extending ridge of Croaghan hill. The site is not apparent on (foot) approach from the south. The land rises northwards and the hillfort is difficult to access, with its interior covered in dense heather and vegetation growth. Evidence of rock outcropping was noted throughout. The passage tomb presents as a conspicuous mound on the highest point of the interior and has a concrete OS trigonometrical station on top (**Plate S3-119**). The tomb has been damaged and robbed out at the west (**Plate S3-120**), at its likely original entrance passage area which overlooks the Kilmonaster passage tomb cemetery c. 2.5 km to the west (**Plate S3-121**). This westerly view is the predominant aspect from the site. The overall site setting (including the hillfort) has been slightly compromised by the presence of commercial forestry to the northeast. However, the broad SW-NE extending shoulder ridge partially obscures views to the lowlands below, including that towards the proposed development boundary at the east/southeast (**Plates S3-122, S3-122 and S3-123**). This, together with overall extensive distance proximity (c. 2.4 km) to the southern terminus area of Section 3 and the A5 Link Road is deemed a Not Significant significance of effect on this site and its heritage landscape setting.

Plate S3-119: View towards west of passage tomb DG070-074002- Croaghan Hill
