Appendix C17.13

Section 3 Detailed Walkover Survey and Photographic Record

Ten-T Section 3, Manorcunningham to Lifford, Co. Donegal

(8th – 10th, 16th, 20th & 21st July 2020, 21 Jan 2022, 21 Sep 2022)

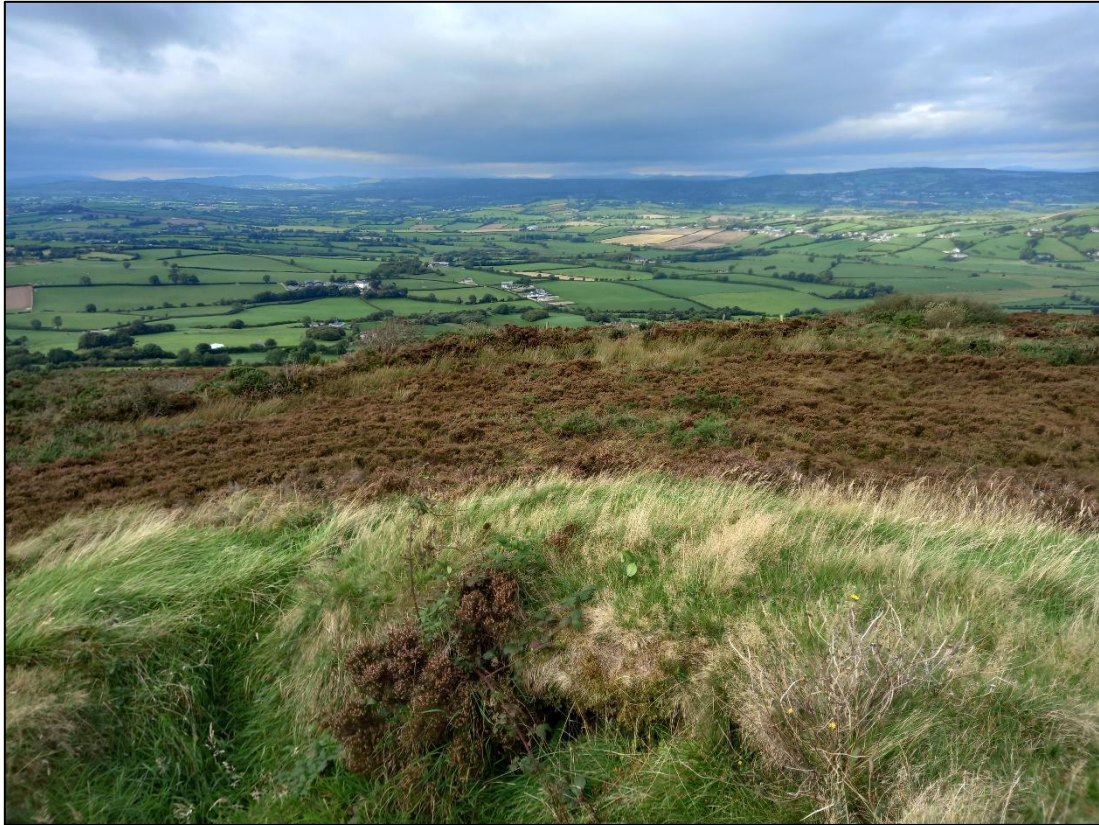
Plate S3-121: View towards west from probable entrance area of passage tomb DG070-074002- Croaghan Hill, overlooking Kilmonaster passage tomb cemetery area
