Deer Collision Risk Assessment

DEER COLLISION RISK ASSESSMENT ON THE TEN-T PRIORITY ROUTE IMPROVEMENT PROJECT, DONEGAL

AUTHOR: T.D.BURKITT PhD (MMU) DIP. FIELD ECOL.(UCC)

SEPTEMBER 2023

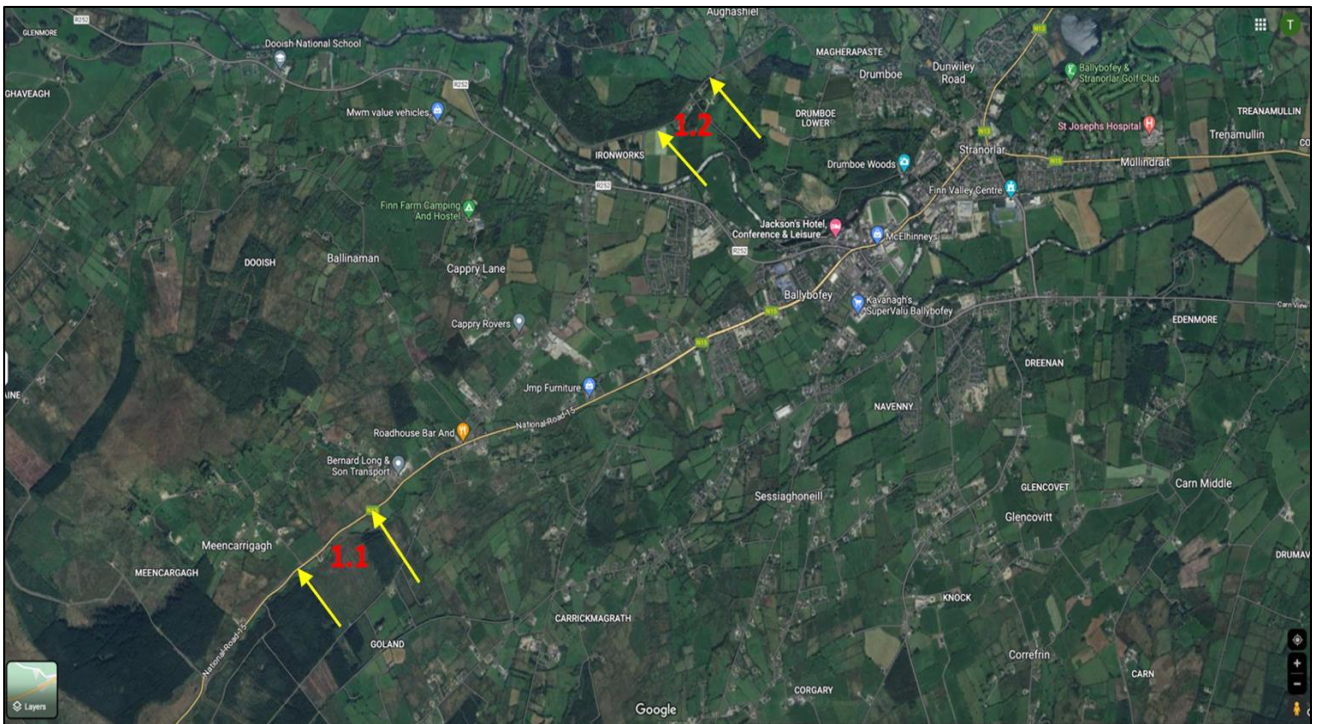
Figure 6: Details of Deer Collision Zones on Section 1 (1.1 and 1.2) - image courtesy of google maps (Map data © 2023 Google)

1.1 (GR H105929) - This section was considered to be an area of low risk of deer collisions although deer were present in the Coillte property adjacent to the N15. There was no visible evidence deer crossing at this point, but in view of the location and proximity to other forestry blocks, measures from Mitigation level 1 are recommended on this section.

1.2 (GR H129955) - This section was a mix of agriculture and urban / sub-urban landscape with a small woodland (Creggan wood) adjacent to the proposed new route. There was no evidence of deer in this woodland and it was considered to be an area of no risk of collisions occurring. No Mitigation is recommended on this section.

In Section 1, it is recommended that the cutting of roadside vegetation be undertaken as the primary mitigation measure at the three locations 1.1, 1.3 and 1.4. In addition, fixed warning signage should be erected on the approaches to those locations to warn drivers of the potential for deer to be active in the area of the road at these locations. At both 1.3 and 1.4 consideration can be given to enhancing the signage with Vehicle Activated Signage (VAS), particularly during the key times of year for deer activity in the autumn and spring.

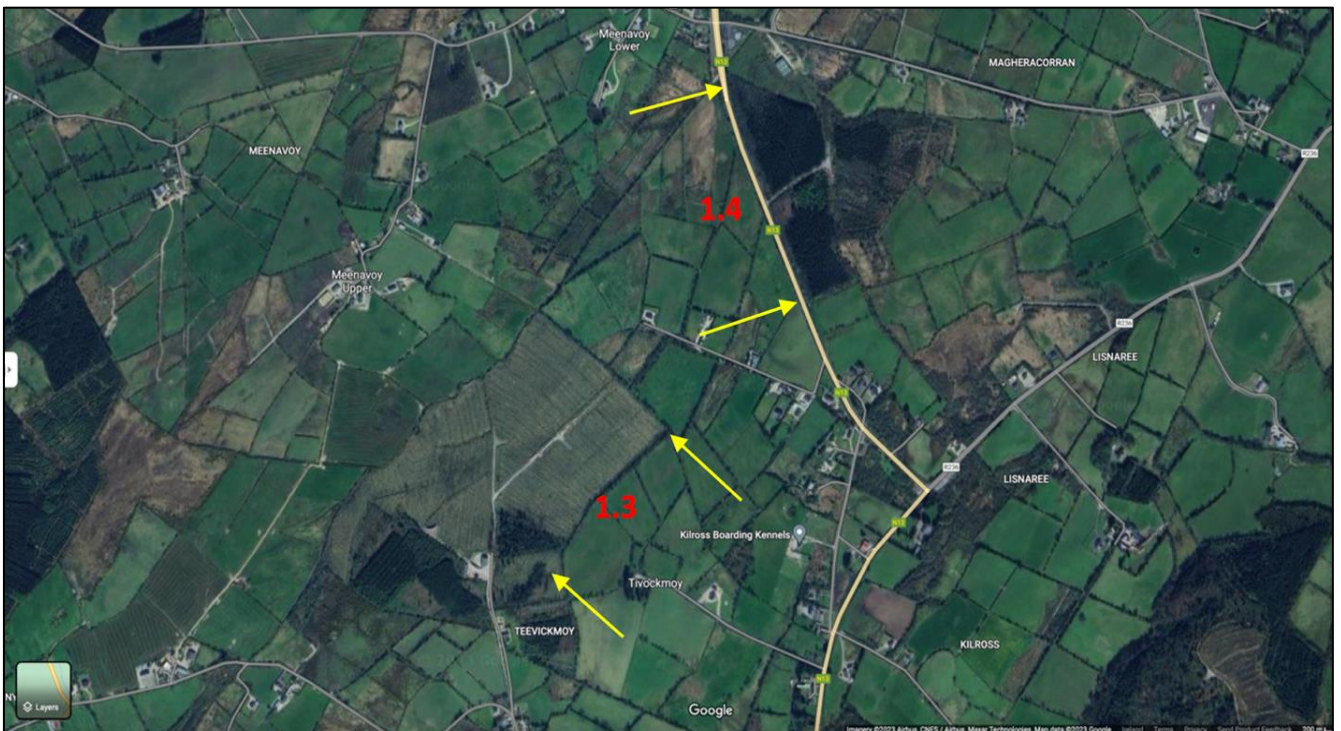
Figure 7: Details of Deer Collision Zones on Section 1 (1.3 and 1.4) - image courtesy of google maps (Map data © 2023 Google)

1.3 (GR H156983) - This section was agriculture / forestry mixed landscape with a significant forestry plantation just north of the proposed new route. There was evidence of red deer in this plantation and given its position in relation to other woodland (1.3km to the east) in the overall landscape, it was considered to be an area of moderate risk of deer collisions occurring. Mitigation level 1 is recommended on this section.

1.4 (GR H163991) - This section was also within an agricultural / forestry landscape and red deer were found to be present in the plantation to the north of the N13. As with the 1.3 above given the position of this plantation within the overall landscape and its proximity to other woodland (within 1.0 - 2.0km) and forestry it was considered to be an area of moderate risk of deer collisions occurring. Mitigation level 1 is recommended on this section.

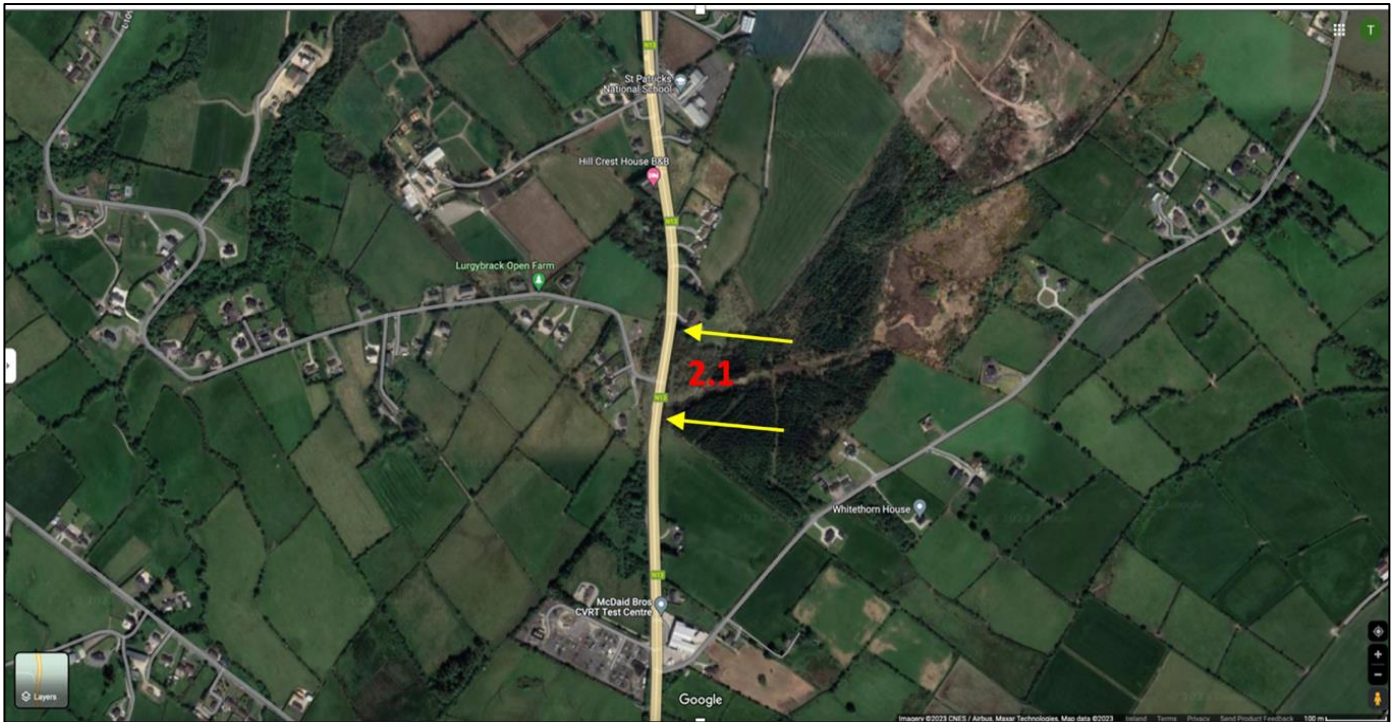
Figure 8: Details of Deer Collision Zones on Section 2 (2.1) - image courtesy of google maps (Map data © 2023 Google)

2.1 (GR C199088) - This section was close to an urban / sub-urban landscape with a small amount of woodland present. However, sika deer were found to be present in the woodland block adjacent to the proposed new route and it was considered to be an area of low risk of deer collisions occurring. Measures from Mitigation level 1 are recommended on this section.

In Section 2, it is recommended that the cutting of roadside vegetation be undertaken as the primary mitigation measure at location 2.1 with fixed warning signage also erected on the approaches to this location. It should be noted that it is proposed as part of the TEN-T PRIPD, that the area of forestry to the east of the road project will be felled which may further reduce the likelihood of deer crossing the road at this location.

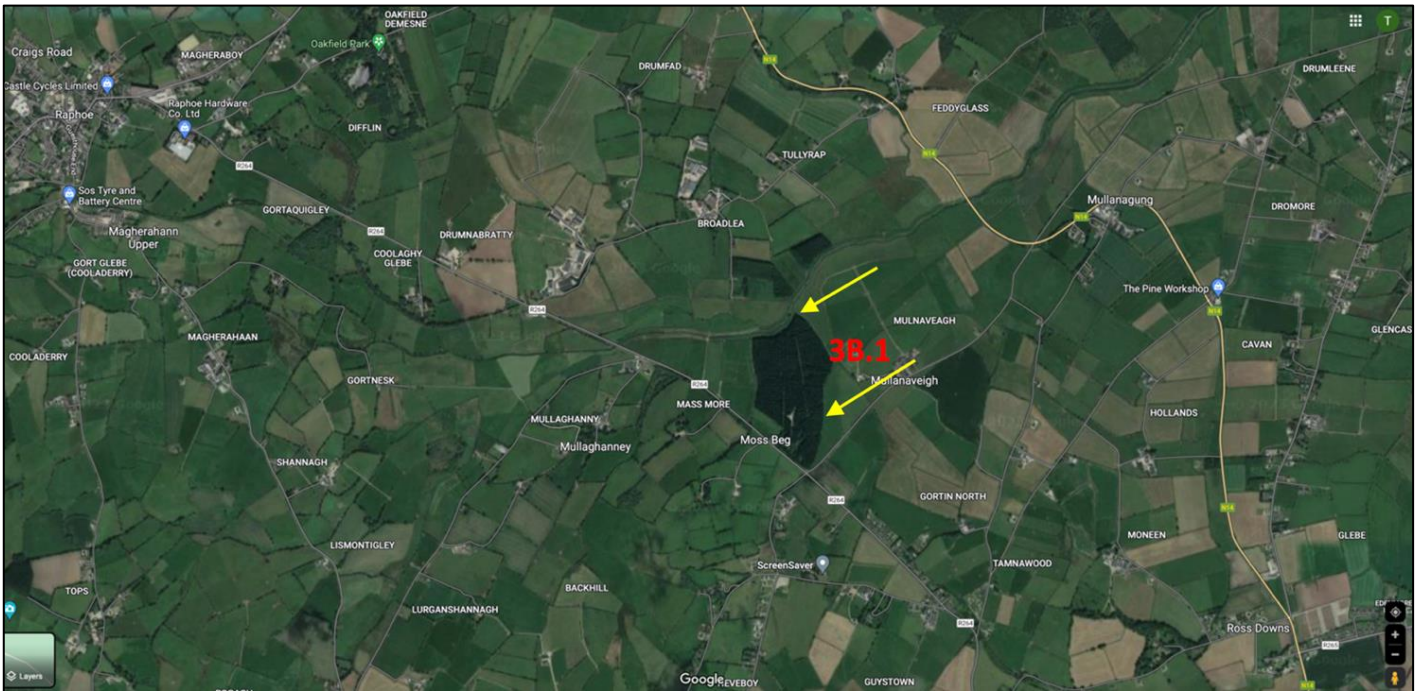
Figure 10: Details of Deer Collision Zones on Section 3B (3B.1) - image courtesy of google maps (Map data © 2023 Google)

3B.1 (GR H295015) - This section was in a predominantly agricultural landscape with occasional scattered woodland. Red deer were found in the plantation adjacent to the proposed new route but a very low density. Given that this plantation is relatively isolated it was considered to be an area of low risk of deer collisions occurring. Measures from Mitigation level 1 are recommended on this section.

In Section 3, it is recommended that the cutting of roadside vegetation be undertaken as the primary mitigation measure at location 3B.1 with fixed warning signage also erected on the approaches to this location. Should deer activity increase in this area, consideration should be given to providing deer fencing between approximate chainages 11+500 and 12+200 both north and south of the proposed new N14.

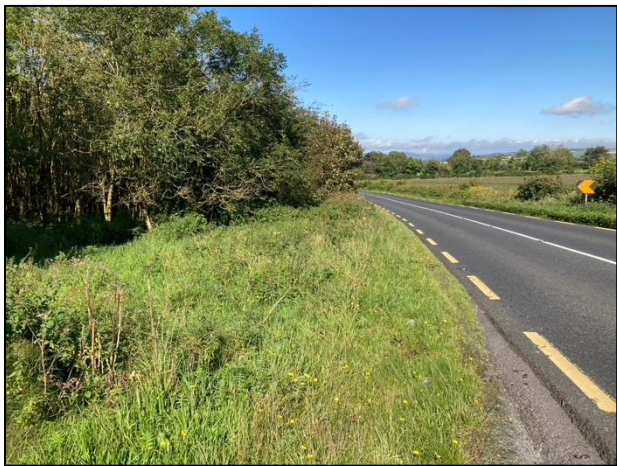
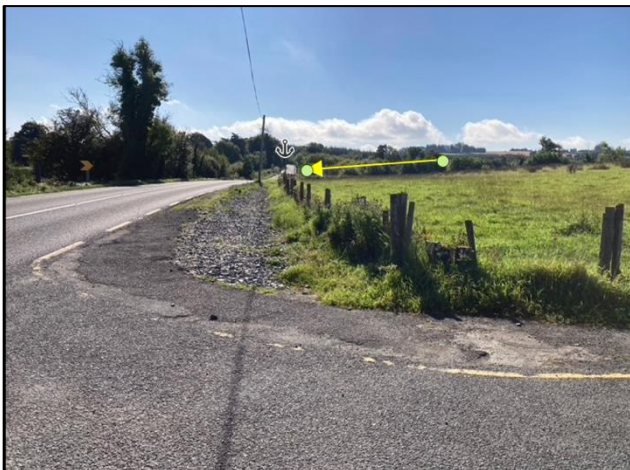
Figure 11: PDCZ 3A.1 looking north (above) and below looking south on N14

3A.1 (GR H269070) - This section of road was in a predominantly agricultural landscape but with scattered patches of woodland. Red deer were present in the woodland adjacent to the N14 and there was a significant amount of deer activity noted in the woodland itself (tracks, droppings, bark-stripping) - more than at any other location. Also, this woodland block is close (within 3.0km) to an identified source population of red deer at Mongorry and it is likely that red deer have migrated from Mongorry northwards via this point to the Inishowen Peninsula. Given the location of the plantation and its proximity to the N14, its position within the overall landscape it was considered an area of high risk of deer collisions occurring. As a minimum, measures from Mitigation level 1 are recommended on this section. However taking into consideration the layout of the proposed new N14 and the potential for increasing deer activity, it is recommended that consideration be given for enhanced mitigation. Measures at this location, e.g. deer fencing, and if appropriate, a deer underpass to reduce the risk of DVCs. It is recommended that Mitigation level 1 is undertaken in the first instance, but due consideration should be given to also undertake Mitigation level 2, provided that sufficient monitoring of mitigation effect is undertaken.

11. *For the High Risk site (3A.1), the same mitigation as the Low Risk sites is proposed supplemented by the inclusion of deer fencing and a deer underpass.*
