Aquatic Ecology Survey Site Images

TEN-T Priority Route Improvement Project, Donegal

TT_MGT0337-RPS-P3-ZZ-RP-E-EN0001

EIAR

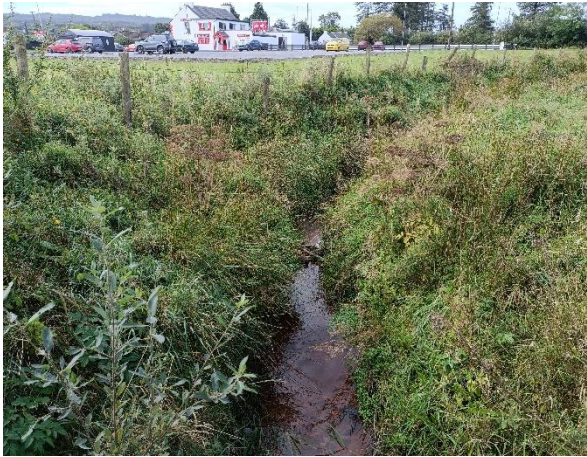
W1-05 (Sept. 2024) Cappry, view of drain upstream of crossing point

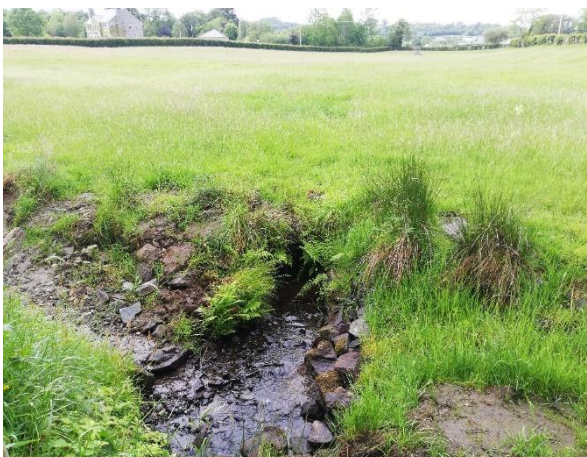
W1-07 (June 2020) Dromboe Lower, view over piped section in field. This will be daylighted as part of proposed works.

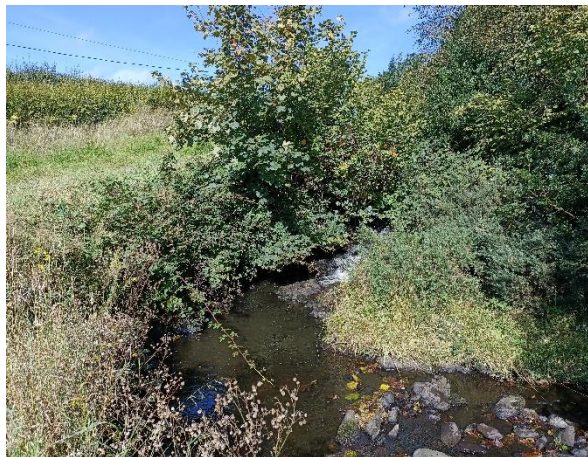
W1-08 (Sept. 2024) Backlees, view upstream in crossing reach. Bedrock rapid / waterfall in view.

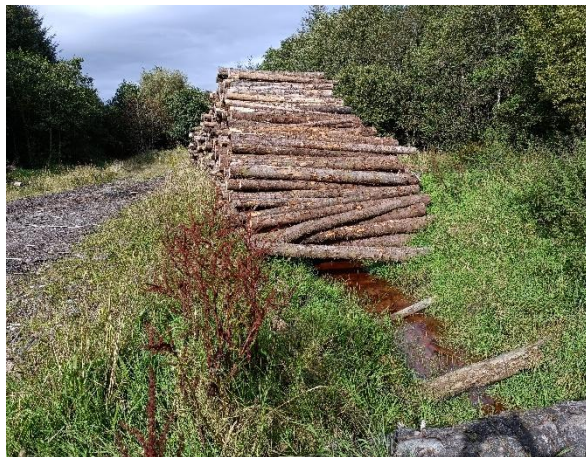
W1-12 (Sept. 2024) Lisnaree, recent forestry harvest stockpiled over shallow low-quality drain.

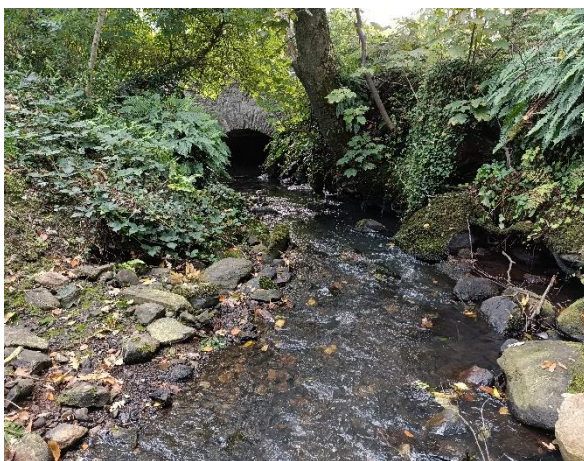
W1-20 (Sept 2024) Mullaghagarry, view downstream towards existing N15 culvert

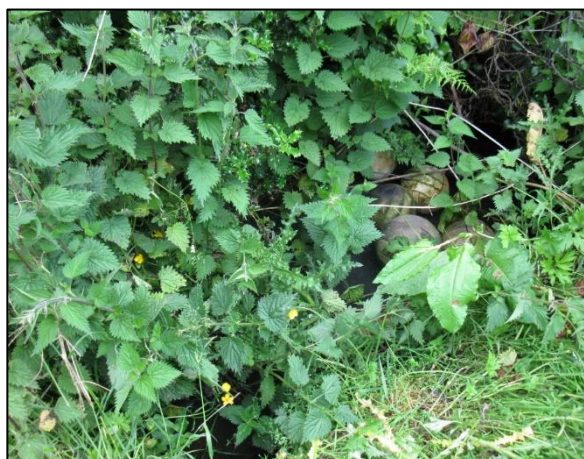
W2-03 (June 2020 and Sept. 2024) Unnamed tributary of Swilly in Drumany - stagnant in field boundary drain

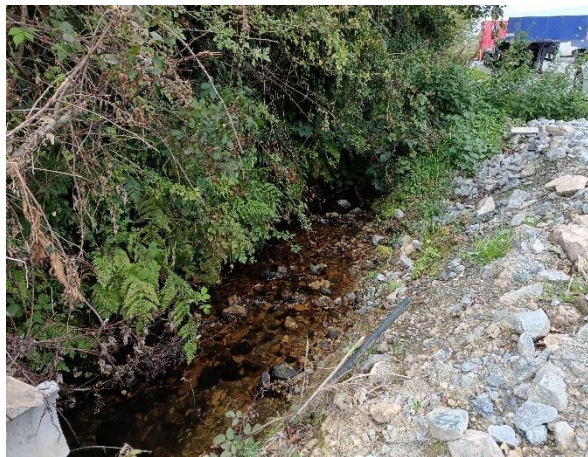
W2-05 (Sept. 2024) Channel had been recently culverted (pipe) for industrial entrance in 2024.
