Aquatic Ecology Survey Site Images

TEN-T Priority Route Improvement Project, Donegal

TT_MGT0337-RPS-P3-ZZ-RP-E-EN0001

EIAR

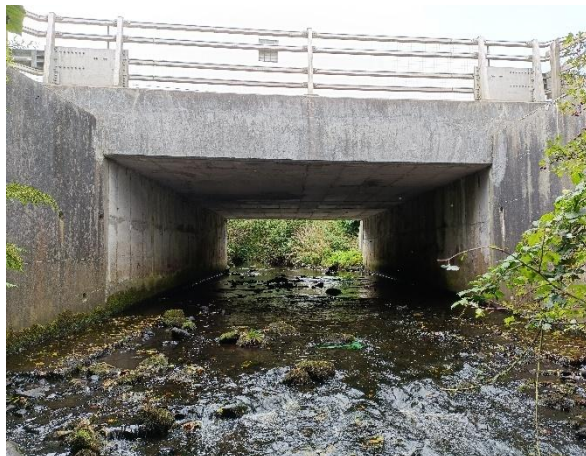
W1-14 (Sept. 2024) Cloghroe River, existing Callan Bridge - N13.

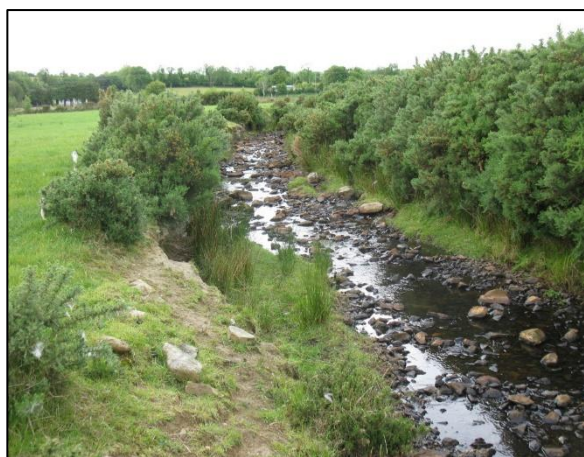
W1-16 (Sept 2024) Tircallan, headwater of Mullaghagarry. Good trout habitat.

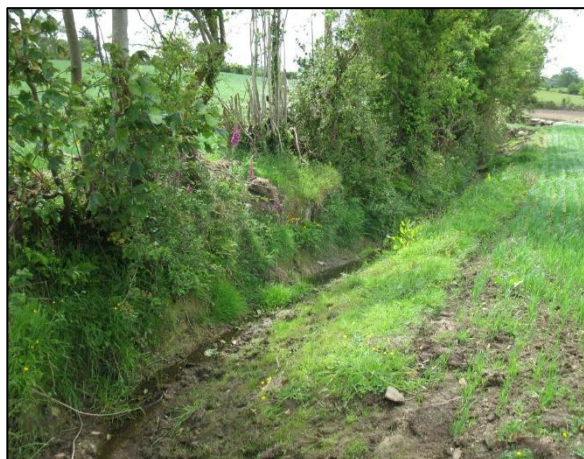
W2-01 (June 2020) Unnamed tributary of Swilly in Drumany - general nature.

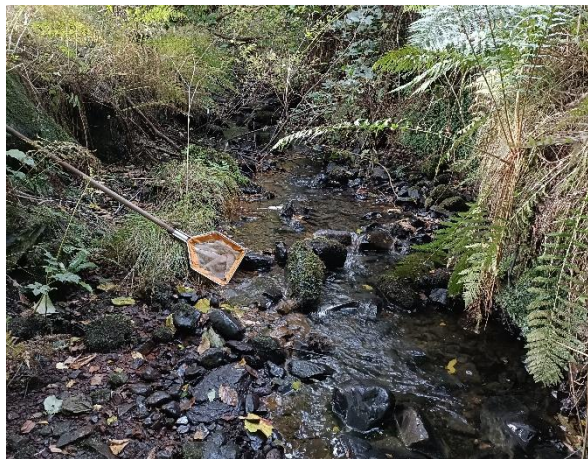
W2-11 (Sept. 2024) Farsetmore at macroinvertebrate sampling site. Wooded stream.

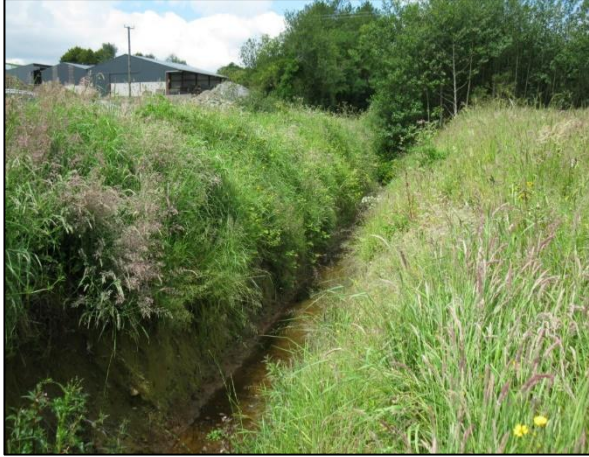
W2-13 (June 2020 and Sept. 2024) Trimragh – no flow, stagnant pools only. Ephemeral.

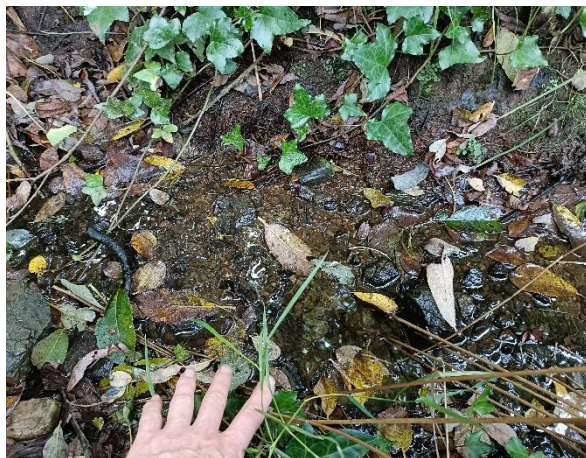
W2-26 (Sept. 2024) Ephemeral drain in Listellian townland (connects to Magheraboy 39).

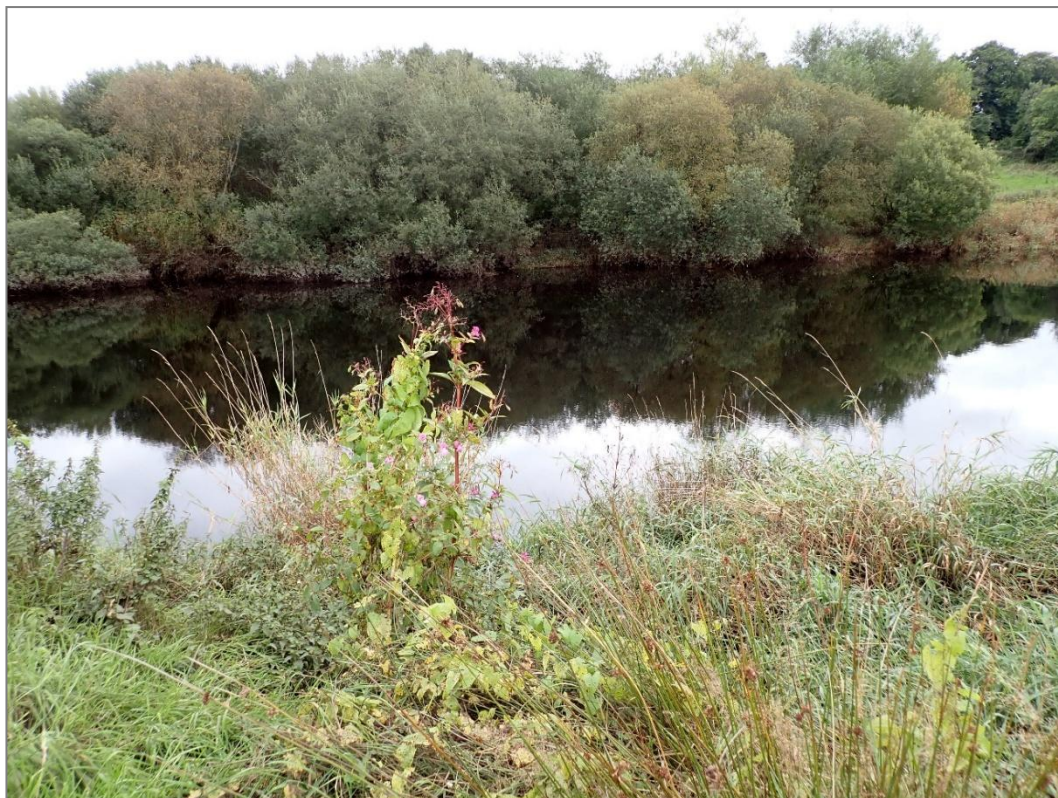
W3-21. River Finn crossing point at Curraghalane (view from south bank).

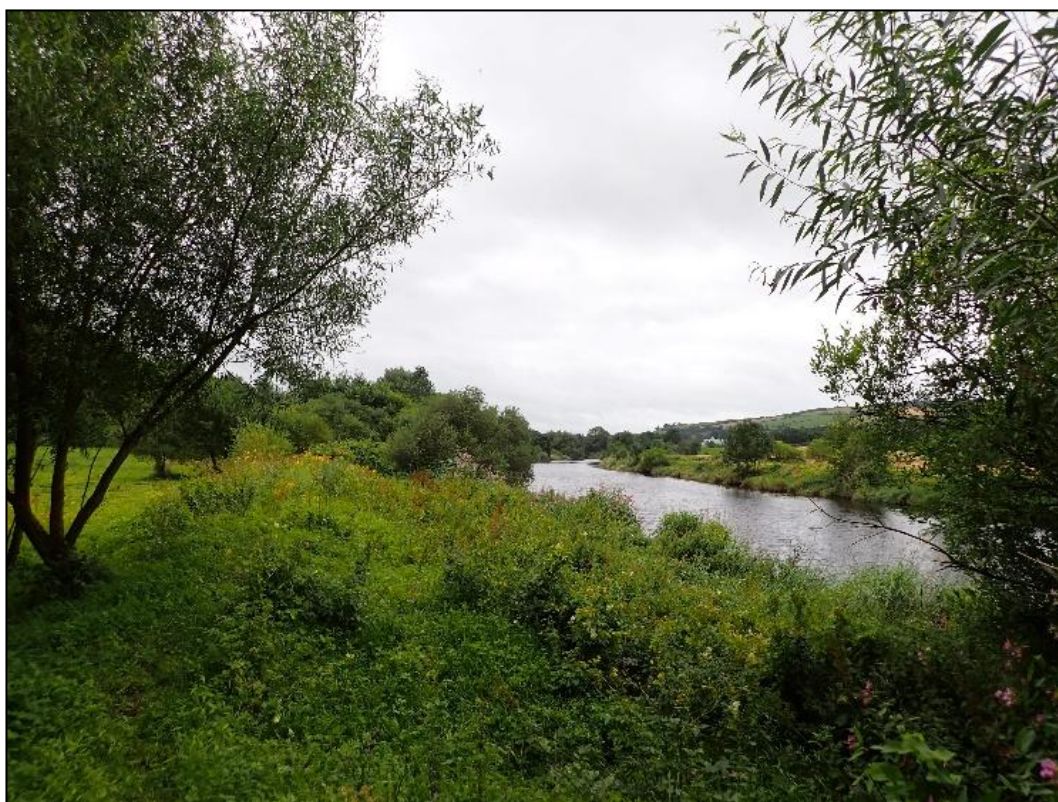
W3-21 River Finn riparian zone at Curraghalane (view from south bank)
